# **Youth Conservation Corps Project**

A Final Report to

The New Hampshire Department of Environmental Services

December 31, 2007

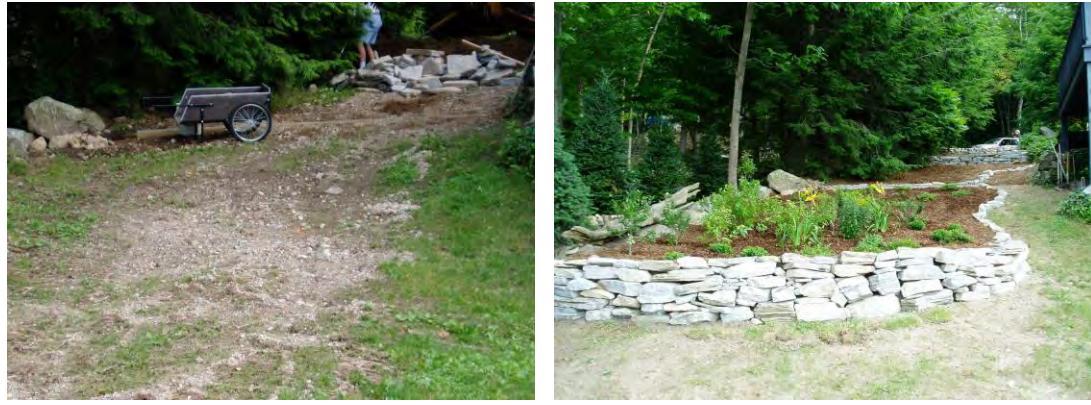
Schier Property Before YCC Work

The homeowner was experiencing a significant amount of sheet erosion toward the lake on both sides of the house. To alleviate this problem a rain garden and rock retaining wall were erected on one side of the house. On the other side of the house, erosion control mulch (ECM) was spread over the entire slope. The owner opted for this over installing a path, due to wanting to be able to rake the area and maneuver the area with a wheelbarrow and other wheeled devices. As a final buffer to sediment entering the lake, we enhanced the existing vegetative buffers on both sides of the dock. A space was left on one side of the dock for boat access.

Schier Rain Garden After YCC Work

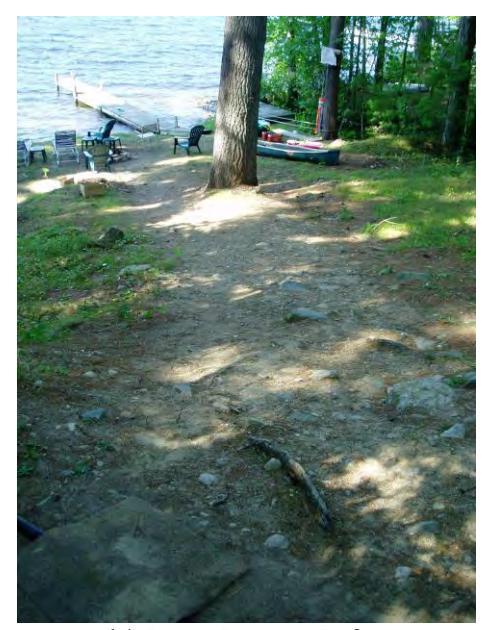
Cook/Morgan Property Before

direct run-off away from the house and into the plunge pool. We installed a dripline trench to infiltrate all the runoff from the roof into the ground on the lakeside of the house. The slope was so sandy and eroded that we decided the best option was to cover the slope with ECM to stabilize the soil on the slope and cover the exposed roots from the large tree at the top of the slope. We also installed a set of infiltration steps from the top of the slope down to the lake. This made maneuvering down the slope to the lake much easier, which was demonstrated during our year end tour. Several elderly members were on the tour and were easily able to walk down the slope to the lake. One board member even commented on how he had come to look at the site before the crew began work and had not dared to walk down to the lake for fear of falling. He found it very easy to walk down the stairs to the lake. The stairs will also help divert water off the trail to the vegetation along the edge of the path. Finally, were able to stabilize the tree along the shore by inserting geotextile fabric and securing the hole with stones.

Cook/Morgan Steps to the Lake After

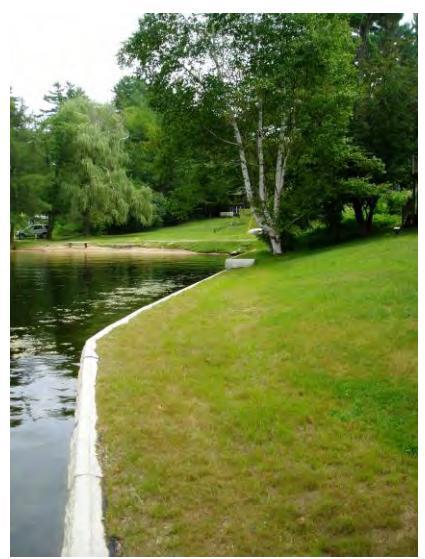
Smith Property Before

We installed a dripline trench on the lakeside of the house to help infiltrate some of the water into the ground before it was able to flow over the grassy slope down to the lake. We also installed a large vegetative buffer along a new retaining wall on the shore of the lake to help filter the water that is running off of the slope towards the lake.

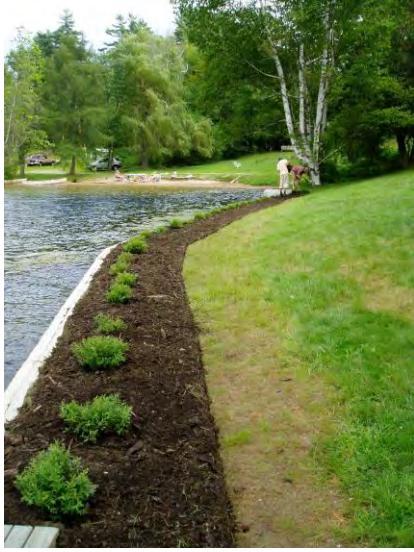
Smith Vegetative Buffer After

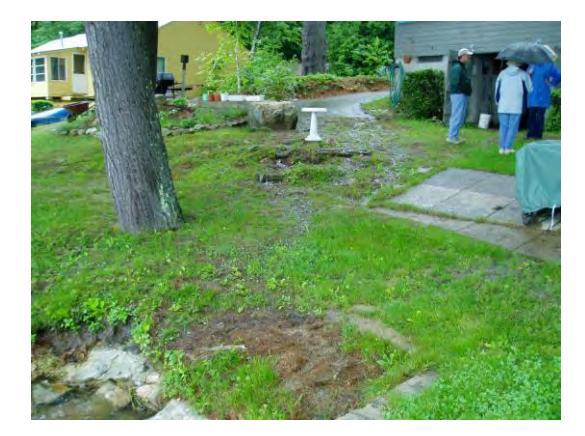
Binette Property Before

We decided that the best way to deal with the driveway runoff was to recommend that the homeowner work with the road association to have an engineer come in and deal with the road situation. We also constructed a rubber razor across the top of the bottom portion of the driveway. This diverted water into a plunge pool which drained into a trench down the slope and into a rain garden, all of which the YCC installed. At the bottom portion of the paved driveway, the YCC constructed a meandering path with infiltration steps down to the lake. This path helped to capture some of the roof run-off before it reached the lake. We recommended that the homeowner install, on their own time, a rain barrel to capture water from the gutters, which were on a portion of the house. Finally at the bottom of an old boat ramp, the YCC installed a vegetative buffer of blueberry bushes.

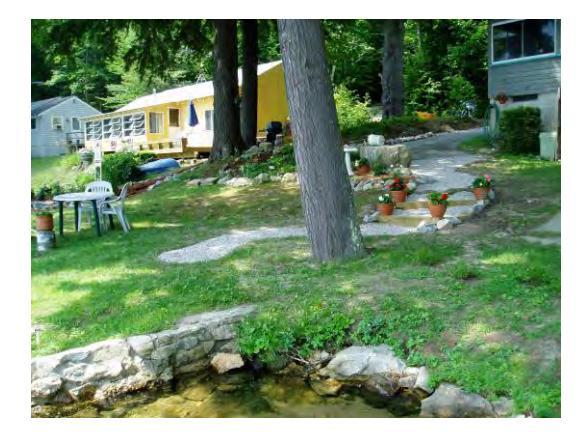
Binette Meandering Path After

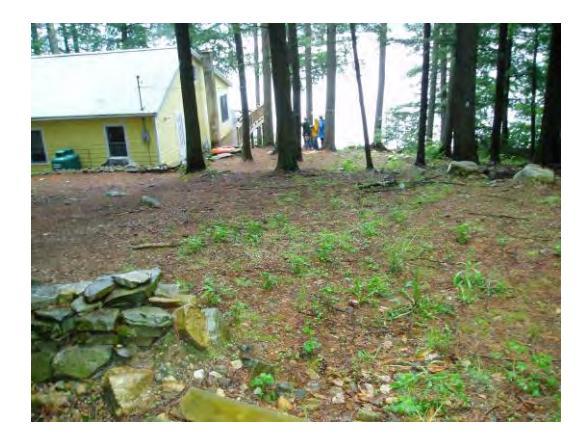
Desroches Property Before

The homeowner had mild erosion on the side of the house down to the lake. An existing plunge pool needed to be enhanced to deal with the amount of storm water run-off that was coming from the road. To deal with the run-off coming down the slope towards the water, the YCC installed to waterbars to divert water away from the house and into existing vegetation. The homeowner also plans to enhance the existing vegetation next summer. Plunge pools were also installed at the end of the waterbars to capture excessive water from large rain events. Finally, ECM was spread over the majority of the slope to help absorb any remaining run-off.

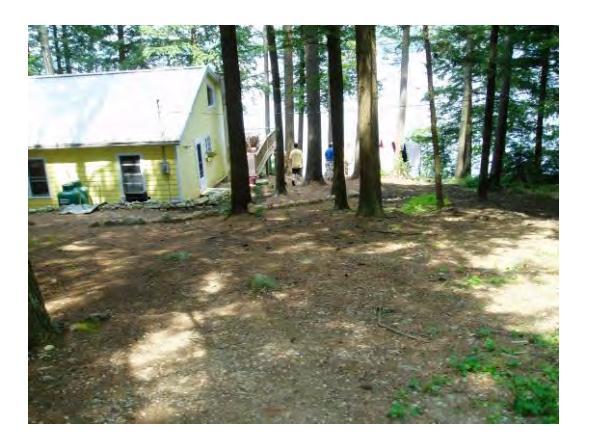
Desroches Waterbar After

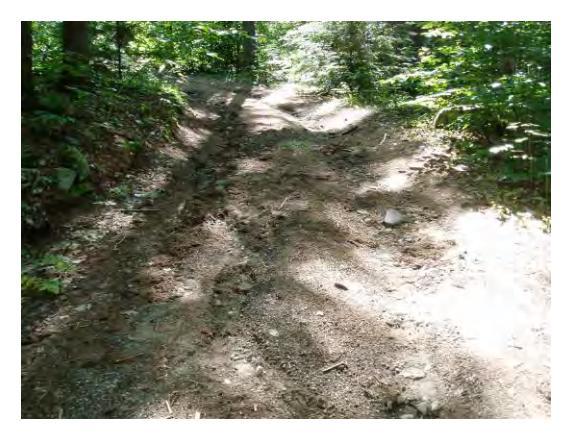
Schlenker Property Before

driveway barely passable. The lot was an irregularly shaped lot that narrowed as it approached Lovell Lake. The camp sits across Chase Lane and is not directly on Lovell Lake, however the gullies from the driveway diverted water directly into a brook that ran into Lovell Lake. The YCC installed 3 rubber razors across the driveway. The rubber razors diverted water into extensive existing vegetation. After the YCC installed the rubber razors, the homeowner had some fill brought in to fill in the gullies between the rubber razors.

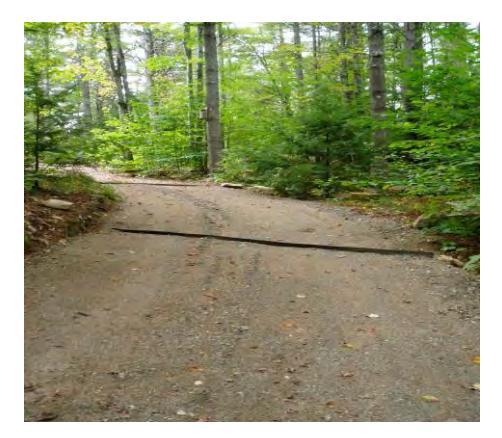
Schlenker Rubber Razor Blades After

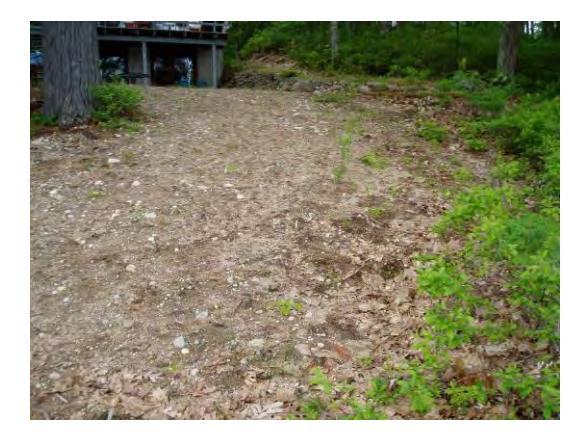
Hacker Property Before

The homeowner had a significant amount of sheet erosion, along with some gullies down to the lake on the lakeside of the house. This was contributed to, in part, due to roof run-off. The majority of the problem on the lakeside of the house was due to work they had completed on their well the previous fall. The large equipment that was needed to complete the wok on the well dug up a large portion of the slope going down to the lake and caused a large amount of soil to become unstable. To alleviate these problems, we installed a dripline trench on both sides of the house to infiltrate water from the roof into the ground. We also planted an area of conservation grass seed mix at the top of the slope to stabilize this flat area that had a large amount of exposed soil. The YCC installed a meandering path with infiltration steps/water bars to divert water off the path into existing vegetation. To stabilize the exposed soil on the slope the YCC spread ECM over the entire slope and planted 30 blueberry bushes.

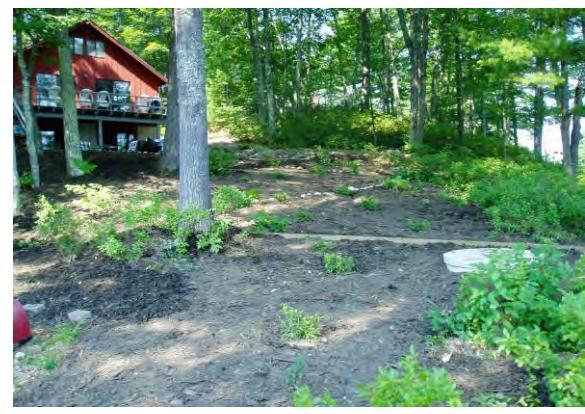
Hacker Meandering Path and Vegetation After

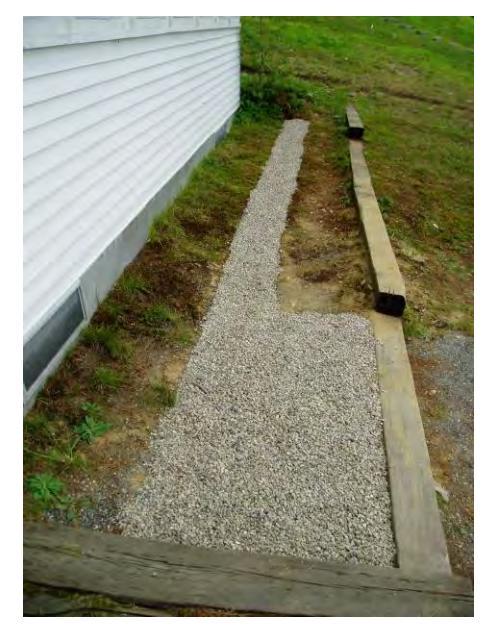
This property had a large amount of impervious surfaces near the house. There were many decks and patios contributing to run-off that was reaching Balch Lake. This property also had a significant amount of roof run-off that was contributed to by the installation of a paved "moat" around the house. The solution we came up with was to install an infiltration trench from the end of the paved moat to a rain garden that the YCC installed. In addition to the rain garden and trench, the YCC installed a dripline trench on the lakeside of the house and shed. We also installed a vegetative buffer along a portion of the shoreline. Finally, the YCC spread a large amount of ECM and planted vegetation along a slope that ran from the dirt road down to the grassy property. This helped to stabilize the exposed soil so it could not run towards the lake.

Kattman Dripline Trench

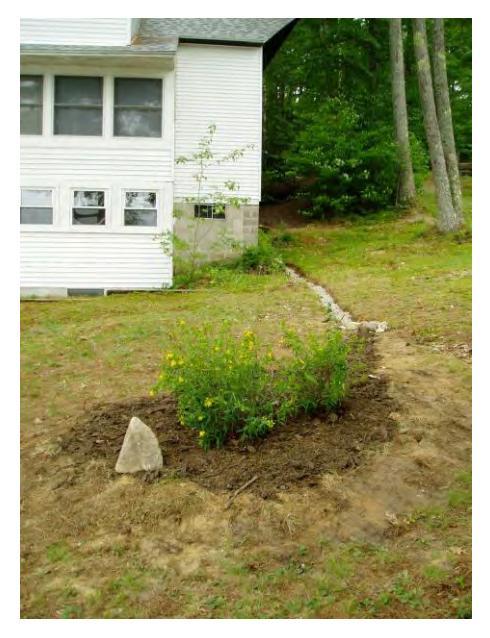
Kattman Rain Garden and Trench

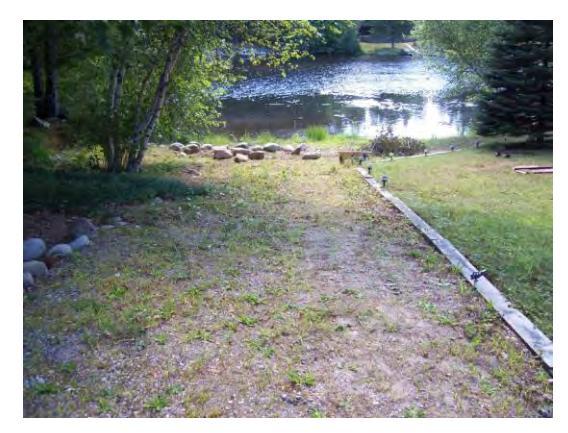
Kimball Property Before

This property experienced sheet run-off down an old boat ramp. The owner no longer wished to use the boat ramp, so we laid timber diverters along the boat ramp to divert water off the path and into existing vegetation. We spread ECM between the diverters. The YCC installed a vegetative buffer along the shoreline to filter any sediment from the water before it reaches the lake. We also extended an existing rock waterbar to help keep sediment from flowing down into the newly formed vegetative buffer. Finally, we enhanced a plunge pool that directed water from the grassy lawn area towards the lake.

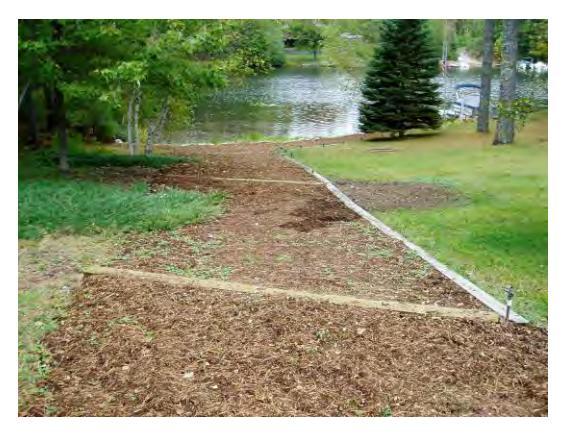
Kimball Mulched Path and Diverters

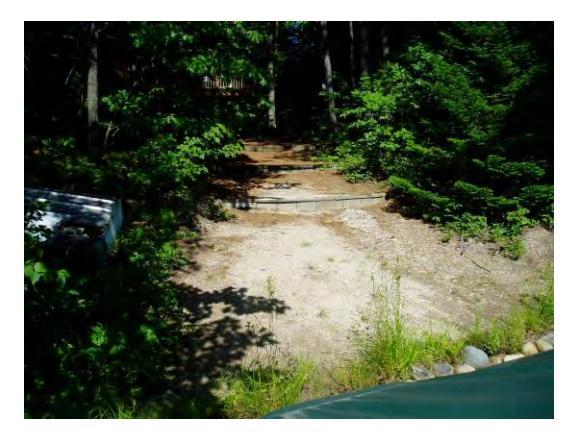
**Cranney Property Before**

This property had a very wide path with terraced steps down to the lake. Quite a bit of material had eroded from the steps. There was also a significant amount of roof runoff. To remedy the problem of the rather wide steps, we laid timber diverters between the existing steps and back filled the timbers with crushed stone to help infiltrate the water into the ground. Because the path was so wide we narrowed it by planting a garden along the length of the path. This garden also helped to stabilize the hillside behind the path. Finally, we installed a dripline trench to help infiltrate water from the roof into the ground.

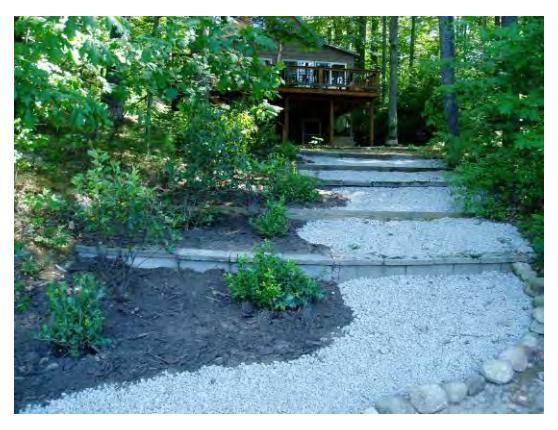
Cranney Infiltration Steps After

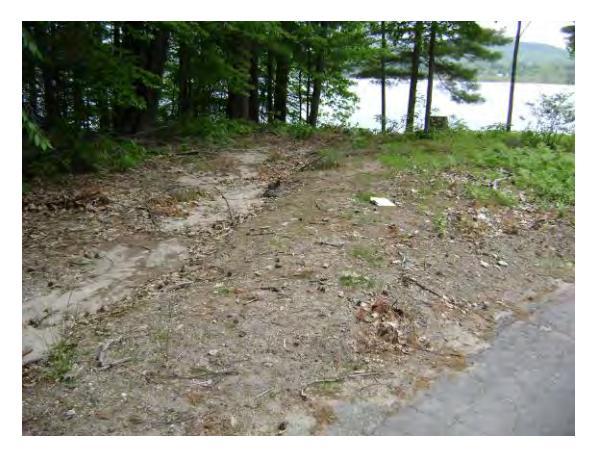
Bonnyman Road Property Before

meandering path leading to the infiltration steps. This site offered a multitude of difficulties, many of which have yet to be resolved due to the crew's limitations and the relatively narrow breadth of the organization's jurisdiction. Future remediations are likely to be needed before this site is adequately resuscitated.

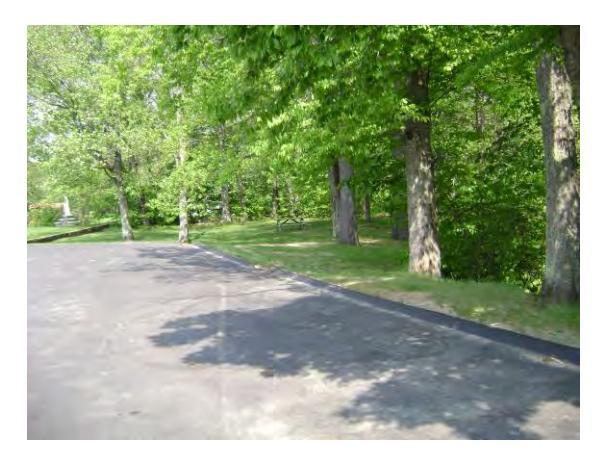
to the river, was a small asphalt berm with breaks periodically cut into it where water could escape. The driveway thus created a large amount of runoff that was concentrated at these breaks where it could erode a considerable amount of sediment as well as carry away the sand that had been spread over the winter on the driveway itself. However, the breaks also focused the water into specific areas, making BMP placement a lot easier. At two of the breaks, where there was enough space before the drop and the river, rain gardens were installed to capture and filter the concentrated runoff from the parking lot. Along the front of the driveway, water was rushing down, carrying across a large sandy area, and diving into the river. Along the side of the sloped driveway, an infiltration trench was installed to capture the runoff pitched towards it. This helped to collect a significant amount of water before it reached the river.

St. Anthony's Church Before

St. Anthony's Church Rain Gardens After

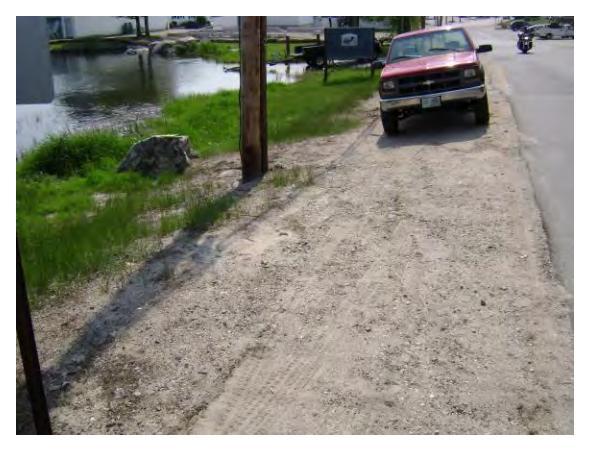
Lovell Lake Boat Ramp Before

This property was a thin strip of land with a moderate slope between Lovell Lake and Witchtrot Road. Cars often parked along the top of the property to use the boat ramp at the lower part of the lot. Water coming off of the road would cut across the top of the property and pick up sediment, washing it into the lake. The area where cars would park was well packed to almost impervious conditions and there was only bare soil exposed. The only vegetation on the site was grass on the lower part of the property. A timber waterbar was installed at the top of the site to divert as much water from the road as soon as possible to prevent it from spreading further down on the site. The waterbar led to a rain garden to collect the runoff before it could enter the lake. Along the road side of the property where cars had parked, erosion control mix was spread above a long line of timber waterbars. The erosion control mix served to stabilize the exposed soil and soak up water. Native vegetation was planted in the area as well to help absorb water and discourage parking in the area.

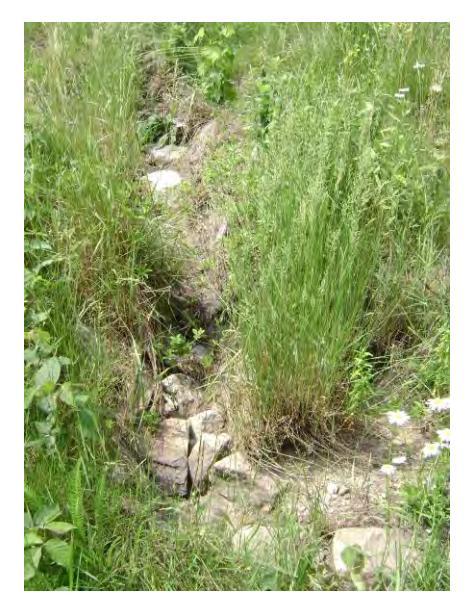
White Mtn Highway Before

This property was right along the White Mountain Highway behind the Mobil station. Runoff was coming from the highway, concentrating to a single channel, and eroding a deep gully down the property. The runoff was eroding sediment and carrying it into the Branch River below. Riprap rock was packed into the gully, stabilizing it and preventing further erosion. Considerable vegetation existed on the site to adequately control the runoff that now flowed over the site with less severity.

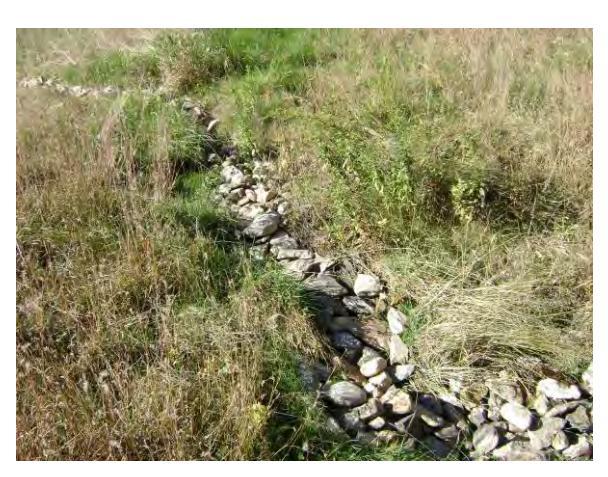
White Mtn Highway Riprap After

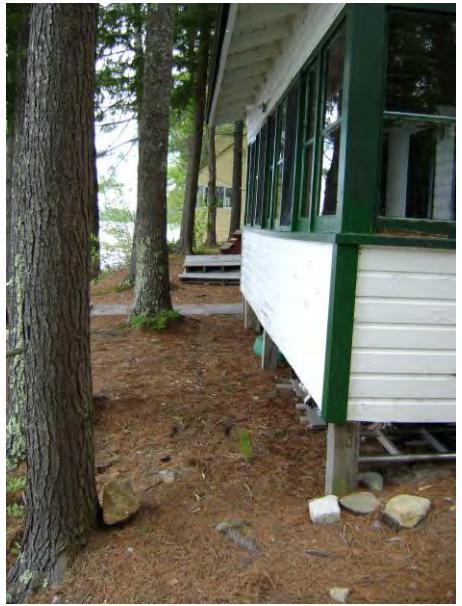
Cummings Property Before YCC Work

The roof of the landowner's camp sloped and drained very close to the shore of the land. A significant amount of runoff was cascading off of the roof, collecting of the ground, and washing into the lake along with a considerable amount of sediment. The sheet erosion here was able to be controlled though the installation of a dripline trench. The trench collects the roof runoff and prevents its immediate flow into the lake and stops any velocity that contributes to excess sediment erosion. The installation of the dripline trench was an effective solution to the

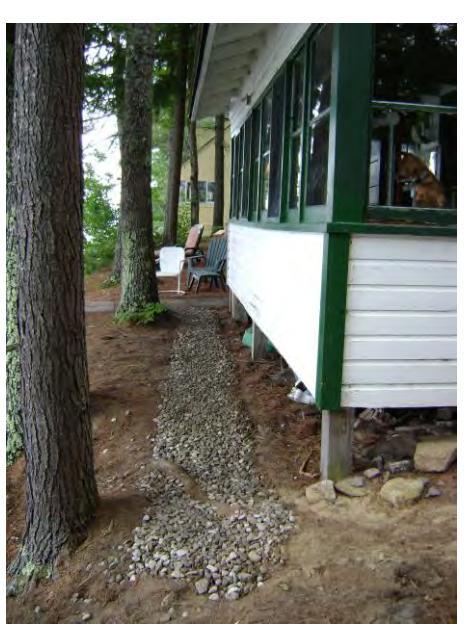
Cummings Rain Garden After YCC Work

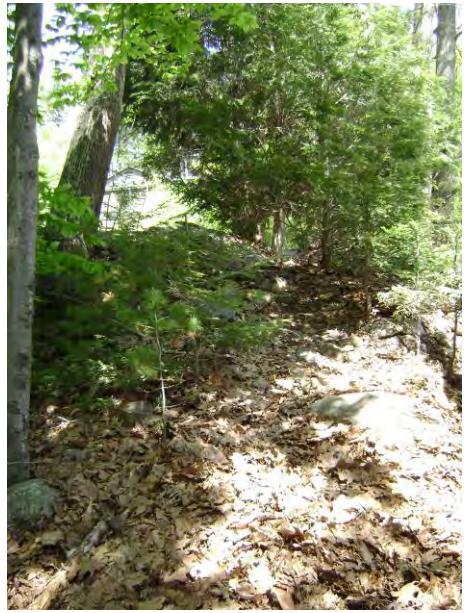
Sundgaard Property Before

The homeowner was experiencing a significant amount of erosion due to her neighbor's driveway. The neighbor had paved his portion of the street and driveway uphill of the property. During events of even light precipitation, a deluge of water would run down the paved area and make a direct like though the property towards the house. Fortunately, there was enough of the landowner's property to install a means of diverting the water away from the house and off into nearby vegetation. An infiltration trench was dug at the top of the property, originating where the water first enters the property. At this spot, the trench was made extra wide and deep to serve as a collection area where the water would first enter the trench and have the opportunity to be absorbed into the ground. The trench snaked through a vegetated area before terminating at another large bowl on the side of the house where runoff could slowly seep out into local vegetation. At one point the crew needed to return to the site to improve the design by relining the trench with an impervious material because water was being absorbed into the ground and seeping to the house foundation. After the remediation, the seeping stopped and the trench worked as designed.

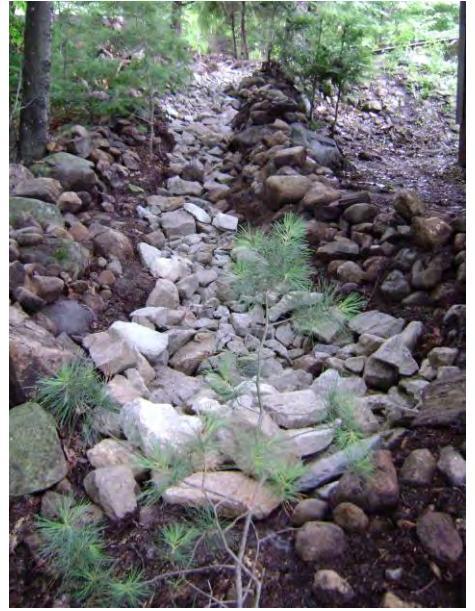
Sundgaard Infiltration Trench After

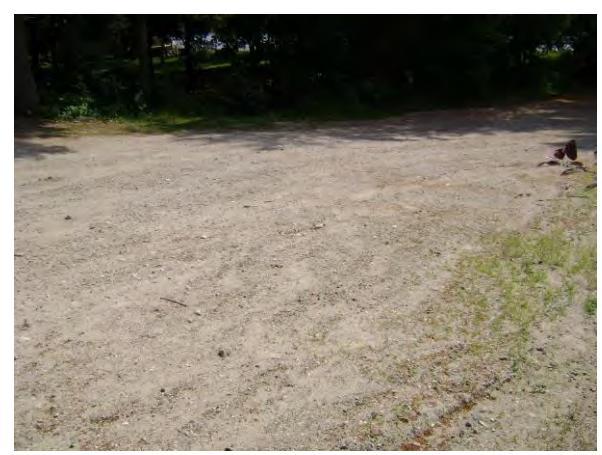
Arnone Driveway Before

This homeowner was experiencing a significant amount of sheet run-off coming from the road and flowing over his driveway and eventually through his property and into the lake. The driveway is very long and wide and a significant amount of water from upland properties eventually finds its way to his property. The homeowner lives at the property year round so a diverter that would hinder plowing could not be installed in the driveway. Runoff from the roof of the garage was also causing some erosion. In order to capture the runoff on the driveway, an open-top culvert was installed across the vast expanse of the driveway's width. This carried water down to the side of the driveway to a vegetated area where a large drywell was installed to collect the runoff and slowly released it into the vegetation. A dripline trench was installed along the side of the garage. Further down the driveway, another open-top culvert was installed across a narrowed section. This culvert led to an infiltration trench running down the side of the driveway, terminating at a drywell where the runoff would finally be slowly released to water the lawn. The design worked rather well, although the open-top culverts will need to be cleaned often to remove the sediment that runoff washes into them.

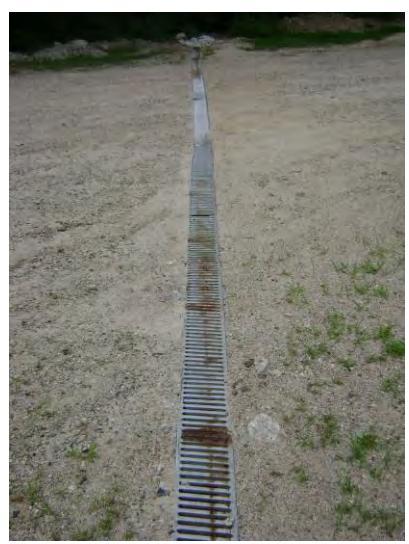
Arnone Open-top Culvert After

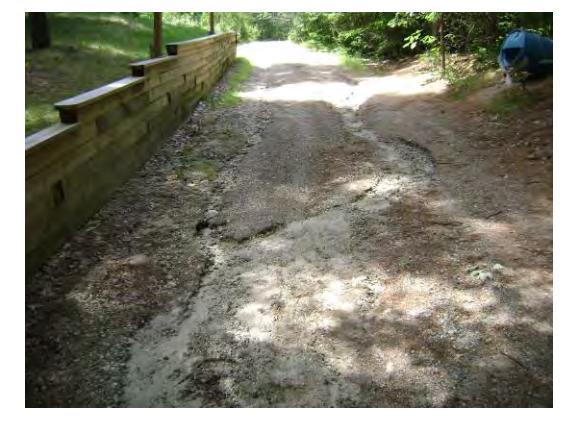
Gregorio Property Before

The homeowner had a significant amount of driveway runoff. Very large and long gullies had formed along the length of the driveway leading down to the house. The lower part of the driveway was flanked by a retaining wall on one side and a hill on the other, making diverting of water difficult. Three open-top culverts were installed along the length of the driveway. Along the base of the retaining wall, an infiltration trench was installed to collect water from the driveway and transport it down to the lowest open-top culvert where it will be cast across the driveway into local vegetation. Leading from the house down to the lakefront beach was a long series of paved stairs. A considerable amount of runoff flowed down these stairs and carved a deep gully across the beach. This runoff carried an incredible amount of sand into the lake. An infiltration trench was installed along the stairs to collect this runoff and transport it along the top of the beach to deposit the runoff into nearby vegetation where it will be absorbed. Because of the pitch of the driveway and the stairs, the open-top culverts and infiltration trenches should be cleaned of sediment regularly to ensure property drainage and flow of water.

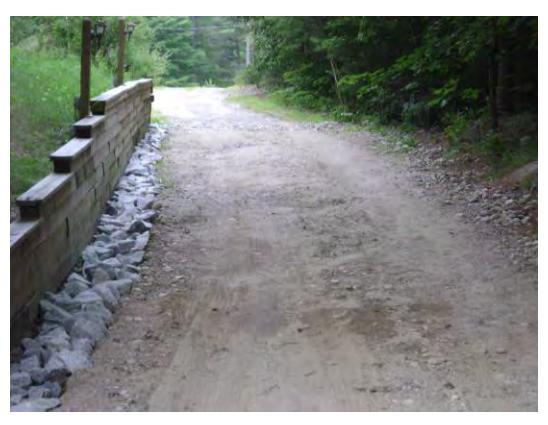
Gregorio Infiltration Trench After

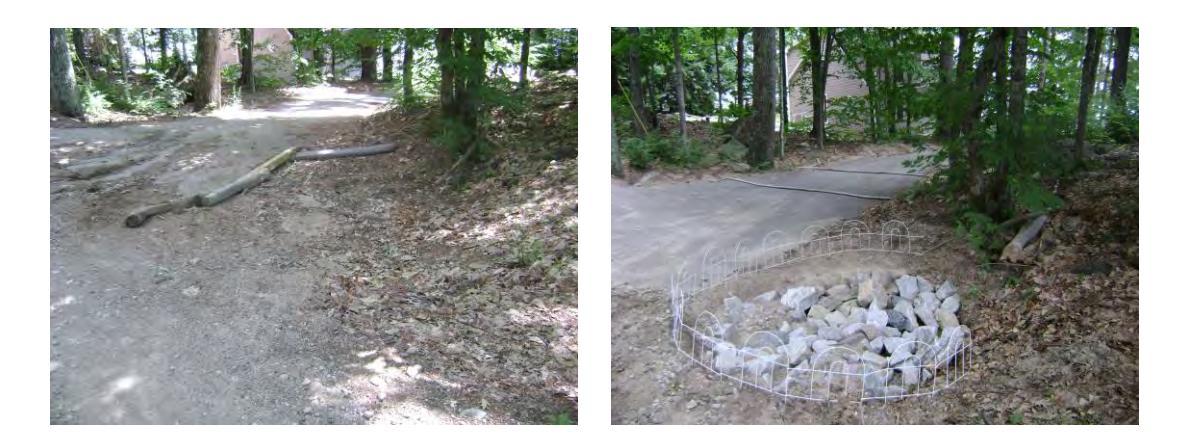
Gottlieb Property Before

The homeowner had a very steep paved driveway where runoff from the road above ran incredibly fast down to the house with a large amount of sediment that eventually mounded up where the runoff finally slowed down as the property levels off by the lake. Fortunately, the driveway was not a straight-shot, and as the driveway turned, there was opportunity to dig a series of turnouts where water could escape into the vegetation along the driveway. Also, at the top of the driveway, there was a small piece of the property that the runoff flowed over before hitting the driveway and flying downhill. On this portion of property, a large drywell was installed to collect the initial road runoff and slowly releasing it so that not all of the water coming from the road would flow down the driveway. Also, the water that escaped and did go down the driveway would not do so at maximum velocity. Because the driveway was paved, we were presented with a challenge for diverting the water from the driveway surface to the side where the turnouts were dug. This problem was solved with the use of donated used fire hose filled with sand. The hoses were laid across the driveway and worked very well. In fact, the hoses and turnouts were so effective that the water that was diverted of the driveway found its way onto the neighbors' property, resulting in another project for the crew later in the season.

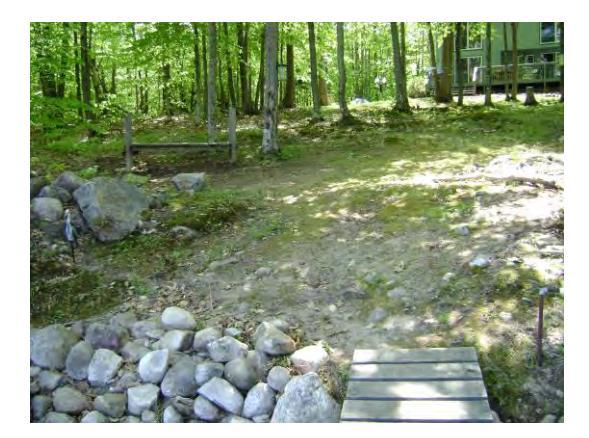
Achille Property Before

The homeowner had moderate runoff coming from the roof and driveway, flowing down over the lawn and eventually going into the lake. The lakefront was the area most in need of remediation as most of the vegetation was gone and a considerable amount of bare soil remained. There was also poor access to the lake due to the slope of the terrain. Waterbars were installed to divert runoff from the driveway. A crushed stone path was created to provide access down to the lake. At the lakefront, infiltration steps were constructed and surrounded by buffer plantings and erosion control mix to prevent any runoff from making its way into the lake. This project proved to be one of the most significant transformations of the summer.

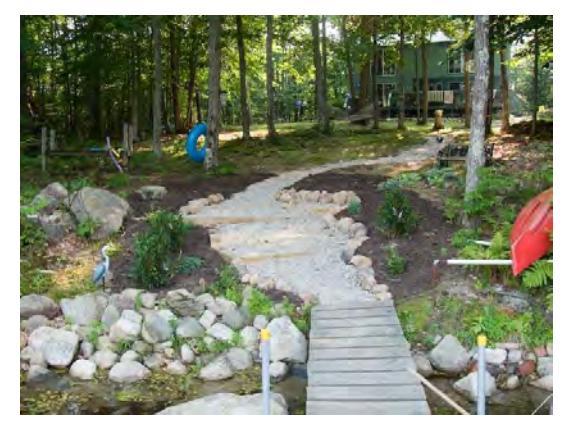
Achille Stabilized Shorefront After

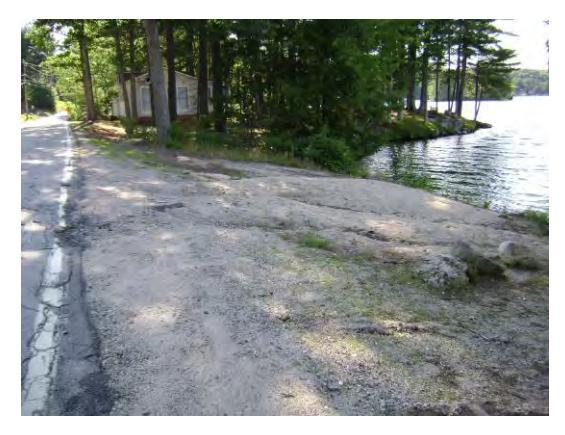
Golden Property Before

The homeowner had a significant amount of gully erosion. The site was a beach lot situated tightly between Lovell Lake Road and Lovell Lake itself. Because of that, an incredible amount of runoff was coming off of the road and eroding deep gullies across the beach. Tremendous amounts of sand had been washed into the lake. A barrier between the road and the beach had to be created in order to prevent the beach from being eroded entirely into the lake. A long timber waterbar was installed that led to a vegetated area on the side of the property where a drywell was placed. Another timber waterbar was installed across the bottom of a parking area leading to another drywell in a vegetated area on the other side of the property. Between the two waterbars a stone-lined path was created to provide access to the dock. Erosion control mix was spread in front of the long waterbar and to the side of the beach in the mulched area, plants were added to additionally stabilize the soil. Crushed stone was spread in front of the shorter waterbar to stabilize the parking area. Since the BMPs were installed, the gullies have not yet returned.

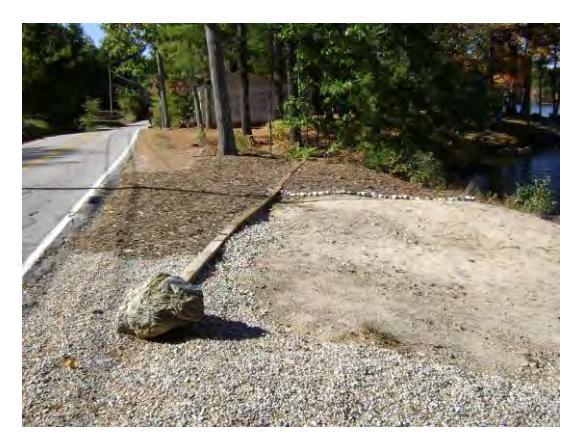
Golden Waterbar and Erosion Control Mix After

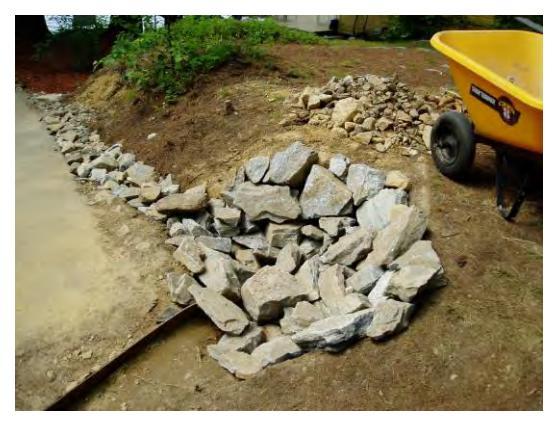
This property had been a YCC project in 2006. Because of the road situation in the area, this property received an incredible amount of runoff coming across it even during minor precipitation events. Last year, the crew needed to return to the property a few times to improve the site designs that the runoff constantly strained. This year, the crew returned for a last time to make final improvements to the site by retrofitting an infiltration trench, adding filters to the drywell and infiltration trench to prevent clogging, and improving a path by replacing the pea stone with a heavier and coarser crushed stone. Aside from these necessary improvements, the rest of the design from the previous year worked very effectively, including the rain garden and rubber razor.

Binette Drywell and Infiltration Trench Before

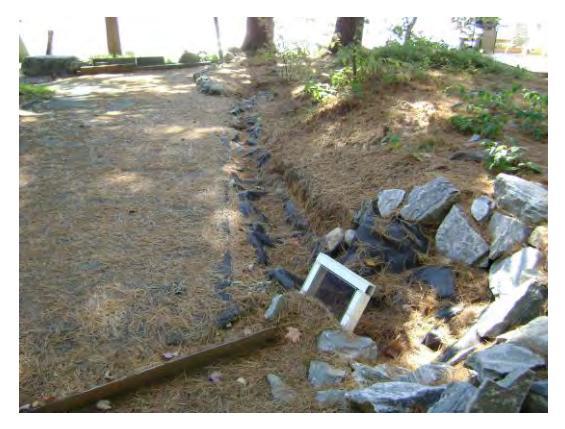
Binette Drywell and Trench with Filters

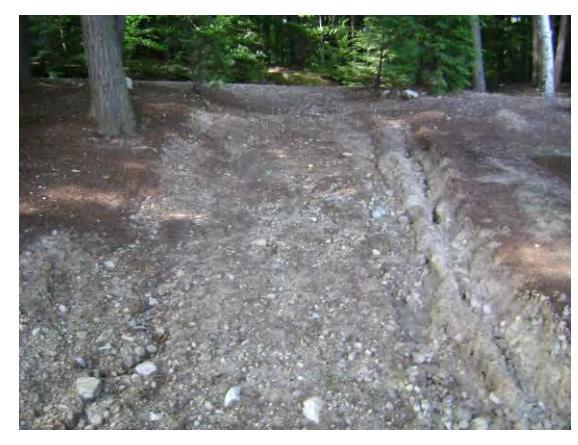
Shannon Property Before

This property experienced gully runoff down an old boat ramp as well as sheet erosion occurring over a retaining wall and across the driveway. The owner no longer needed the boat ramp so we laid timber waterbars along the very top of the boat ramp to divert water from the road off the path and into existing vegetation. Below this, we constructed a retaining wall using concrete blocks from the landowner's replaced lakefront wall. This new wall was constructed in line with the existing railroad tie retaining wall. We spread ECM between the diverters and planted vegetation on top of the new wall. An additional tier was added on to the lowest level of the existing timber retaining wall. Above this wall was a natural basin where road runoff collected and eventually breached the wall to flow down towards the lake. A rain garden was planted here with native vegetation. Behind the rain garden, a small soil berm was created. The rain garden, soil berm, and additional tier on the retaining wall all combined to prevent the washing of runoff over the wall. They collectively manage the water effectively.

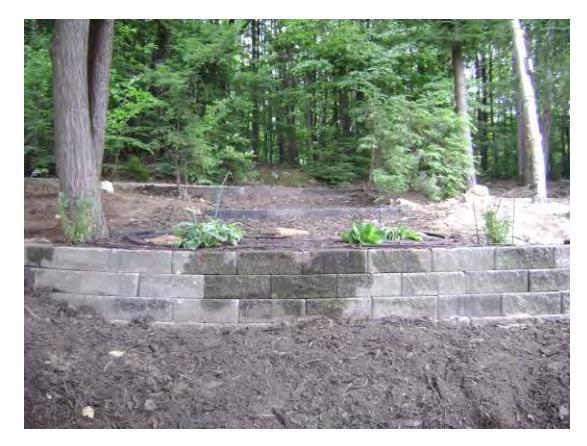
Shannon Retaining Wall and Waterbars After

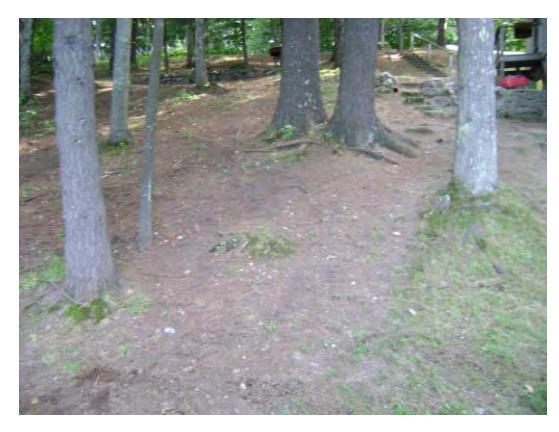
Ortiz Property Before

This property was on a very long sloping hill leading to the lake. Due to the mature pine trees shading the property, there was little to no ground vegetation. Few barriers existed to stop or even slow runoff streaming down the hill from entering the lake. Much of the pine needles had washed away leaving bare soil exposed. Runoff from the roof was also contributing to the problem. It was decided that the best approach to this very broad problem was to cover as much of the property with strategically place timber waterbars and erosion control mix. The erosion control mix covered and stabilized the bare soil and the timber waterbars diverted runoff into nearby vegetation. Dripline trenches controlled roof runoff and prevented it from washing into the lake. Finally, a vegetated buffer strip was installed along the shore of the lake where, ordinarily, water running down the bare slope would directly enter the lake with its sediment load.

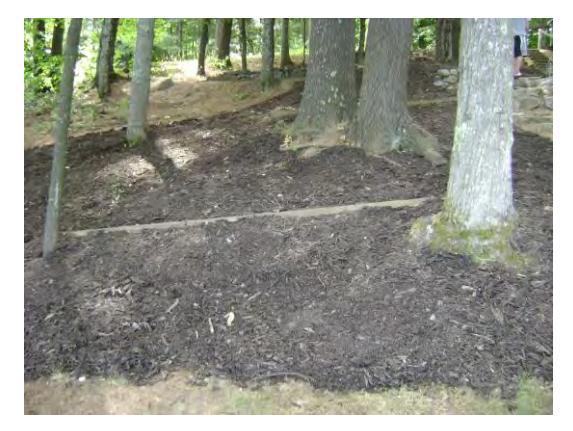
Oritz Waterbar and Erosion Control Mix After

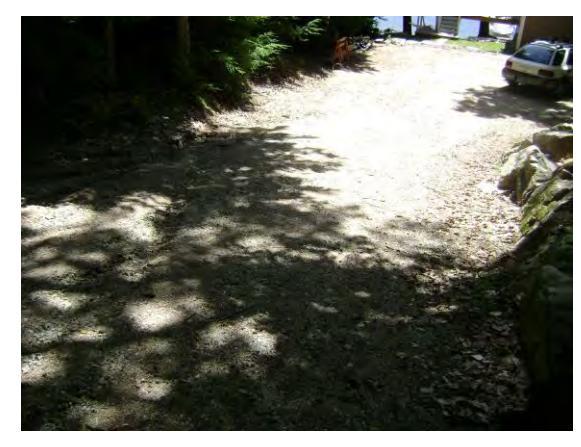
McKinley Property Before

This landowner had runoff coming onto her property due to a previous project the YCC had done earlier in the season. Water was rushing though the woods and coming onto the side of the driveway and eventually down to the lake. A long, multi-leveled timber waterbar was installed along the edge of the woods in order to keep the water in the vegetation and guide the runoff into a flat area where it could be properly absorbed and controlled. Water was along coming from the road and running down the considerably steep driveway, carving gullies and bringing sediment into the lake. Because the driveway was gravel and the house was used very little if at all in the winter, two rubber razors were installed across the driveway. Also, an infiltration trench was installed along the lower pitched side of the driveway. The rubber razors divert water into the infiltration trench where it is guided down to the end of the driveway where the infiltration trench terminates in a flat area of local vegetation where the runoff is managed and prevented from entering the lake.

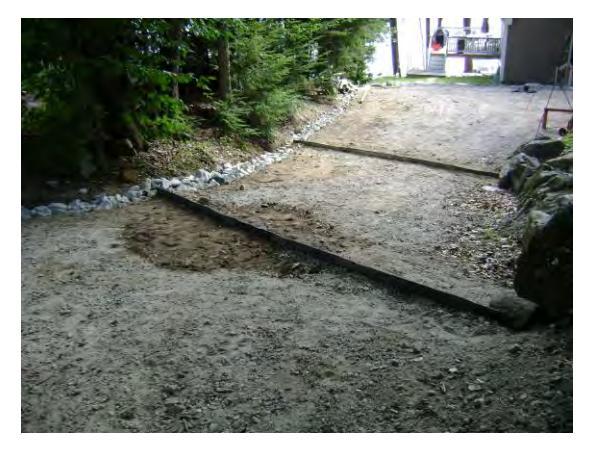
McKinley Rubber Razors and Trench After

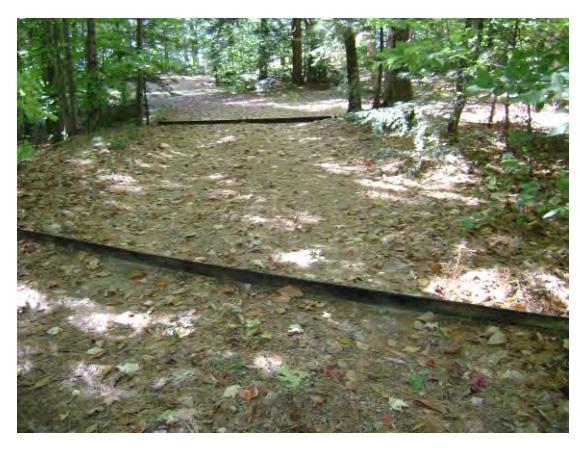
This property had a long gravel driveway leading from a paved, well used road. A considerable amount of runoff was coming from the road and flowing down the driveway, carving deep gullies in the driveway surface. Sediment from the driveway was being washed into the lake. The landowner did not use the driveway in the winter and it would not be plowed. A series of rubber razors were installed to periodically divert water off the driveway into vegetation where it could be absorbed and controlled.

Heacock Upper Rubber Razors After

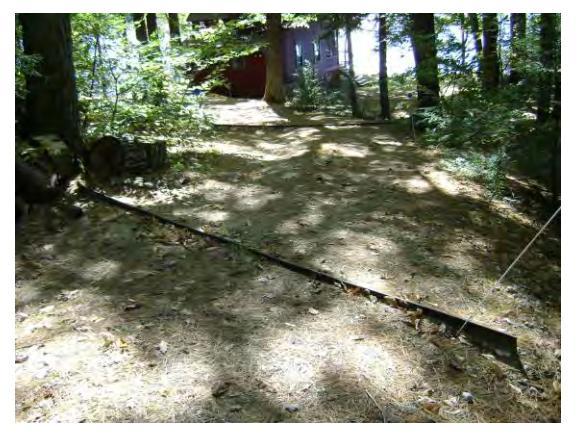
Heacock Lower Rubber Razors After

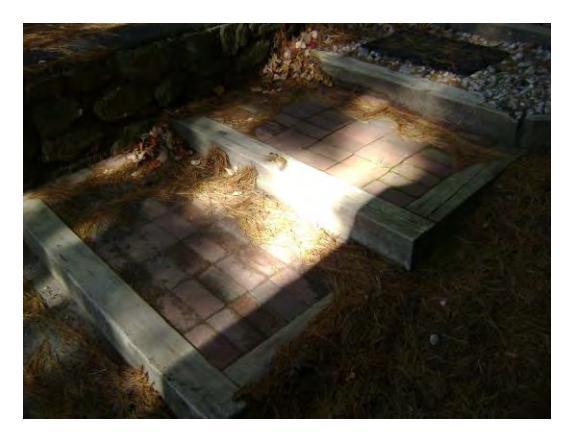
This property was experiencing a lot of runoff coming from the paved road and flowing down the driveway and over wooded area, all bringing sediment into the lake. Also, a series of impervious stairs led to the lake that runoff simply washed over. Turnouts along the side of the driveway were dug to allow water running over the driveway surface areas to escape into the lower lying vegetation where the water would be prevented from getting to the lake. Timber waterbars were installed in the wooded area below and to the side of the driveway in order to divert and slow the runoff in this area. Also, a waterbar was installed below the driveway where it could divert water into the woods. The two highest stairs leading to the lower lawn and the lake were retrofitted into infiltration steps by removing the impervious material of the step and backfilling it with crushed stone that will absorb the water flowing over it. Finally, at the base of the steps, a rain garden was installed to capture any remaining water that might make it into the lake.

Darling Impervious Steps

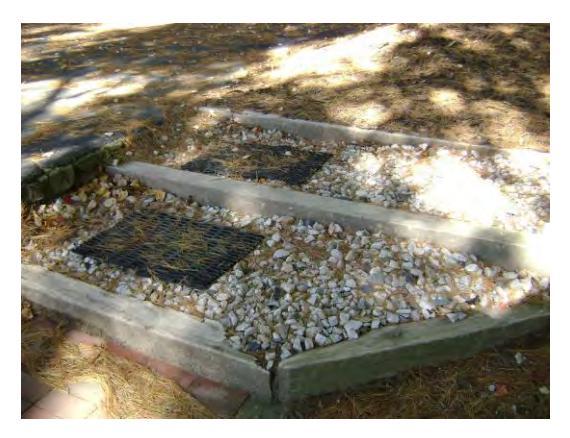
Darling Retrofit Infiltration Steps After

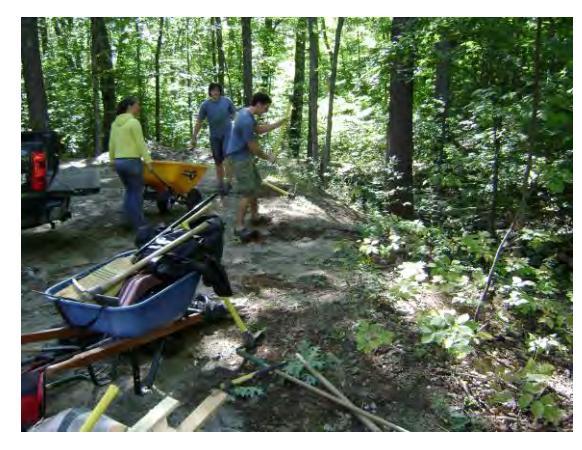
Canal Road Before

This property had a lot of road runoff traveling across it, picking up sediment, and running down a steep slope into the canal. Without the capability of repitching the entire parking area, the crew had to prevent the water that was coming onto the site from reaching the canal. Also, the design could not be located anywhere that it would be in the way of plowing activities. Therefore, at rock waterbar was installed along the edge of the site, immediately above the slope leading to the canal. The waterbar diverted water to a drywell further down the slope to an area where it leveled off enough to allow the construction of a drywell.

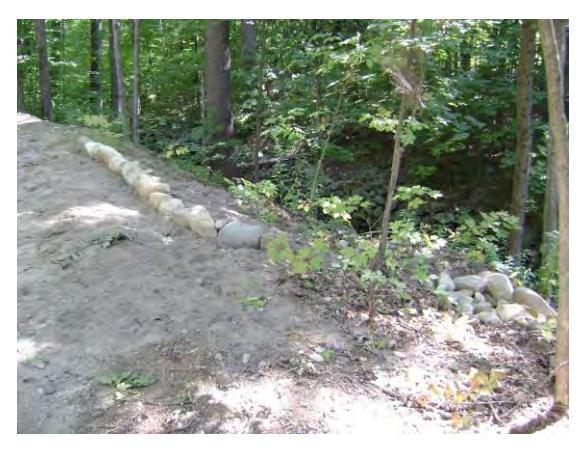
Canal Road Waterbar and Drywell After

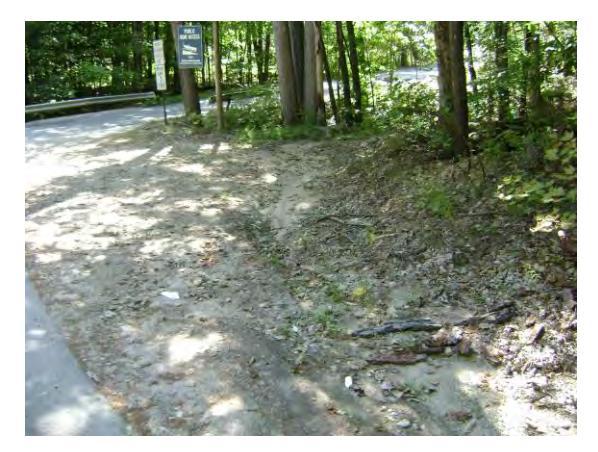
Robinson Road Before

down into the canal with enough velocity to carve a gully into the terrain, resulting in sediment being washed into the water. Extending the infiltration trench and leading it to a drywell controlled the runoff and prevented it from washing directly into the canal.

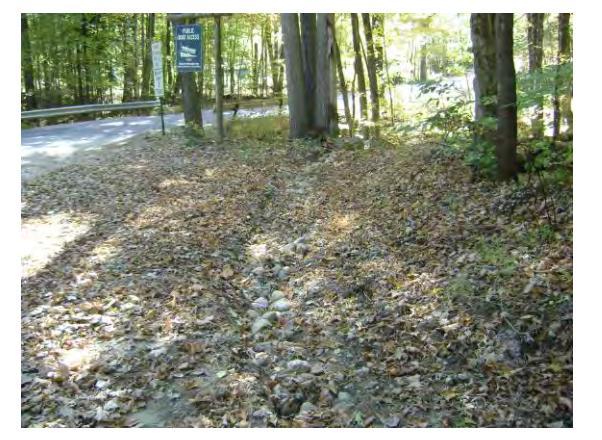
Robinson Road Infiltration Trench After

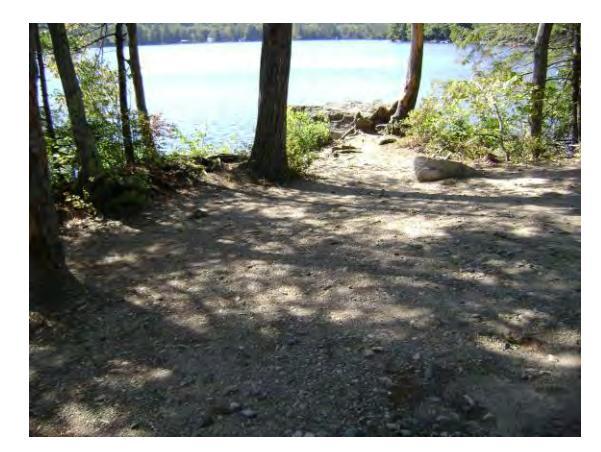
New Bridge Road Before

This property was situated between the road and the lake. Runoff from the road ran across the site, picked up sediment, and flowed into the lake. There was no significant vegetation to prevent any erosion or absorb any of the water. A rock waterbar was constructed across the property to act as a barrier, preventing the washing of water and sediment into the lake.

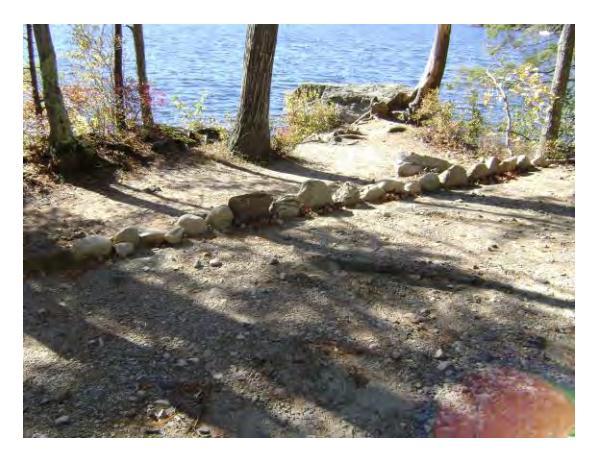
New Bridge Road Waterbar After
