The Acton Wakefield Watersheds Alliance

Youth Conservation Corps

2021 Season Report

December 2021

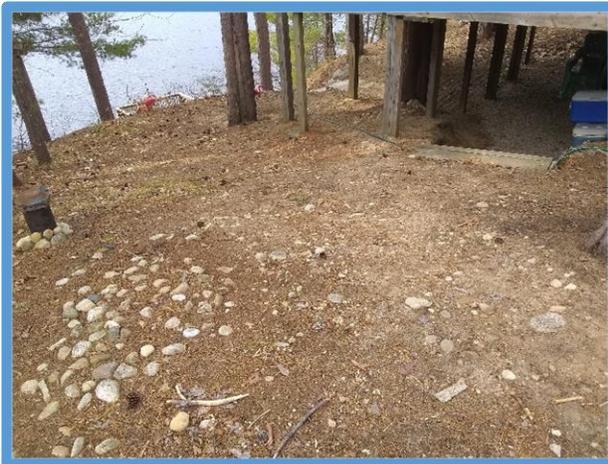
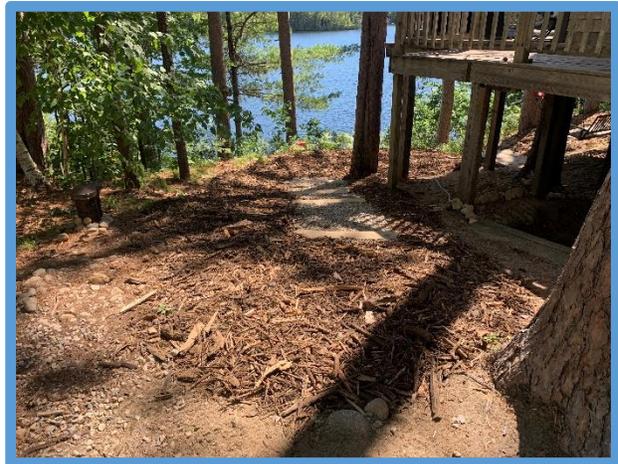
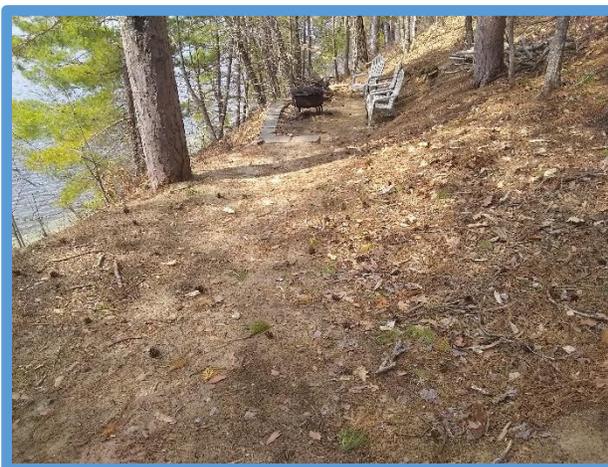
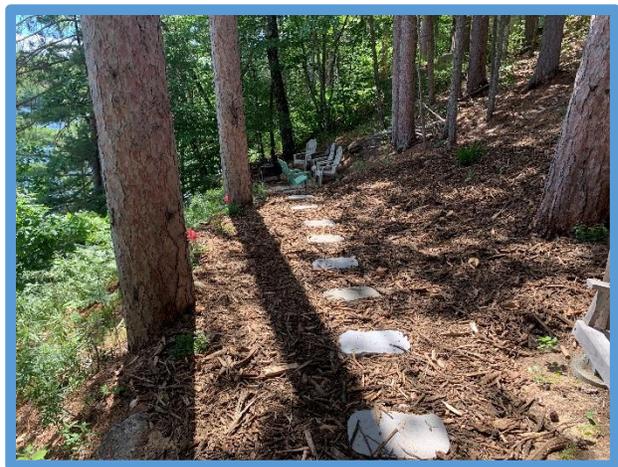
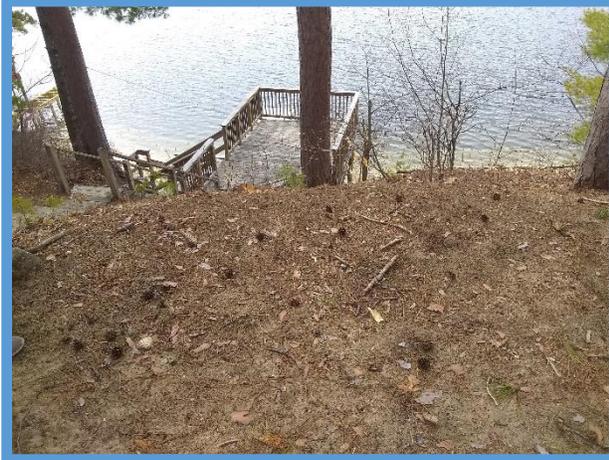
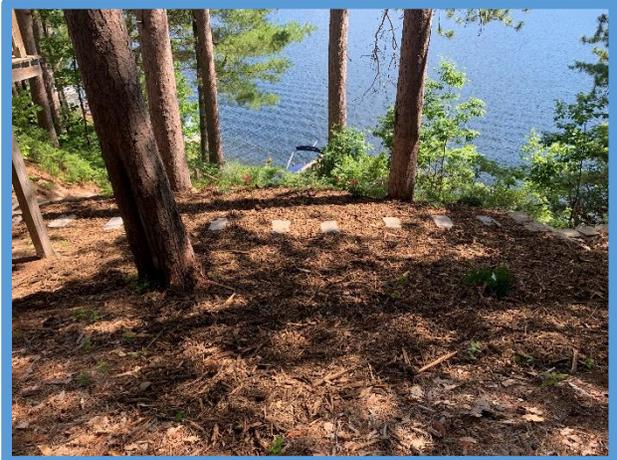
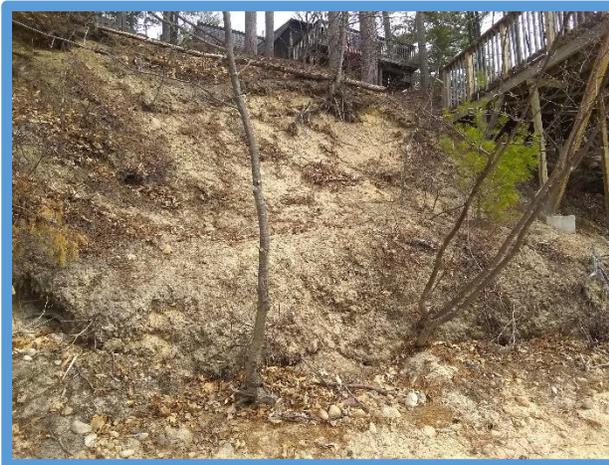
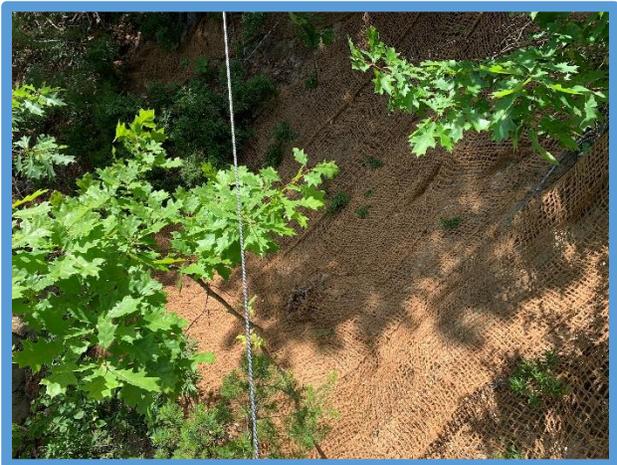
Julie Cavanaugh

This was our crews first site of the season. While still getting to know each other, the crew did a great job installing many different BMP's as well as a new one to even the more experienced crew members. The Cavanaugh's had sheet erosion on each side of their house as well as a massive bank erosion problem that needed addressing.

Our crew installed four waterbars and turned the area in between into a pathway filled with crushed rock that would allow runoff to infiltrate into the ground. Around the pathway we placed erosion control mulch to cover the rest of the bare soil. This mulch continued farther down the property and all along the front of their deck. This was important because it left no exposed soil anywhere on the lake side of the house. Along the edge of the slope the crew installed native plants to provide structure for the soil on the bank. Near the edge of the water, they had a massive bank erosion problem that had to be addressed. We installed an erosion control blanket over the bare slope and planted native grasses that will help to hold the soils on the slope together.

Total Number of BMPs	Approximate Cost to Landowner
16	\$1,907.00
Tons of Sediment Reduced	Pounds of Phosphorus Reduced
4.1	4.1
Crew Hours	Crew Value
103.5	\$1,060.00
BMPs Installed	Materials Used
Erosion Control Mulch	Erosion Control Mulch – 8 yards
Native Vegetation	Crushed Stone – 1 yard
Waterbars	Pressure Treated Lumber - 16 feet
Infiltration Pathway	Erosion Control Blanket – 320 ft ²
Bank Stabilization	Plants - 20

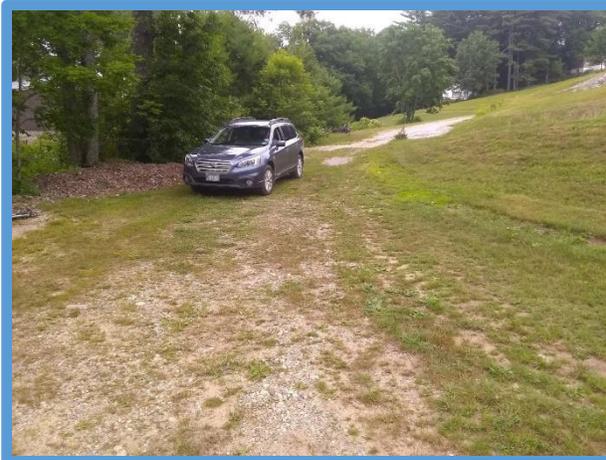
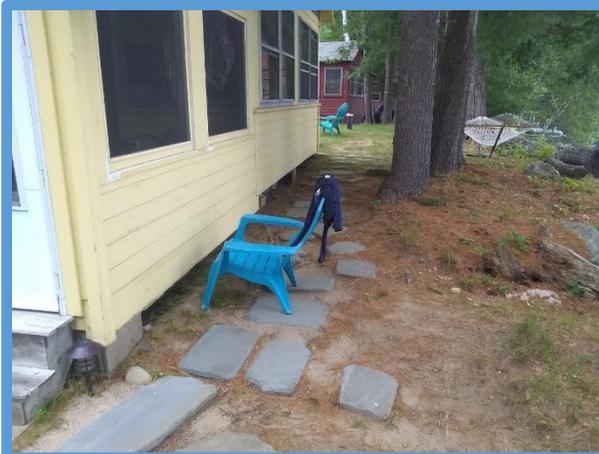
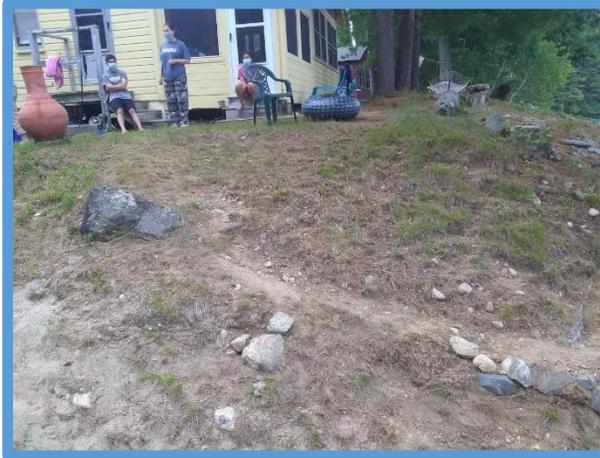
The erosion problems on the Sakellarios' property were a great example of non-point source pollution, as their runoff came from many different places. They had a massive bare hill above their property as well as very little vegetation close to the water. This resulted in massive gullies being formed on their beach and surrounding yard. The crew did a great job installing BMP's that would help solve the problems they were having, all while getting baked by the scorching heat.

We started by installing three rubber razors on the driveway as it was where most of the water was channeling. The razors as well as the drywells installed next to them were the first line of defense against runoff. They also had water coming off their roof causing a dripline to form. Our solution was to install a dripline trench to catch the water and allow it to infiltrate in the ground. Around the trench we also laid down erosion control mulch to cover the rest of the bare soil. Near the edge of their house, they had a walking path down the slope that had begun to deteriorate. Here we installed eight waterbars ranging from one foot to six feet in length. The point of the waterbars was to add a block for water rushing down the slope. Around the waterbars we planted native vegetation and installed more erosion control mulch to cover the remaining bare soil and help keep the soil intact.

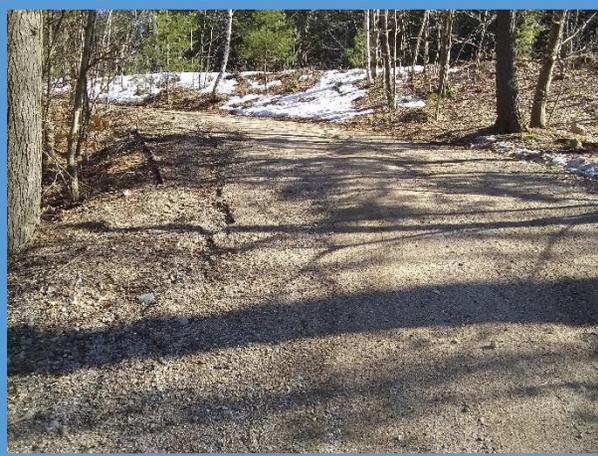
Concord Point was our first shared access property of the season. It had deep gullies caused by an enormous amount of runoff making its way down the long road and straight into the water. This caused the roadway to become impassable for people what wanted to launch their boats or even walk down to the water. The crew did an excellent job installing the BMP's at this site in a timely manner, as our day had to be cut short by the beginning of the rainy season that was this past July.

The project itself was a relatively simple project but in no way less important. The amount of runoff reaching the lake on this site made it one of our top priorities. The crew ended up installing three rubber razors spanning the width of the road. On the ends of each of the rubber razors they dug a very deep drywell to accommodate for the massive amounts of sediment that would be filling them. All in all, the project turned out great and since we had a site on the very same road later in the season we got to come back and look at how well the site was holding up.

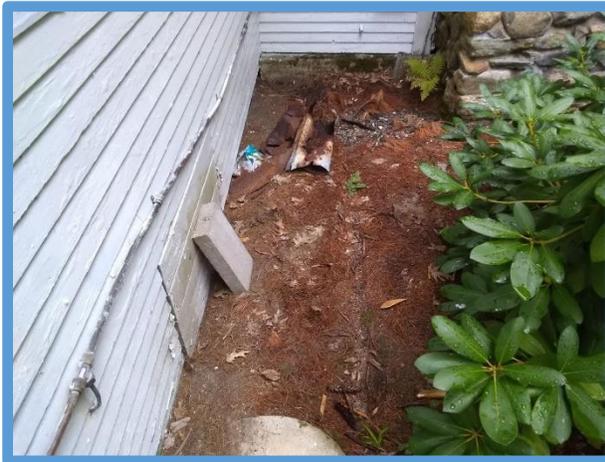
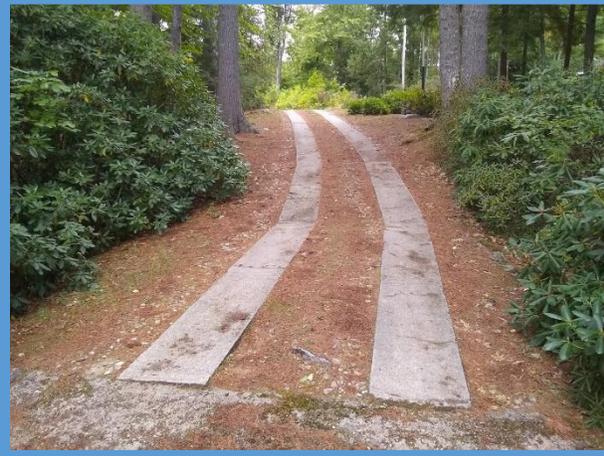
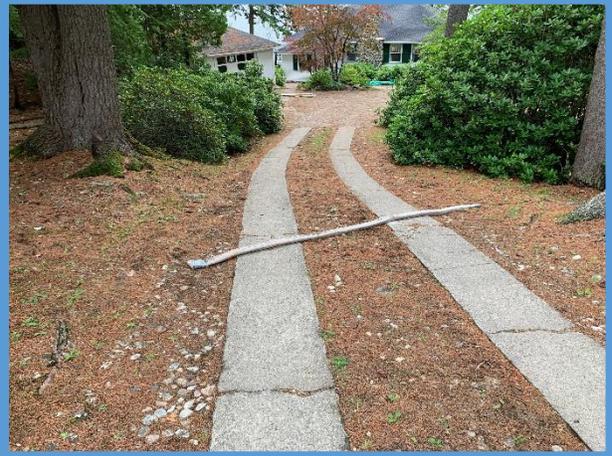
Dabney Frake

The Frake's property was another site that seemed to be having a lot of trouble with runoff. While we were there working, they showed us multiple videos of the extreme torrent of runoff that would come down their driveway and sometimes even flood the front of the house. We had to address erosion problems in many different places using many different methods to gain control over their runoff problem. This posed quite a challenge for the crew, but like always the crew succeeded and completed some of their best work.

At the Frake's we installed two rubber razors on a side road each with a drywell for the runoff to infiltrate into. The crew then installed four other drywells/small infiltration trenches to collect water coming from downspouts or off pathways. On one side of the property, we laid down erosion control mulch covering a large area of bare soil. On top of all of this we installed two firehoses to divert any runoff that would come down their driveway into a large area of vegetation. The vegetation would help trap water and runoff and allow it to naturally infiltrate into the ground. To finish off the project we planted native vegetation on an eroding slope up near the rubber razors. The plants will help keep the soil intact and prevent erosion.

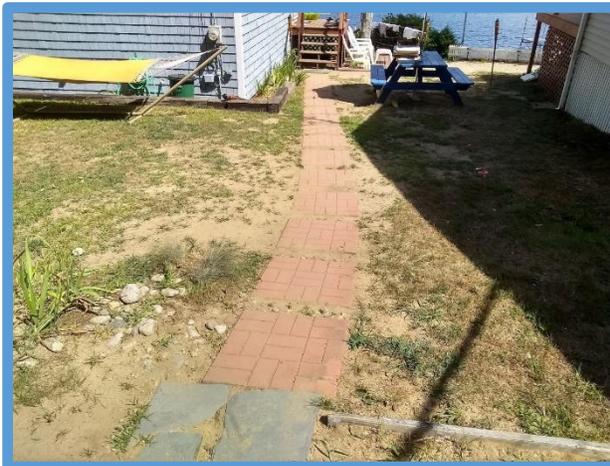
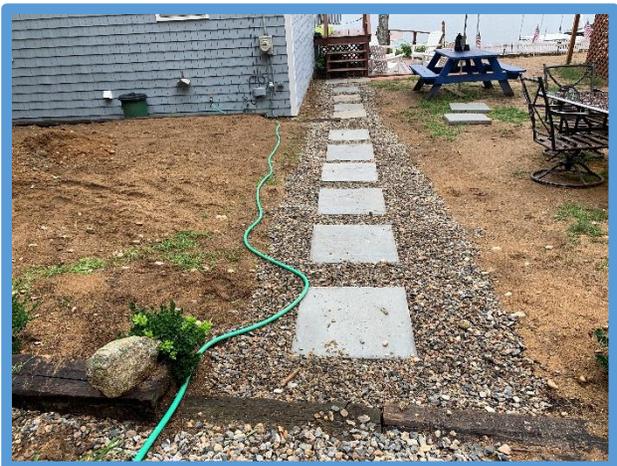
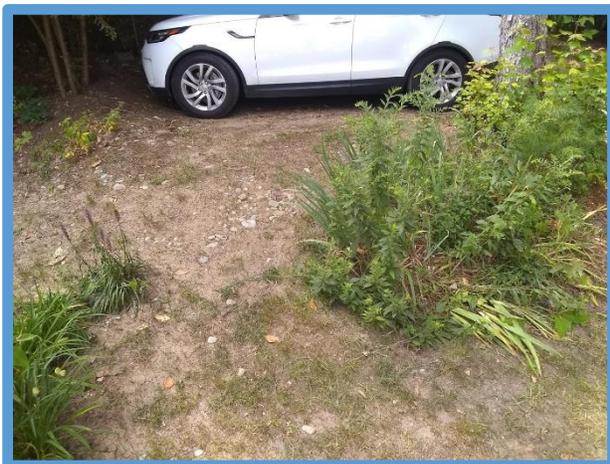
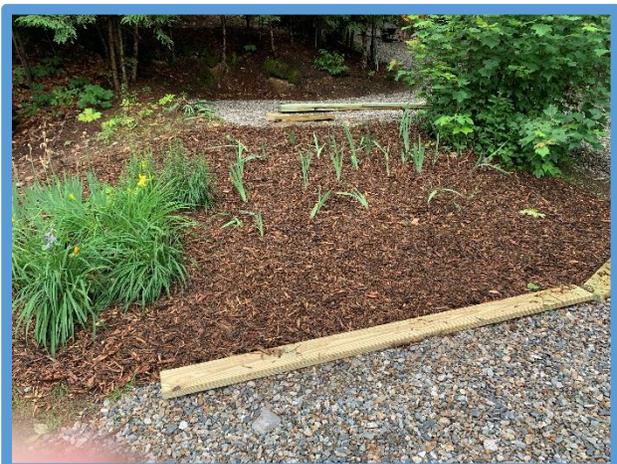
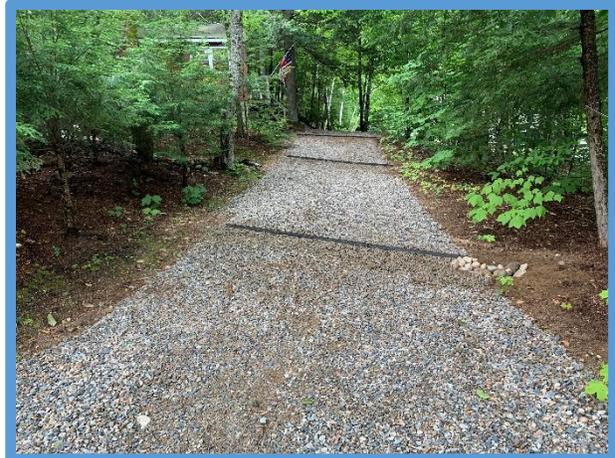
Stacy West

The West's property was another great site that needed attention. They had significant erosion coming down their driveway and continuing through the front yard and eventually ending up in the lake. The crew came in and did a great job installing the necessary BMP's to fix the property of its runoff issues.

First, we dug an infiltration pathway through the front yard to offer a massive amount of area for runoff to infiltrate into the ground. Then, they planted native plants purchased by the homeowner as well as transplanted plants from the property in areas where the soil needed to be supported by more root systems. Most of the area around the driveway was bare soil so erosion control mulch was laid down to act as cover and prevent sheet erosion. The last thing the crew did was install three rubber razors on their driveway coupled with drywells to trap any runoff that would be diverted.

Total Number of BMPs	Approximate Cost to Landowner
15	\$1,035.00
Tons of Sediment Reduced	Pounds of Phosphorus Reduced
1.1	1.0
Crew Hours	Crew Value
71	\$1,280.00
BMPs Installed and Maintained	Materials Used
Erosion Control Mulch	EMC – 3 yards
Infiltration Pathway	Crushed Stone – 5 yards
Pavers	Rip Rap – 1 yards
Rubber Razor	2x6 Pressure Treated Lumber – 96 feet
Drywells	Rubber – 60 feet
Native Vegetation	Plants – 25

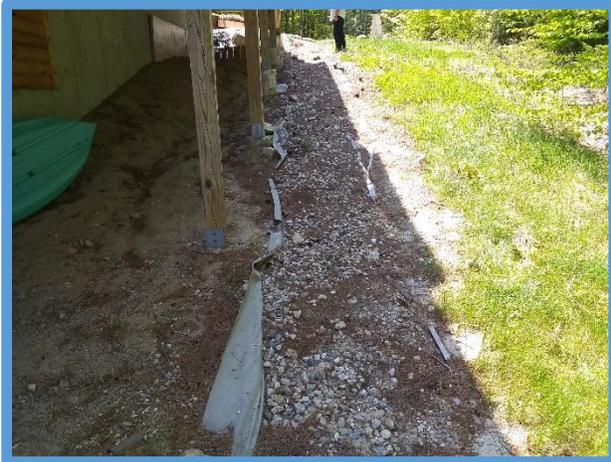
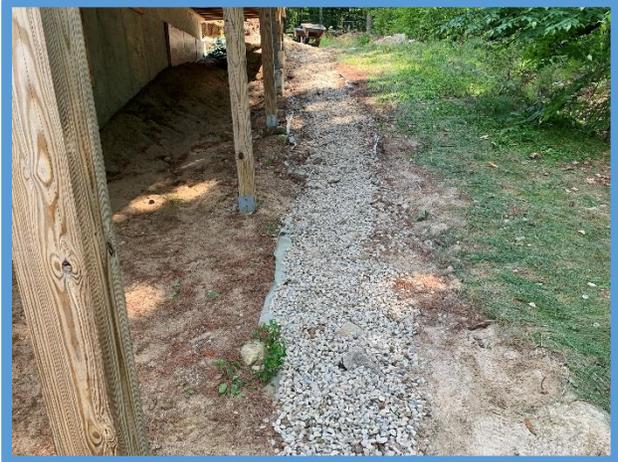
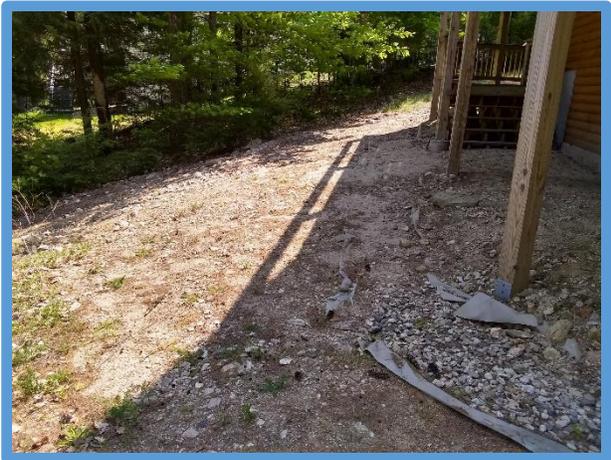
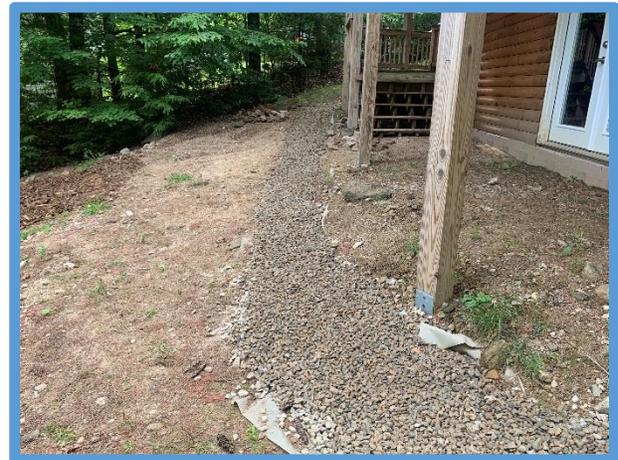
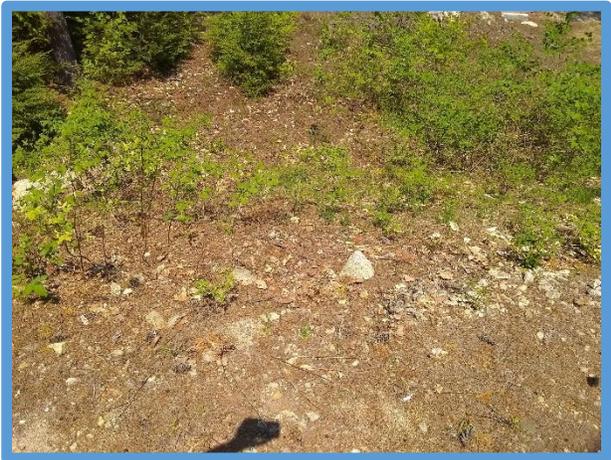
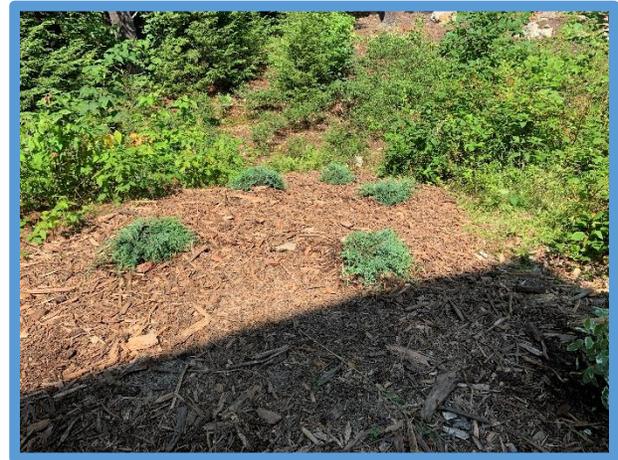
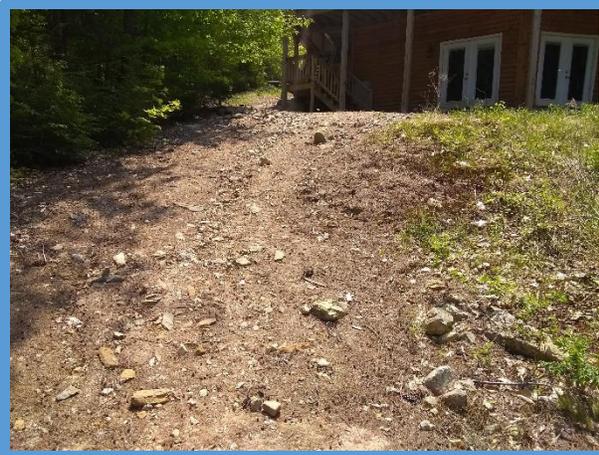
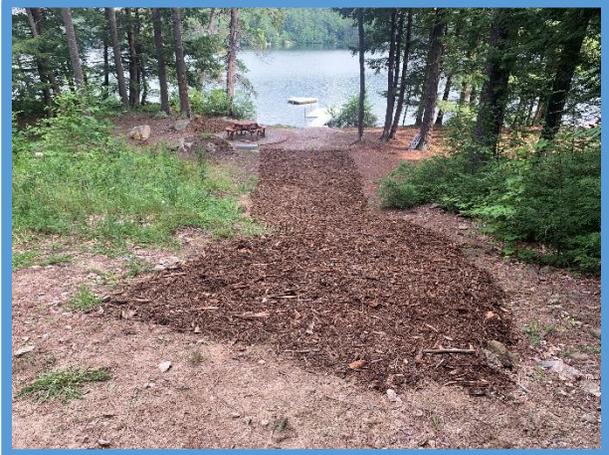
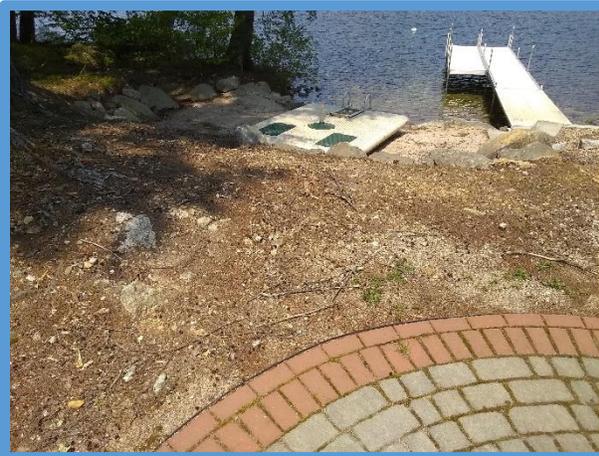
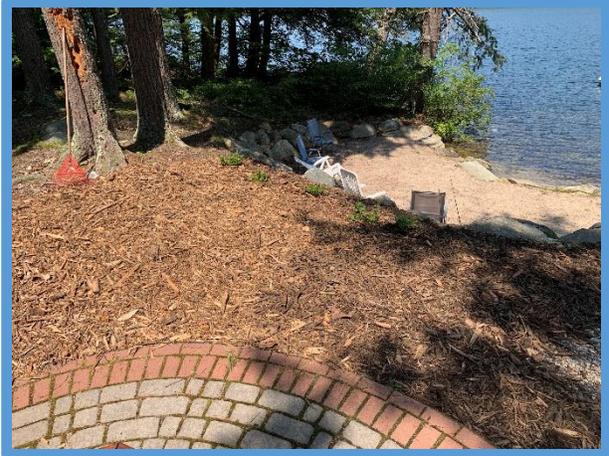
This project was the first project we did on Lovell Lake this year, so it was exciting to be back. Dave had just moved into his house and was made aware that he had severe erosion issues that needed to be addressed. He called AWWA in a panic expecting to have to pay lumps of money to remediate all his problems but was greatly relieved to hear that AWWA could solve his problems without the great expense. After a quick site visit a design was made and the crew got to work. We laid down erosion control mulch around the entire property including in front of the house, on the slope off the back deck, on the pathway down to the water, under the side deck where there were deep gullies from erosion, and down by the water on the edge of the existing patio. Throughout those places we planted native plants to help hold the soil together and prevent it from eroding further. On top of all of that we retrofitted an existing but well filled in dripline/infiltration trench that wrapped its way around almost the entire house. To finish off the project the crew installed two rubber razors in his driveway to divert any runoff that had been making its way down the road and onto his property. On the end of each of those two rubber razors a drywell was installed to contain the runoff and give it time to infiltrate into the ground.

Total Number of BMPs	Approximate Cost to Landowner
19	\$1,420.00
Tons of Sediment Reduced	Pounds of Phosphorus Reduced
4.2	3.6
Crew Hours	Crew Value
154	\$2,550.00
BMPs Installed and Maintained	Materials Used
Erosion Control Mulch	EMC – 30 yards
Native Vegetation	Plants - 30
Rubber Razors	Crushed Stone – 3 yards
Dripline Trench	Loam – 1 yard
Drywells	2x6 Pressure Treated Planks – 64 feet
	Nails – 1 Box
	Rubber – 30 feet

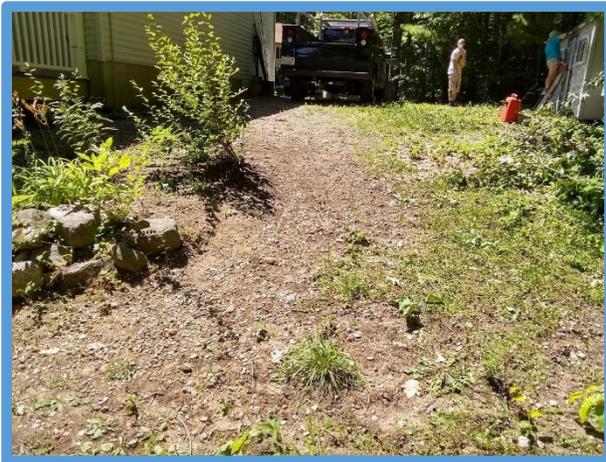
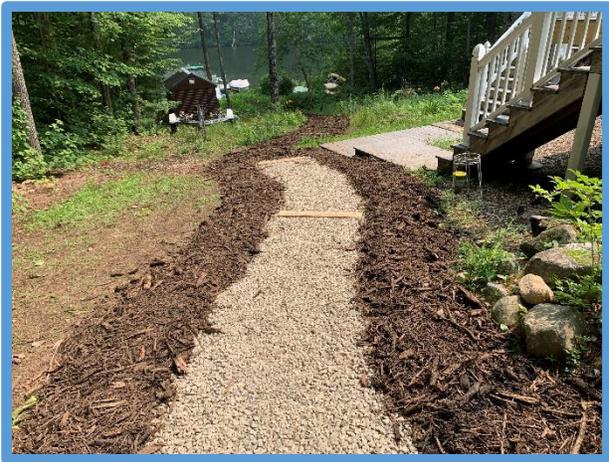
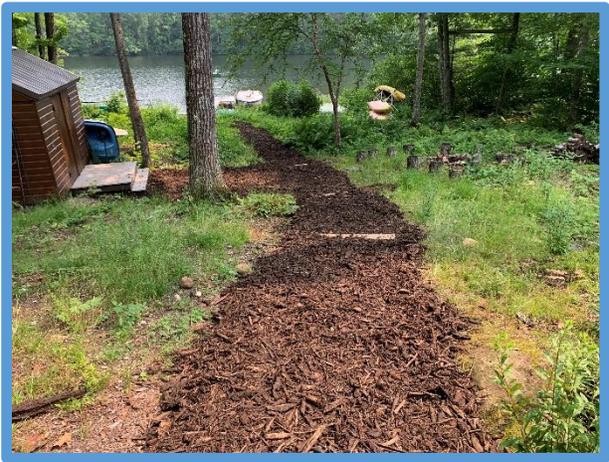
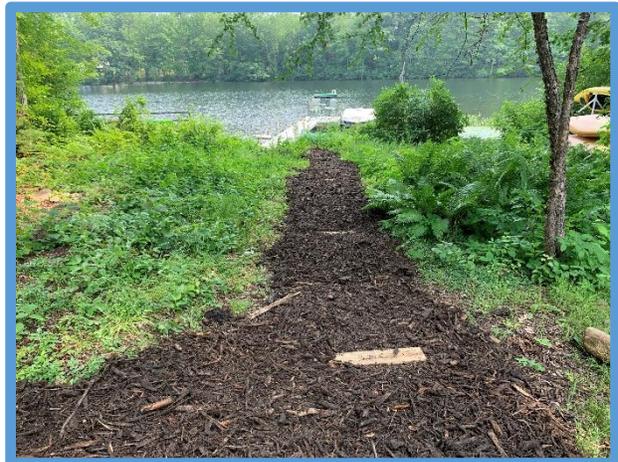
Pam Grignaffini

The Grignaffini's site was the first site the crew had done this year that had a relatively small number of different BMP's. The crew worked hard over the course of two days to install fourteen waterbars spanning entire pathway down to the water. Beforehand, this pathway was a channel for runoff, but the crew converted it into an amazing infiltration pathway and then a long winding erosion control mulch pathway. About halfway down the slope next to a shed the crew also installed two drip line trenches to allow water coming off the roof to infiltrate into the ground. This was also lined with mulch. The project was altogether a very simple fix that was just made difficult due to the scale. The crew did a great job and the project looked great after completion.

Total Number of BMPs	Approximate Cost to Landowner
10	\$893.00
Tons of Sediment Reduced	Pounds of Phosphorus Reduced
0.8	0.6
Crew Hours	Crew Value
70	\$1,165.00
BMPs Installed and Maintained	Materials Used
Erosion Control Mulch	EMC – 10 yards
Dripline Trench	Crushed Stone – 5 yards
Infiltration Pathway	6x6 Pressure Treated Lumber – 48 feet
Waterbars	Rebar – 56 feet

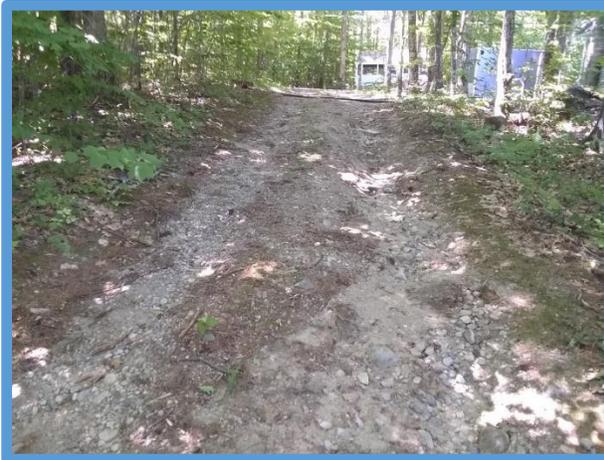
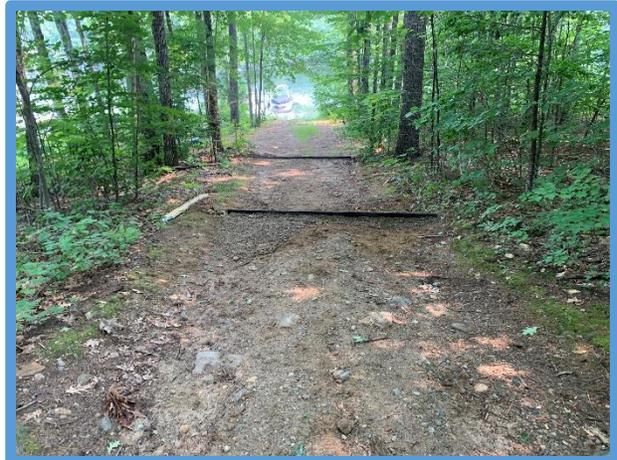
The Hummingbird Road project was our second and final shared project of the season. It was a simple half-day project where the crew installed two rubber razors and drywells on a boat launch. The project although small, was still a very important project for the crew to complete. The boat launch had been ripped apart by the past month's heavy rain and was in need for a fix up.

Total Number of BMPs	Approximate Cost to Landowner
4	\$311.00
Tons of Sediment Reduced	Pounds of Phosphorus Reduced
1	0.8
Crew Hours	Crew Value
19	\$370.00
BMPs Installed and Maintained	Materials Used
Rubber Razors	Rubber – 30 feet
Drywells	Crushed Stone – 1 yard
	2x6 Pressure Treated Lumber – 60 feet
	Rip Rap – ½ yard

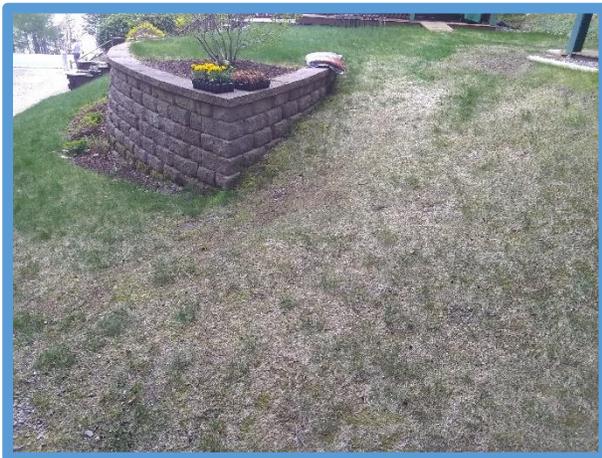
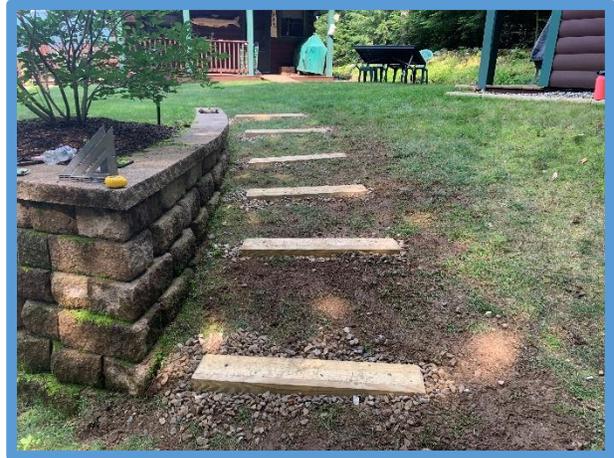
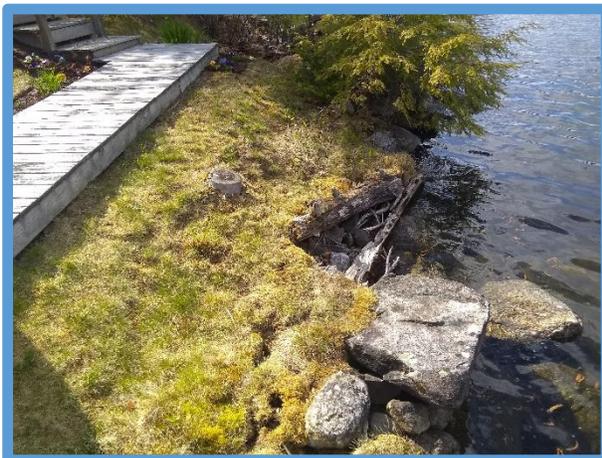
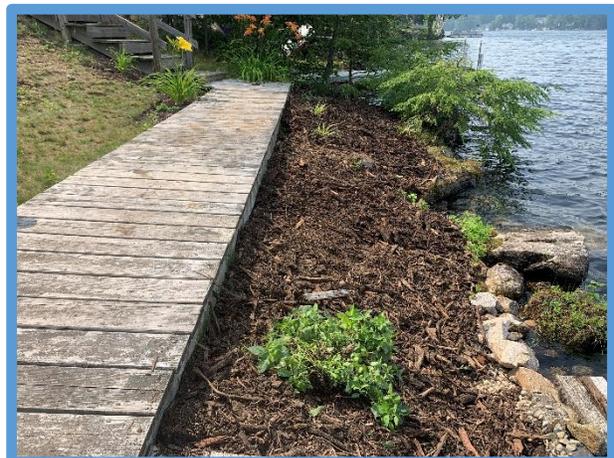
Richard Chiasson

The Chiasson's was another great site for the crew this season. This was a less physically strenuous project that allowed the crew really put a lot of detail into their work. We installed six waterbars on a slope up by the main house that was seeing a healthy amount of runoff. The runoff would continue down the driveway and into a stream that eventually led into Lovell Lake, from this point. As well as the waterbars the homeowners themselves installed dripline trenches on the sides of their shed that were able to trap much of the runoff they were experiencing. The other aspect of this site was a bank stabilization effort. Along the shoreline of the lake, they were experiencing undercutting so the YCC crew planted fifteen native plants with good root systems to help hold the soil on the shoreline together. Then, they laid erosion control mulch throughout the plants to help cover the bare soil as well as provide new nutrient rich soil as the mulch breaks down.

Total Number of BMPs	Approximate Cost to Landowner
10	\$479.00
Tons of Sediment Reduced	Pounds of Phosphorus Reduced
0.2	0.2
Crew Hours	Crew Value
30.5	\$523.75
BMPs Installed and Maintained	Materials Used
Waterbars	EMC – 1 yard
Erosion Control Mulch	Crushed Stone – 1/2 yard
Native Vegetation	6x6 Pressure Treated Lumber – 18 feet
	Rebar – 16 feet
	Plants – 15

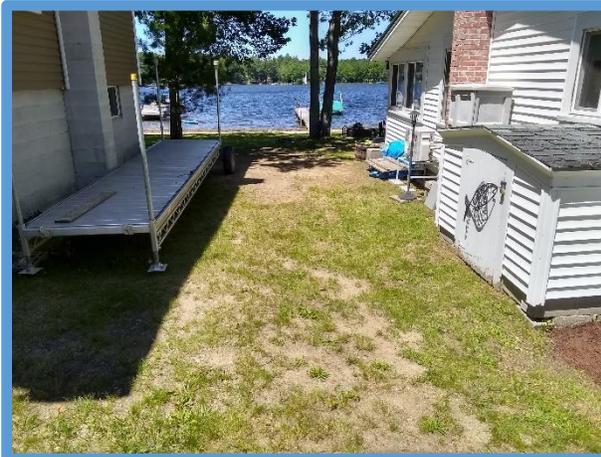
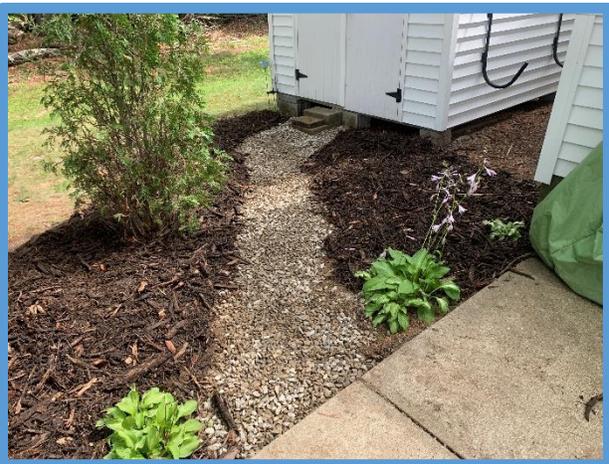
Ralph Ferraro

The project at the Ferraro's was a first for AWWA. It was the first time the YCC had done a project on Loon Pond in Acton. Needless to say, everyone was excited to expand our region of projects and to really do a good job as well. For the project itself it was rather simple, there was a giant section of bare soil on the side of the house which continued around to the back patio. By the patio you could see exposed roots from trees and sheet erosion from the massive amounts of runoff coming off the patio. Our solution was to lay down erosion control mulch along the side of the house that continued around the front covering all the exposed soil and roots. Then we dug a long infiltration trench along the edge of the patio that would trap any water that would rush off. To finish up the project we installed a small infiltration pathway leading from the edge of the patio to the side shed. This area was also bare soil and exposed roots before our crew came in a did their work.

Total Number of BMPs	Approximate Cost to Landowner
6	\$362.00
Tons of Sediment Reduced	Pounds of Phosphorus Reduced
0.5	0.4
Crew Hours	Crew Value
33	\$545.00
BMPs Installed and Maintained	Materials Used
Infiltration Trench	EMC – 9 yards
Erosion Control Mulch	Crushed Stone – 2 yards
Infiltration Pathway

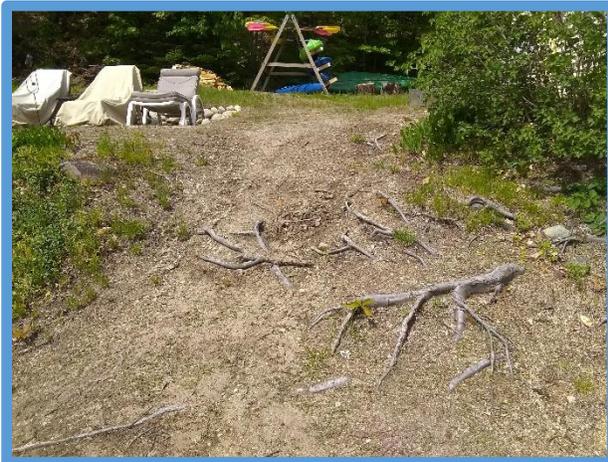
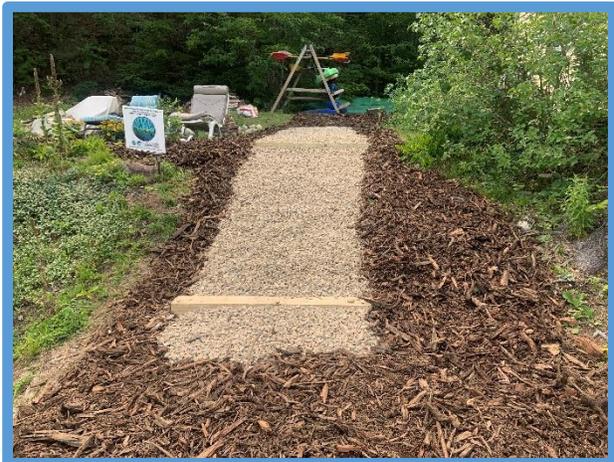
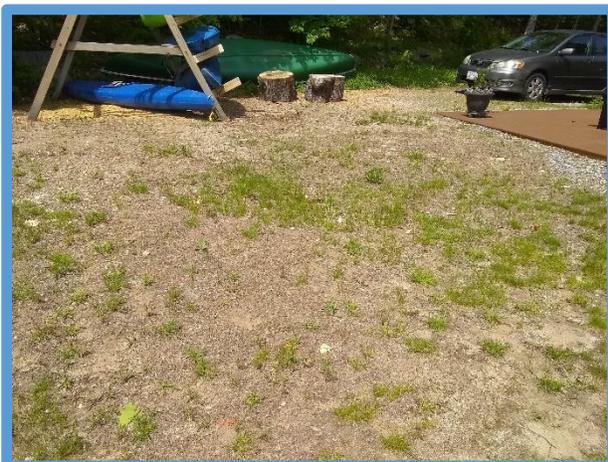
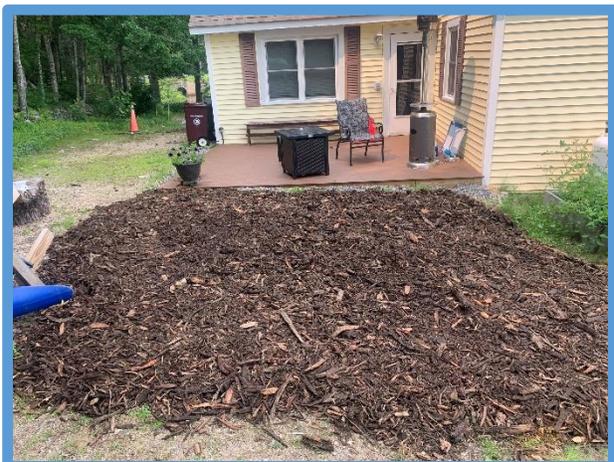
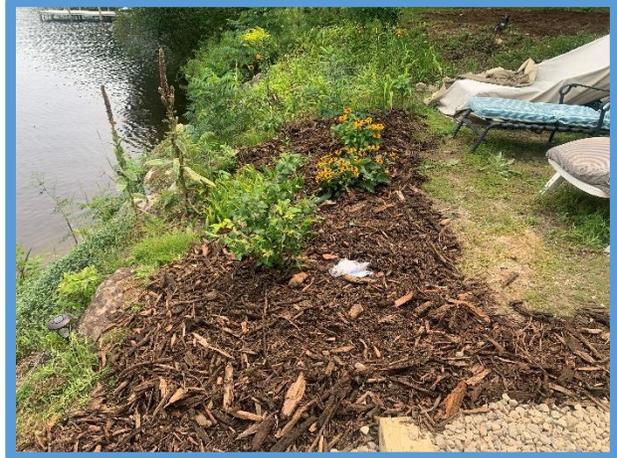
Dan MARRS

After two of the smaller projects, we moved onto the MARRS' project. Although the project itself was not anything the crew hadn't seen, the weather made it a tougher project. This project fell during one of the worst days of the aftermath of the wildfires out west. It took its toll on the kids and had us taking frequent breaks. But with some hard work and a tasty lunch from Dan, the kids were able to put together a project worth sharing with everyone and proudly shared our work during the YCC tour.

For the project itself the crew installed an infiltration pathway with a waterbar at the top and the bottom to help support an eroding access point to the water. They then edged the pathway with erosion control mulch and continued the mulch to cover the bare soil above the trench. This was very important as the whole area was slowly eroding into the lake. To finish up the project the crew planted native plants along the edge of the slope to help keep the soil from further eroding.

Total Number of BMPs	Approximate Cost to Landowner
8	\$398.00
Tons of Sediment Reduced	Pounds of Phosphorus Reduced
0.5	0.4
Crew Hours	Crew Value
50.5	\$842.00
BMPs Installed and Maintained	Materials Used
Infiltration Pathway	ECM – 6 yards
Erosion Control Mulch	Crushed Stone – 3 yards
Native Vegetation	6x6 Pressure Treated Lumber – 12 feet
Waterbars	Rebar – 8 feet
	Plants – 5

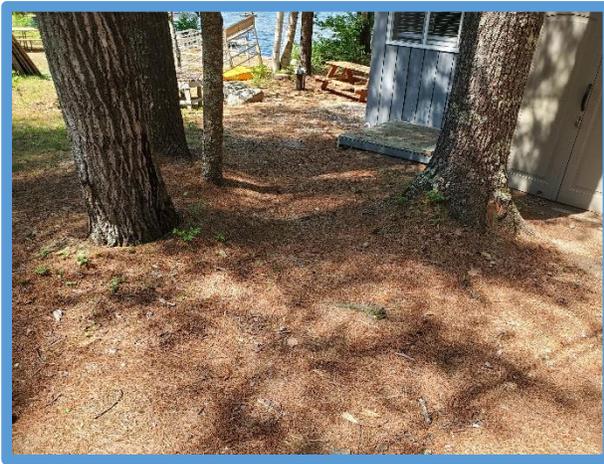
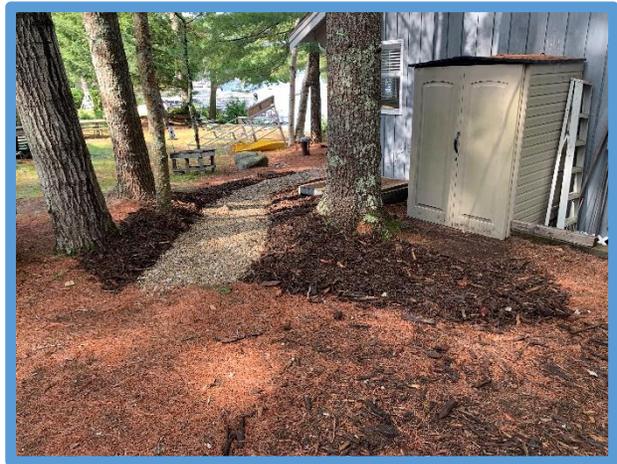
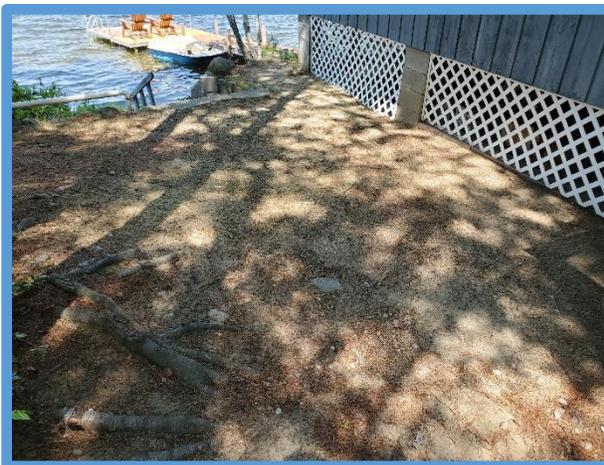
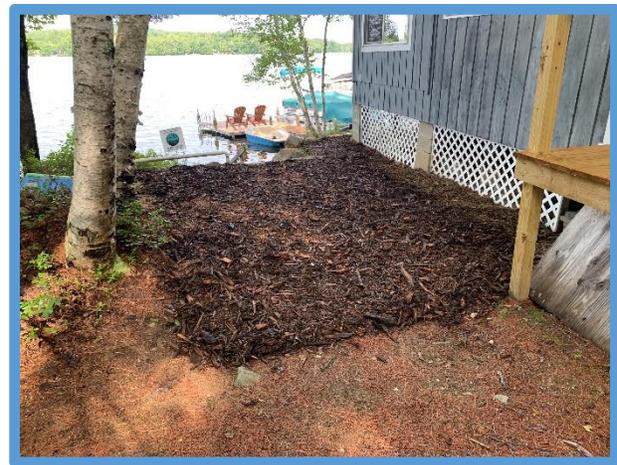
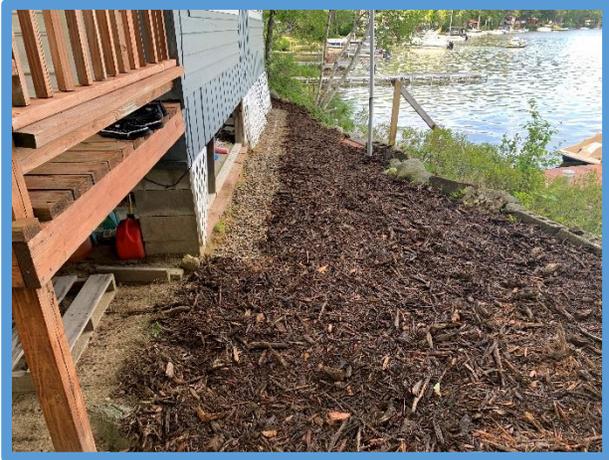
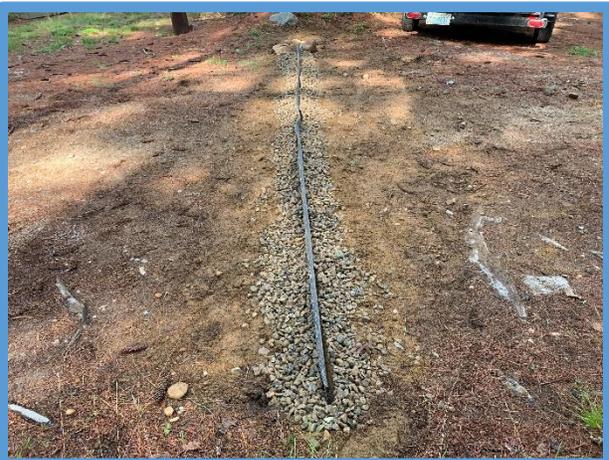
Maureen Meyer was another great project host for the crew this season. She had a YCC project quite a few years back and the runoff had started to overwhelm the old project. The crew came in and added on to the existing infiltration pathway and made it over twice as long. On top of that they mulched around the pathway giving it aesthetic value as well as coving the bare soil in the area. Further down the side of the house the crew laid down more erosion control mulch in an area where runoff was gradually scraping away at the soil. Then, around the front of the house the crew installed a dripline trench spanning the length of the roofline. This would help trap any water that was coming off the roof and allow it to easily infiltrate into the ground instead of going directly into the lake. To finish up the project the crew installed a rubber razor in the road. The idea for the razor was to prevent runoff from coming down the road and entering her driveway and eventually making its way to the lake. At the end of the rubber razor the crew dug a massive drywell to hold the excessive amounts of runoff that were rushing down the road.

Total Number of BMPs	Approximate Cost to Landowner
13	\$315.00
Tons of Sediment Reduced	Pounds of Phosphorus Reduced
0.5	0.4
Crew Hours	Crew Value
57.5	\$967.50
BMPs Installed and Maintained	Materials Used
Drywell	EMC – 5 yards
Rubber Razor	Rubber – 15 feet
Dripline Trench	2x6 Pressure Treated Lumber – 30 feet
Erosion Control Mulch	Crushed Stone – 3 yards
Infiltration Pathway	Rip Rap – 1 yard

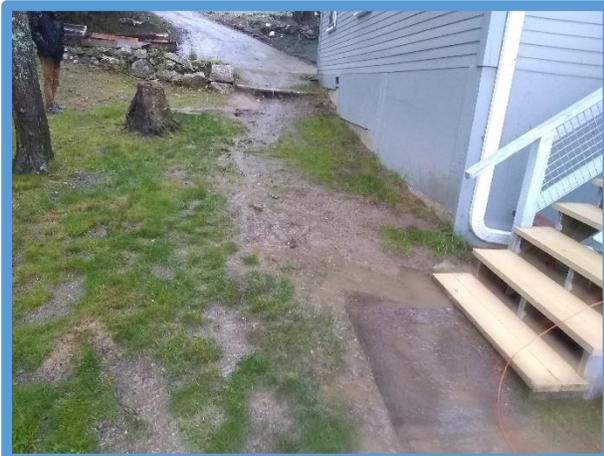
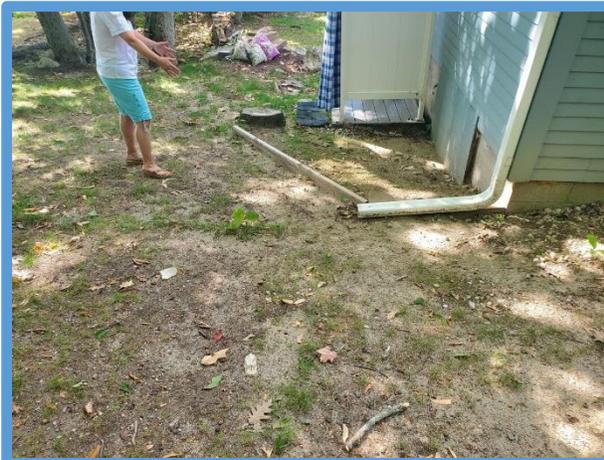
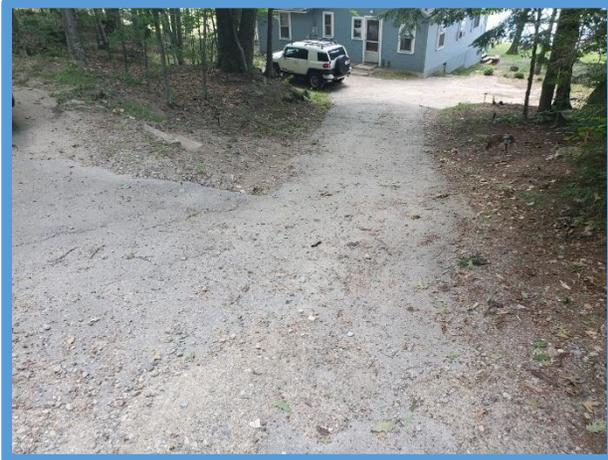
Monette Cotreau

Monette was experiencing massive amounts of sediment making its way down her driveway and into the lake. It rained during our initial site visit, so we were able to see firsthand how bad the erosion problem was.

It took the crew a little over a day to install all the BMP's on the site. They started with a long infiltration pathway lined with pavers and native vegetation. The pathway's aim is to trap all the runoff coming down the driveway and prevent it from getting into the lake. Above the trench the crew installed three firehose diverters on the driveway. Much like rubber razors, firehose diverters divert water and sediment into drywells dug at the end of each one. This site was a little tricky because about three inches underneath the dirt layer was more pavement. The crew ended up changing the design of the drywell to have a small trench dug in between the end of the firehose and the beginning of the drywell. We found through testing that the trenches did a great job at helping the runoff reach the drywell. Around the side of the house the crew dug an infiltration trench underneath a downspout. This trench allowed water to infiltration into the ground instead of rushing down the side lawn and into the lake. As a final step the crew laid down erosion control mulch over a parking area at the top of the driveway. The area had recently been turned to dirt and needed protection from erosion.

Total Number of BMPs	Approximate Cost to Landowner
12	\$550.00
Tons of Sediment Reduced	Pounds of Phosphorus Reduced
0.6	0.5
Crew Hours	Crew Value
70	\$1,167.50
BMPs Installed and Maintained	Materials Used
Infiltration Trench	EMC – 6 yards
Firehose Diverters	Firehose – 40 feet
Native Vegetation	Plants – 10
Erosion Control Mulch	Crushed Stone – 3 yards
Infiltration Pathway	Rip Rap – 1 yard
