The Acton Wakefield Watersheds Alliance

Youth Conservation Corps

2021 Season Report

December 2021

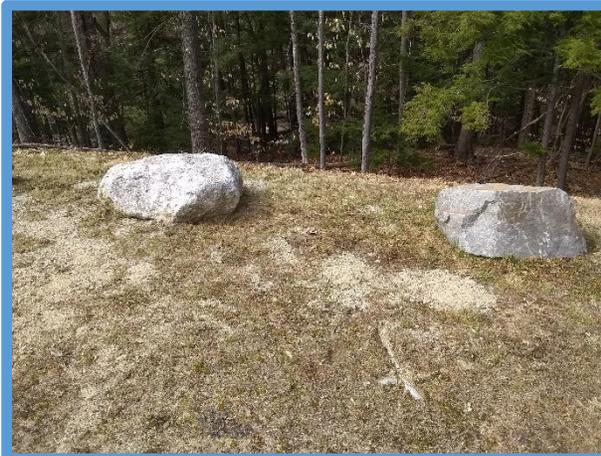
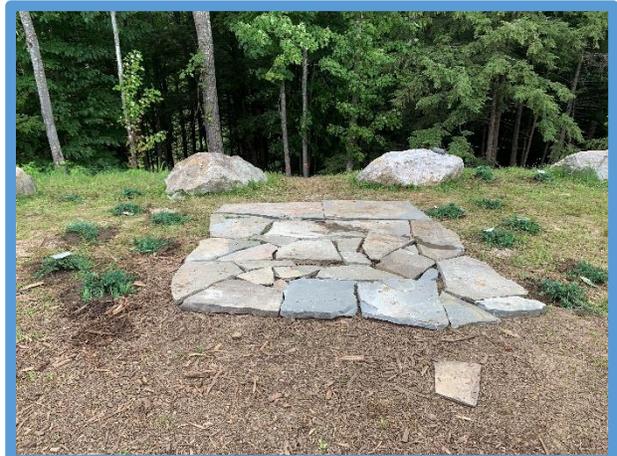
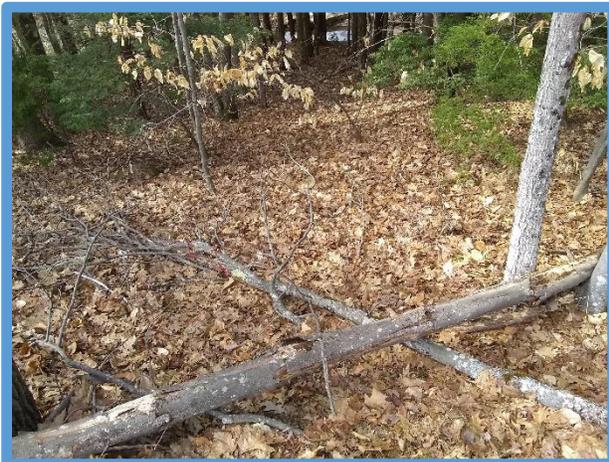
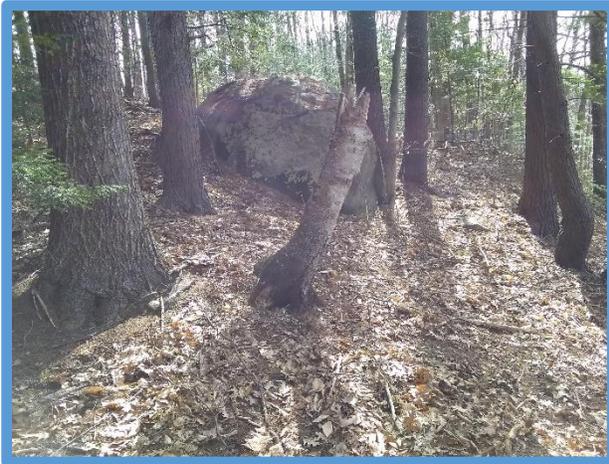
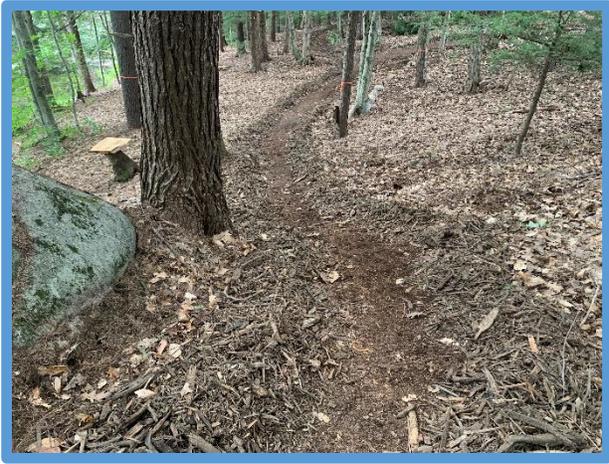
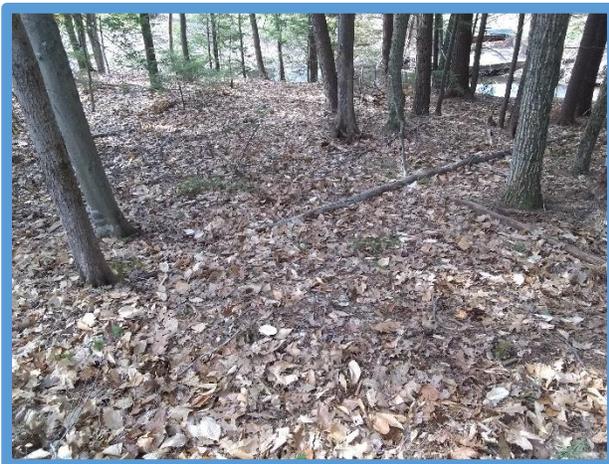
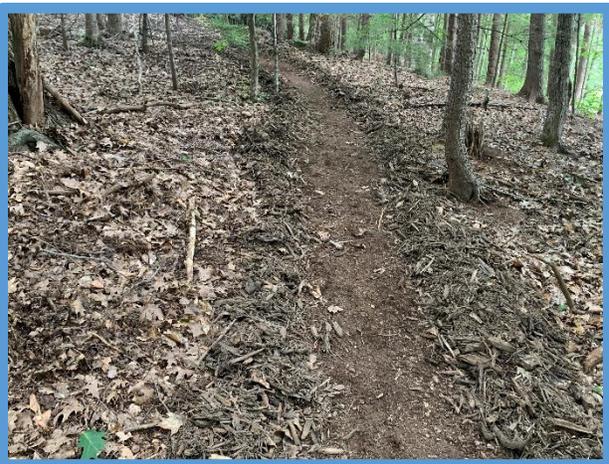
The Paul School project was unlike most sites the YCC has ever done as it was more of a community project. The aim was to provide the school with pathways that protect against erosion that led to the locations where they plan on making outdoor classrooms in the future. Our task was to design a path with good stabilization down a steep slope. The crew did a great job over the course of three days installing the pathway and lining it with a berm of erosion control mulch. The outcome looked great and since it rained while we were working on the project, we got to see that it would indeed stand up against runoff. Around the upper portion of the trail, we planted sixty juniper bushes to help hold the soil together and eventually spread to cover the entire slope.

Total Number of BMPs	Approximate Cost to Landowner
12	\$1,170.00
Tons of Sediment Reduced	Pounds of Phosphorus Reduced
NA	NA
Crew Hours	Crew Value
99.75	\$1,637.50
BMPs Installed and Maintained	Materials Used
Pathway	EMC – 10 yards
Erosion Control Mulch	Plants – 60
Native Vegetation

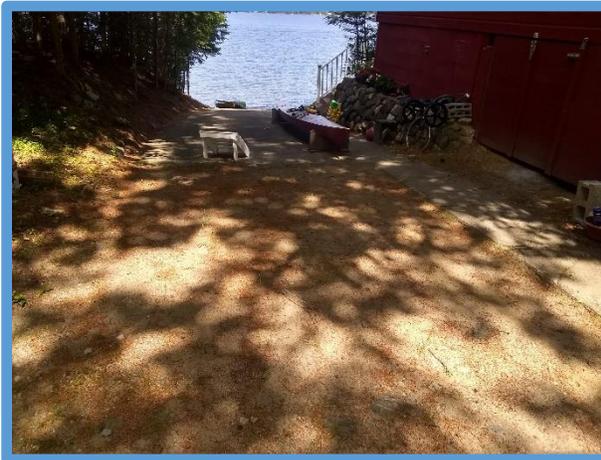
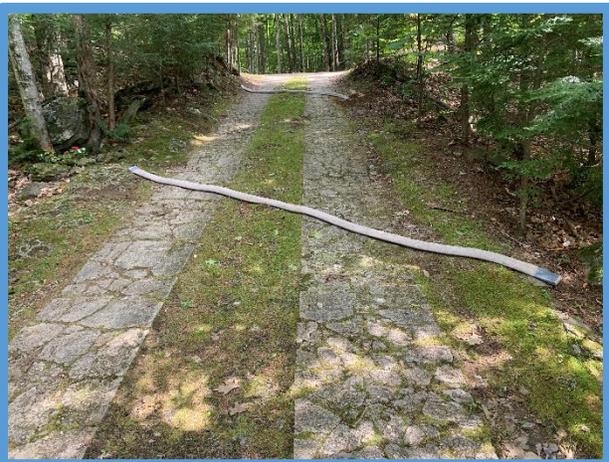
Les Swensen

The project at the Swensen's at first sight was expected to be rather simple, but after beginning the digging process the crew was proven wrong. The digging at this site was the most difficult we had faced this season, and we had a lot of it. Nevertheless, the crew once again excelled and got what turned into a more difficult site done in one day. For the project itself the crew installed a massive infiltration trench in front of a paved driveway. In the past, runoff would run directly down the driveway and into the lake, but with the new trench, water is only able to infiltrate into the ground in front of the driveway. Next the crew laid down erosion control mulch in areas next to the parking spots used by the homeowner. Runoff had previously been seen coming down the driveway and rushing through that spot. For further protection we decided that installing two firehose diverters would be imperative in reducing the amount of runoff coming down the driveway. This would ultimately put less stress on the BMP's further down the hill.

Total Number of BMPs	Approximate Cost to Landowner
14	\$354.00
Tons of Sediment Reduced	Pounds of Phosphorus Reduced
0.5	0.4
Crew Hours	Crew Value
53.5	\$883.75.00
BMPs Installed and Maintained	Materials Used
Infiltration Trench	EMC – 5 yards
Erosion Control Mulch	Crushed Stone – 4 yards
Firehose Diverter	Firehose – 24 feet

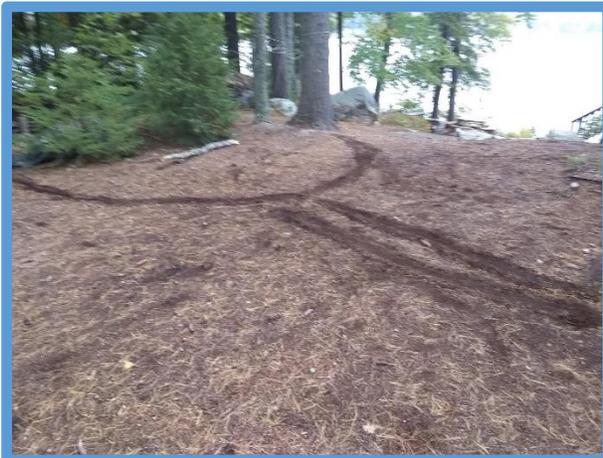
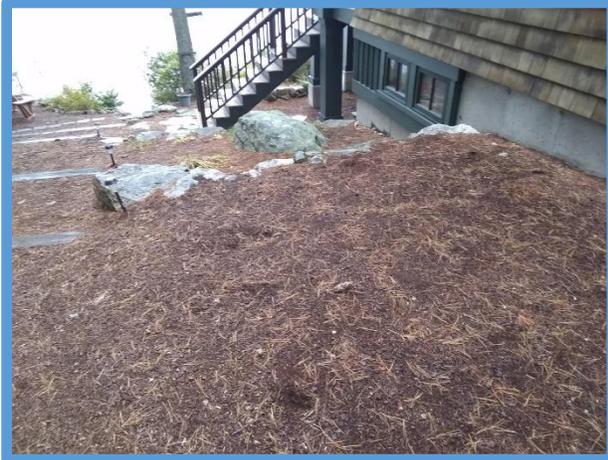
Nancy Ginns

The Ginns project was special as it was the only project the crew did that included a rain garden. A rain garden requires extensive digging and is always one of harder BMP's to install. Nonetheless the crew did any amazing job digging it three feet deep and filling it in with crushed rock, loam, and erosion control mulch. A rain gardens main purpose is to provide a large area for water storage. This was especially important on the Ginns property because they have a large amount of rain falling on a very exposed section of their property. The crew also dug a long infiltration trench leading into the rain garden to act as a block for runoff. Any runoff traveling down the slope would be trapped by the trench and eventually end up in the bottom of the rain garden where it can get soaked up by the native vegetation that the crew planted. Even after the installing of the rain garden the project wasn't done, the crew went on to retrofit four existing waterbars with crushed rock as well as spreading eight yards of erosion control mulch around the property. To finish the site, the crew installed a vegetated buffer on the edge of the slope overlooking the waterbars. This buffer provided structure through root systems to the eroding slope as well as covering more bare soil. The crew did a great job with the difficult project and earned praise from the homeowners for their effort.

Total Number of BMPs	Approximate Cost to Landowner
14	\$684.00
Tons of Sediment Reduced	Pounds of Phosphorus Reduced
2.7	2.3
Crew Hours	Crew Value
97	\$1,572.050
BMPs Installed and Maintained	Materials Used
Infiltration Trench	EMC – 8 yards
Erosion Control Mulch	Crushed Stone – 6 yards
Native Vegetation	Loam – 4 yards
Rain Garden	Plants – 10
Retrofit Infiltration Steps

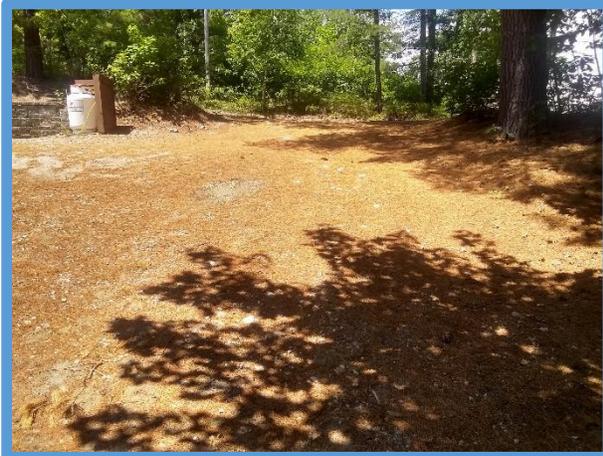
Wendy Marchand

The Marchand's was our second to last site for the YCC season. It was simpler project that consisted of just two rubber razors, mulch, and plants. During this project we were missing one of our more senior crew members, but the crew was still able to get the project done in just one day. The Marchands had a poorly vegetated driveway that they used for launching their boat. This driveway allowed water to run directly into the water, so the crew installed two rubber razors to divert the rushing runoff. The runoff would then get trapped by a drywell and infiltrate into the ground. Next to the driveway they had an eroding slope that needed fixing. The crew laid down erosion control mulch and planted around fifteen native plants that would help hold the bank together better. These plants while spread out now, will overtime grow to cover the entire slope.

Total Number of BMPs	Approximate Cost to Landowner
10	\$753.00
Tons of Sediment Reduced	Pounds of Phosphorus Reduced
1.2	1.0
Crew Hours	Crew Value
39	\$660.00
BMPs Installed and Maintained	Materials Used
Rubber Razor	EMC – 5 yards
Drywell	Crushed Stone – 1 yard
Native Vegetation	Rubber – 35 feet
Erosion Control Mulch	2x6 Pressure Treated Lumber – 80 feet
	Plants – 12
	Rip Rap – 1 yard

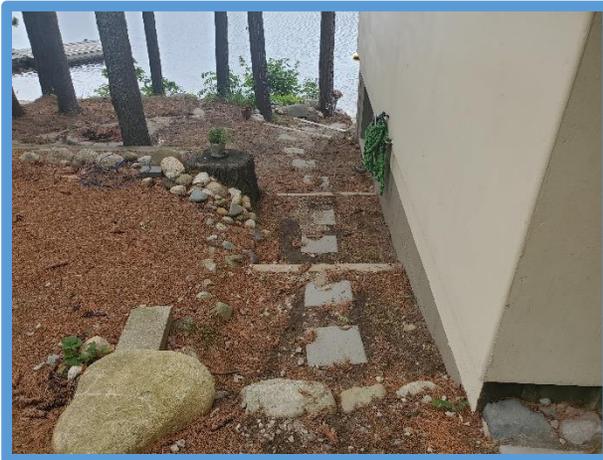
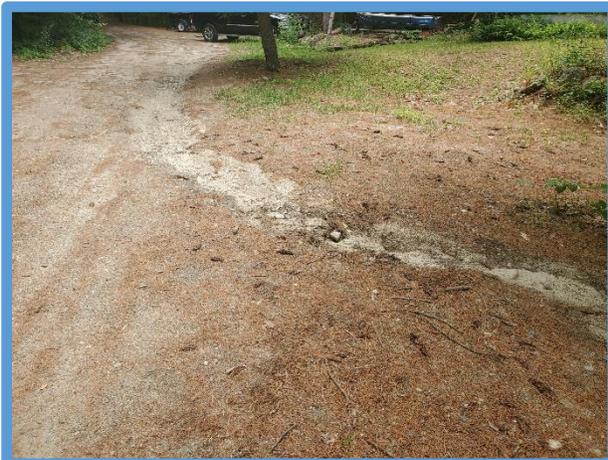
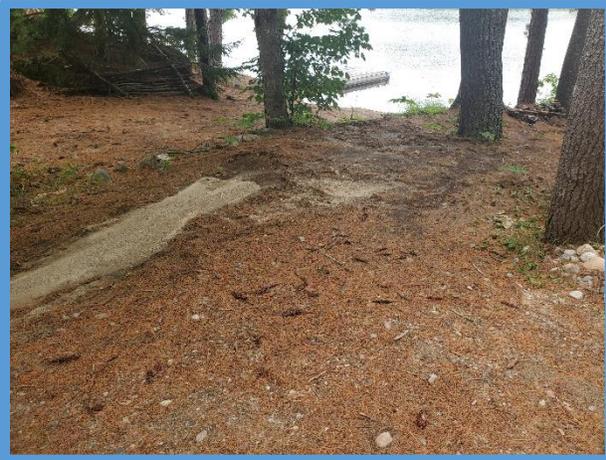
Al Doucet

The Doucet's project was the last of the season for the YCC crew. Earlier in the season we did a project next door to the Doucet's, and this project was a continuation of the problem both properties were facing. The runoff was originally continuing past the first site and flowing through the Doucet's parking area and into the lake. Our solution was to dig a rip rap trench on the side of the road and continue it through the parking area. On top of the problems, they were having in that area they were also having problems with runoff rushing down the side of their house where they had existing infiltration steps. After identifying the problem, the crew got to work and in no time had dug an approximately 35-foot-long rip rap trench as well as retrofitted the five steps leading around the house. This project in combination with the previous project are sure to drastically reduce these erosion issues and help to eliminate one more entry point for polluted runoff into the lake.

Total Number of BMPs	Approximate Cost to Landowner
8	\$178.00
Tons of Sediment Reduced	Pounds of Phosphorus Reduced
1.2	2.0
Crew Hours	Crew Value
59.5	\$1,028.75
BMPs Installed and Maintained	Materials Used
Rip Rap Trench	Rip Rap – 4 yards
Retrofit Infiltration Trench	Crushed Stone – 1 yard
