The Acton Wakefield Watersheds Alliance

Youth Conservation Corps

2020 Season Report

December 2020

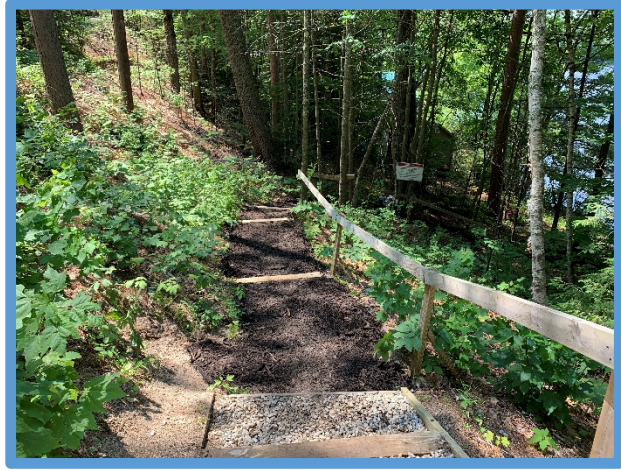
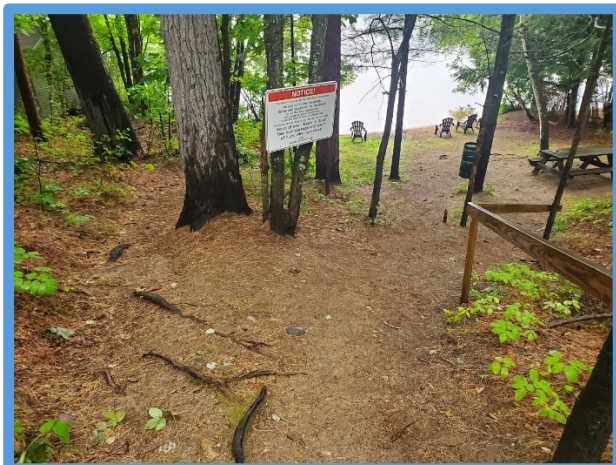
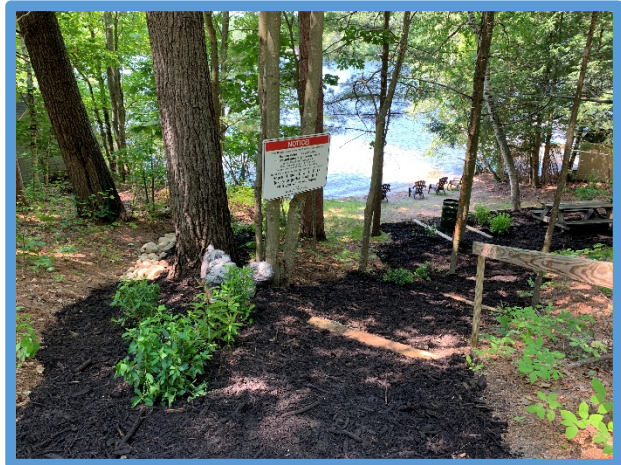
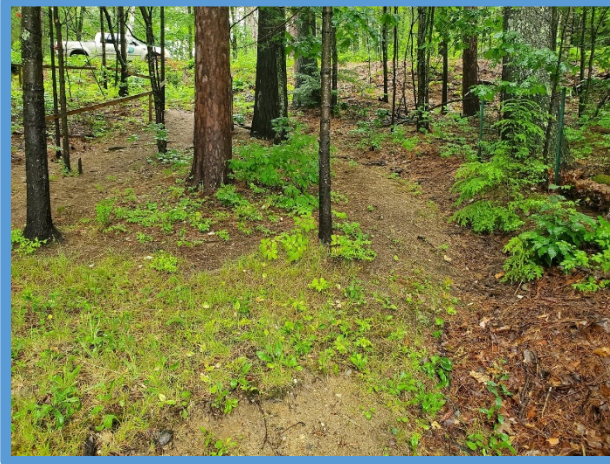
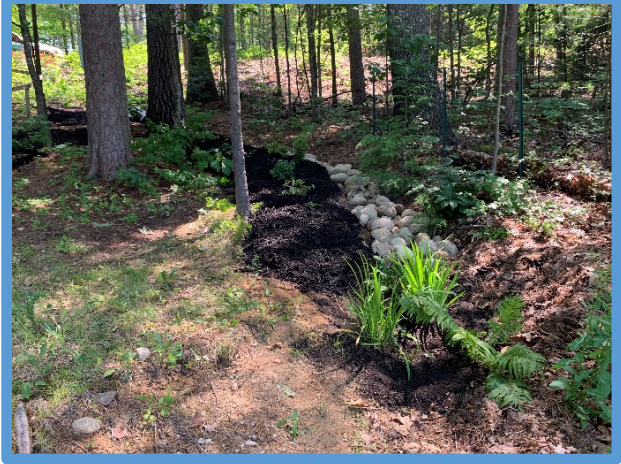
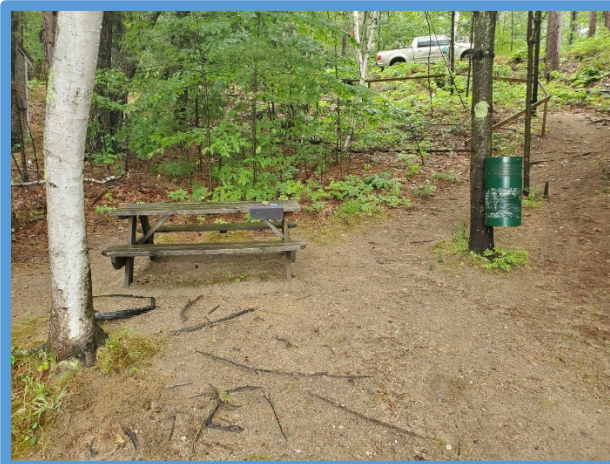
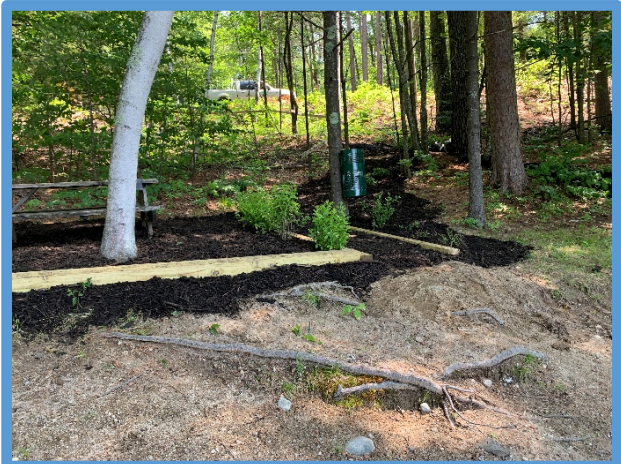
The Pine River Association came to AWWA this season with a few potential YCC projects, the first of which was their association beach. We realized quickly that it was an excellent spot for a project, with its steep winding slope that led directly to the water. This site had lots of erosion from the road as well as the slope that leads down to the beach itself.

Our crew placed six waterbars and retrofitted four steps by digging them out and filling them with crushed rock as a first line of defense against soil erosion. Then, around those waterbars and down the winding slope we laid erosion control mulch on the exposed soil. On the left side of the path the crew dug a three-foot deep by two-foot wide trench, which we filled with rip rap. Around the picnic area at the bottom of the slope we placed three more waterbars to help keep the slope intact as well as plantings in and around those three waterbars. The bottom portion of the site was tied together with erosion control mulch.

Total Number of BMPs	Approximate Cost to Landowner
23	\$550
Tons of Sediment Reduced	Pounds of Phosphorus Reduced
1	0.9
Crew Hours	Crew Value
103.5	\$2,572.50
BMPs Installed	Materials Used
Erosion Control Mulch	Erosion Control Mulch – 10 yards
Native Vegetation	Crushed Stone – 2 yards
Waterbars	Pressure Treated Lumber - 60 feet
Retrofit Steps	Rip Rap – 9 yards
Rip Rap Trench	Plants - 20

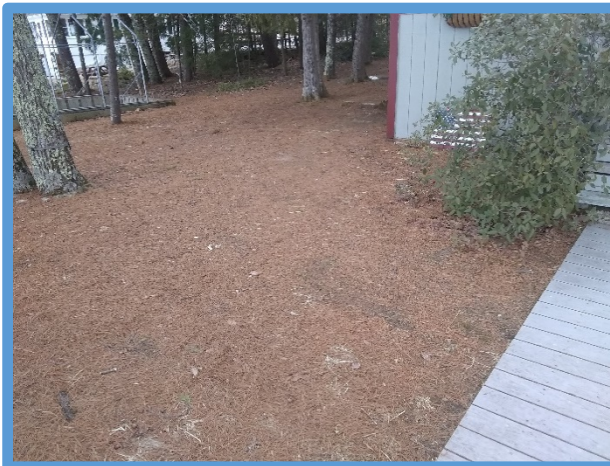
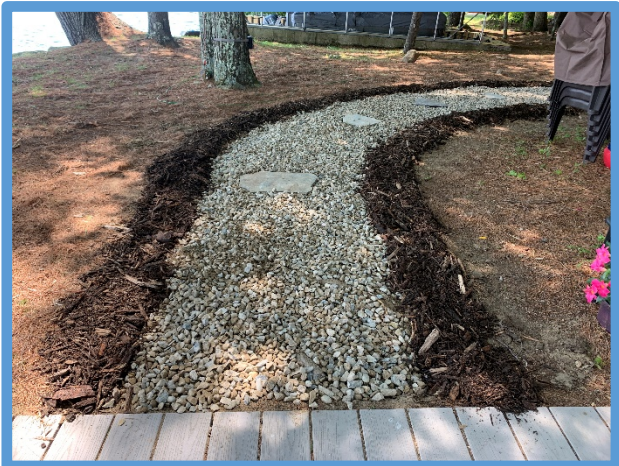
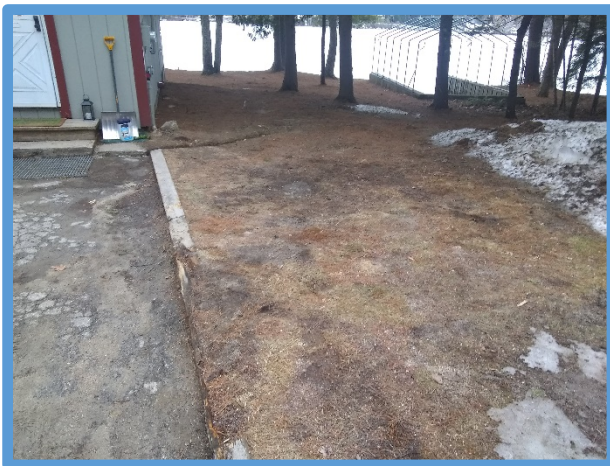
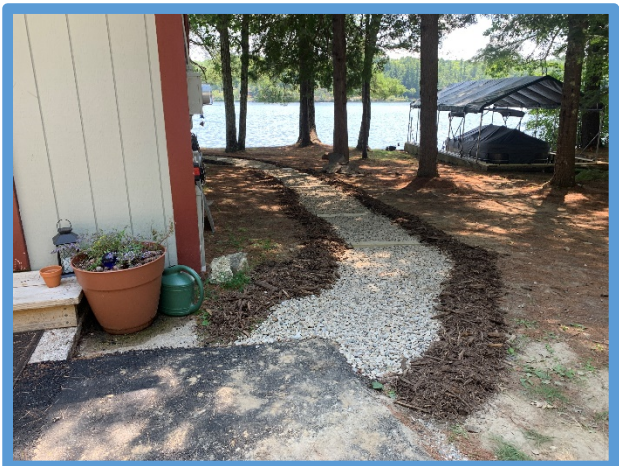
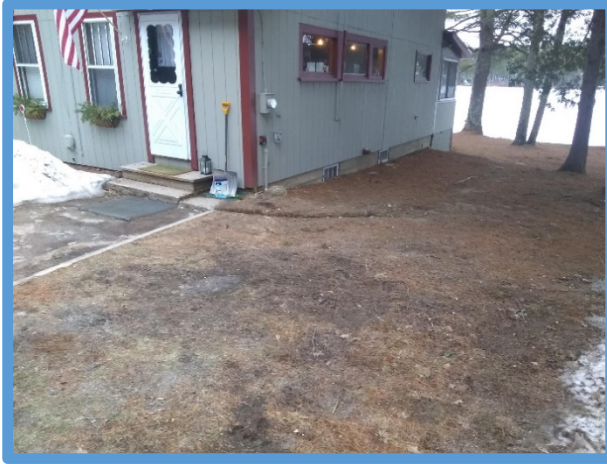
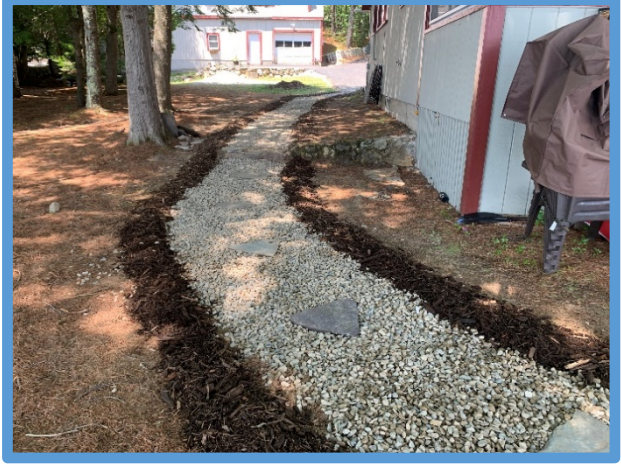
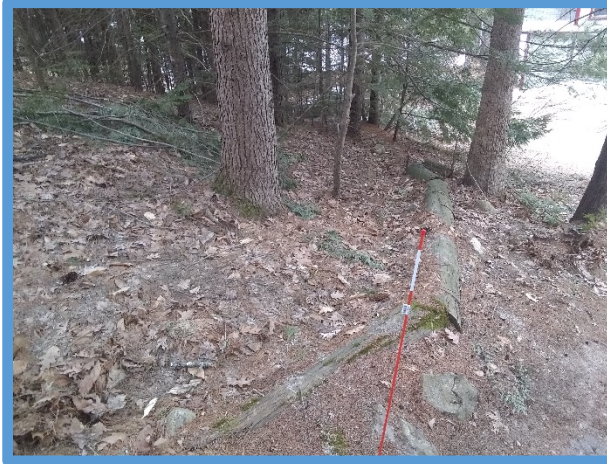
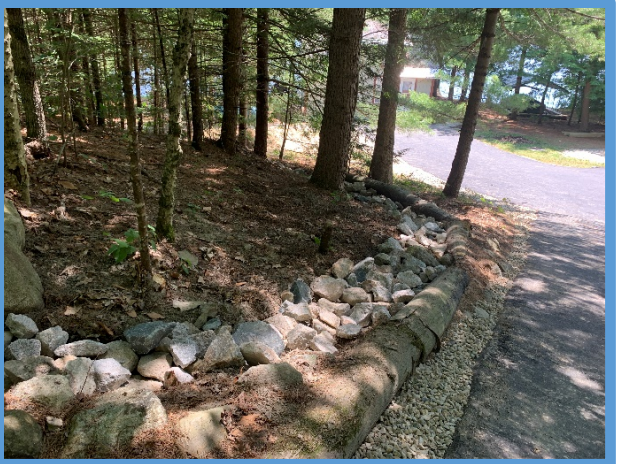
Robert & Mary Plante

The Plante's property, although not a very steep slope, was still a major source of runoff and soil erosion. Water would race down their driveway, across their side yard, and into the lake. There was an existing pathway that the water seemed to be following so it was an excellent spot to fit in some of our BMP's.

We installed a seventy-foot-long winding infiltration pathway where the erosion was occurring, as well as waterbars to break the pathway up into sections, with erosion control mulch on the sides as a finishing touch. The infiltration pathway started at the corner of their driveway and ended on the lake side of their house next to a wooden walkway that lead to the water. Runoff would enter the yard at the start of the pathway and any water that did not infiltrate into the ground immediately was stopped by the waterbars placed along the path or the erosion control mulch lining the sides. We also cleaned out a pre-existing rip rap trench that went down the side of their driveway that was filled with sediment from the road.

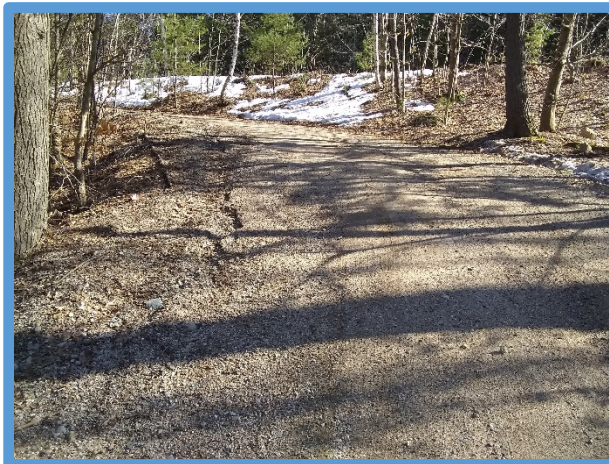
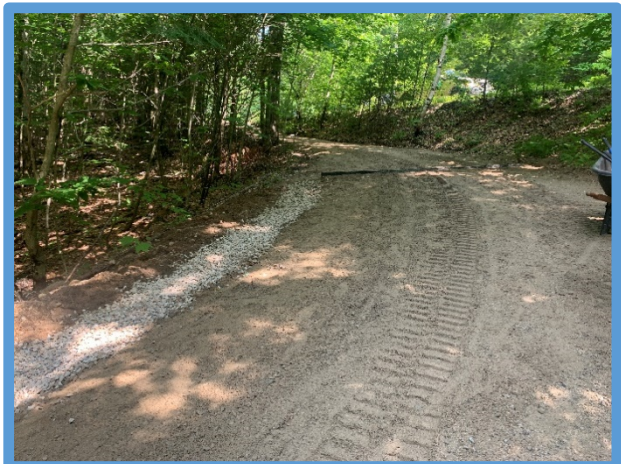
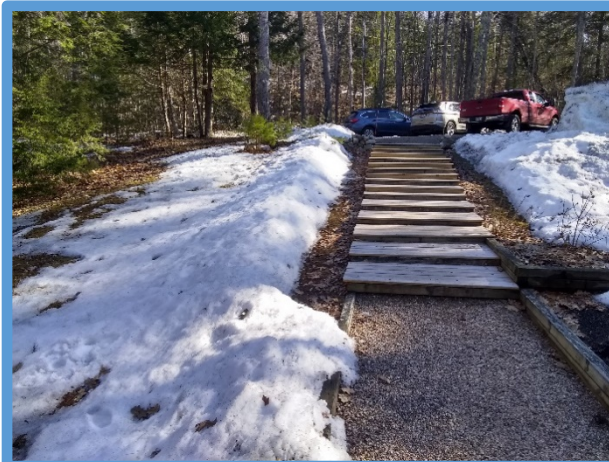
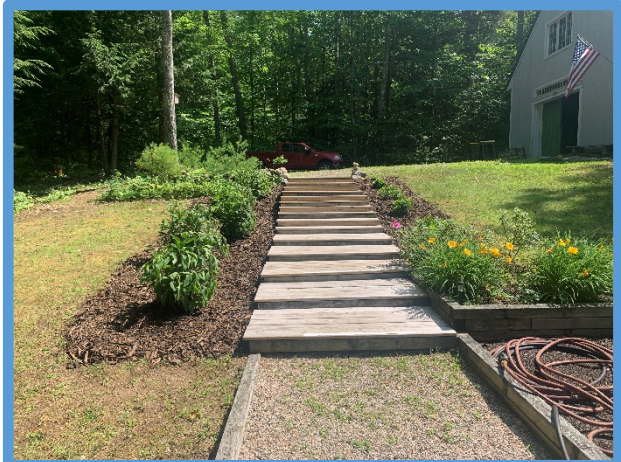
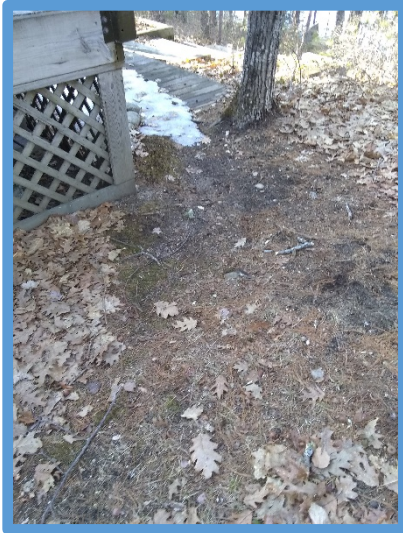
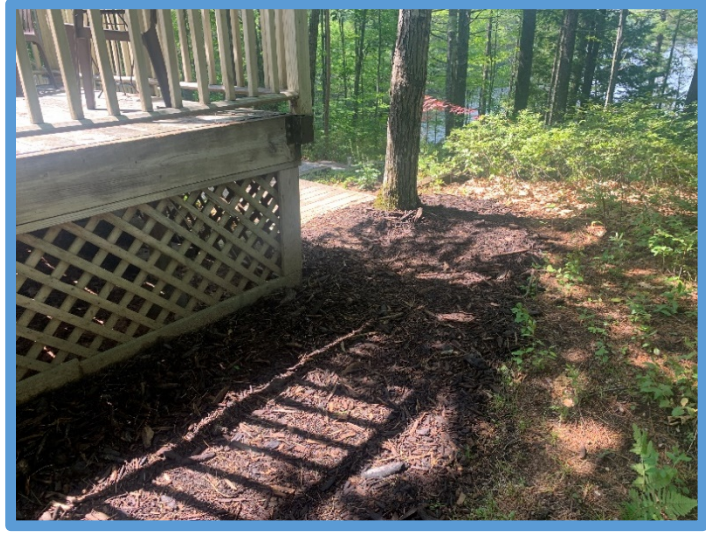
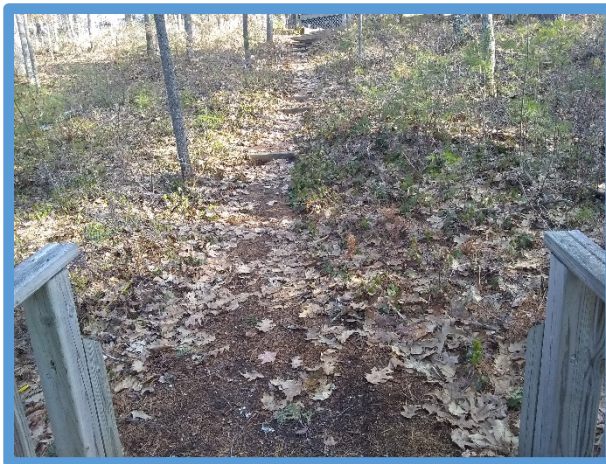
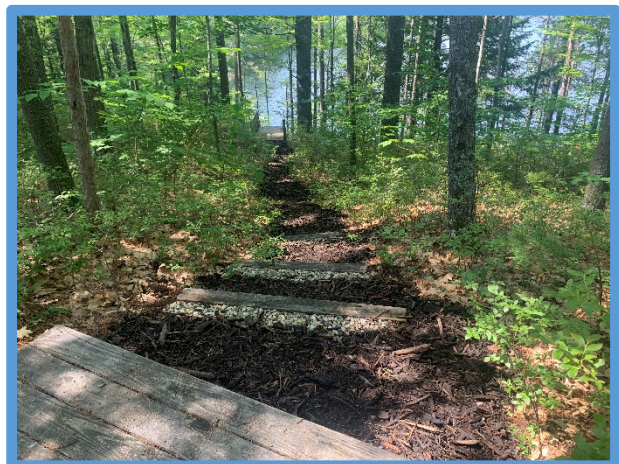
Bruce & Denise Bowden

The Bowden's were one of very few projects that AWWA has done on Balch Lake in its fifteen-year history, and we were very excited to be there. They have a long steep driveway down to their house that needed reinforcing with a few of our BMP's. Their pathway to the water and area around their house were also ideal for erosion control.

As a crew, we installed three rubber razors in their driveway to divert water off the driveway and into naturally forested soils. We then installed a sixty-five-foot-long infiltration trench alongside the driveway to further support the driveway from washouts and erosion. Down at the house we installed a dripline trench to allow water coming off the roof of their house to better infiltrate into the ground. Next to the wooden stair that lead to the porch, we planted native vegetation and put down erosion control mulch. The erosion control mulch extended along the side of their house and down the path that lead to the water. In that path there were a few existing waterbars that we retrofitted with crushed stone.

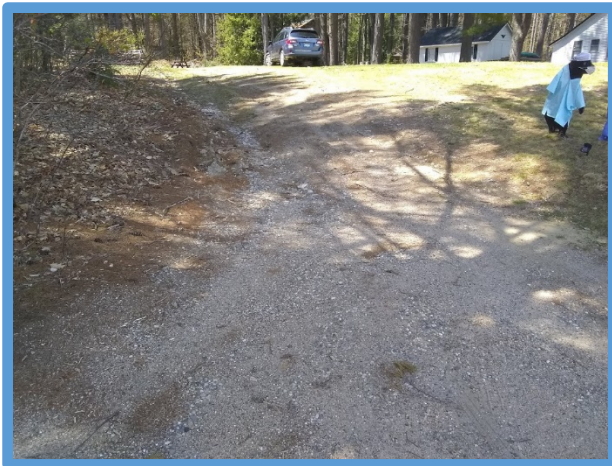
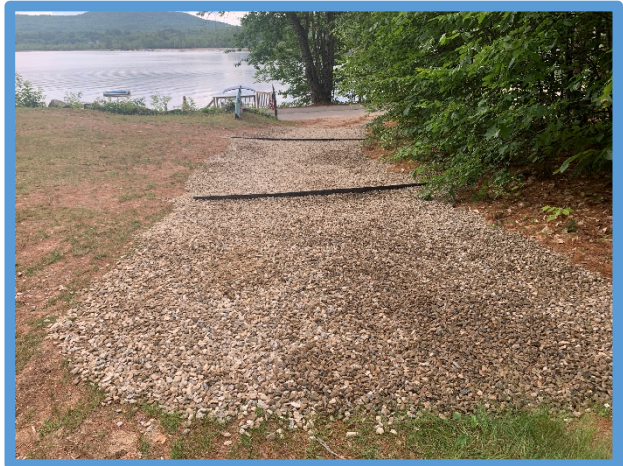
Ed & Debbie Harrington

The crew was excited to see a simpler but still very important site at the Harrington’s. They have a slope leading down to the water that doubles as a driveway and had significant erosion. Runoff would travel through their backyard across the road and down into the lake across the street. For this site we installed a very large infiltration pathway that included two rubber razors and their adjoining drywells, within the infiltration pathway itself. This would hopefully do its job by slowing down the pace of the water and then diverting it into the drywells on the ends of the rubber razors.

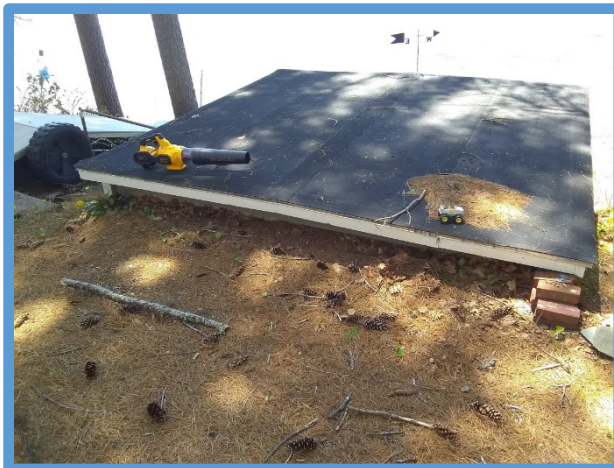
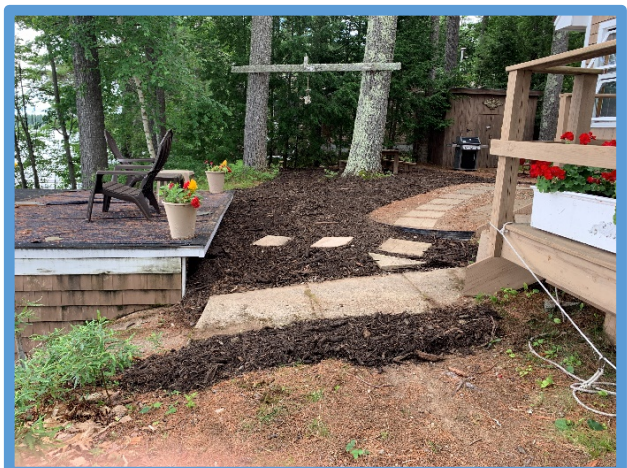
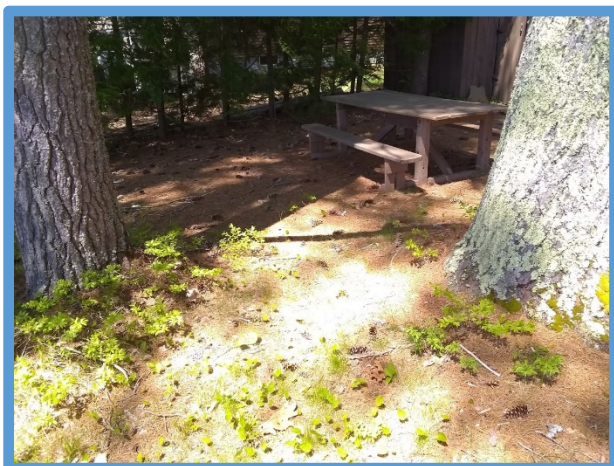
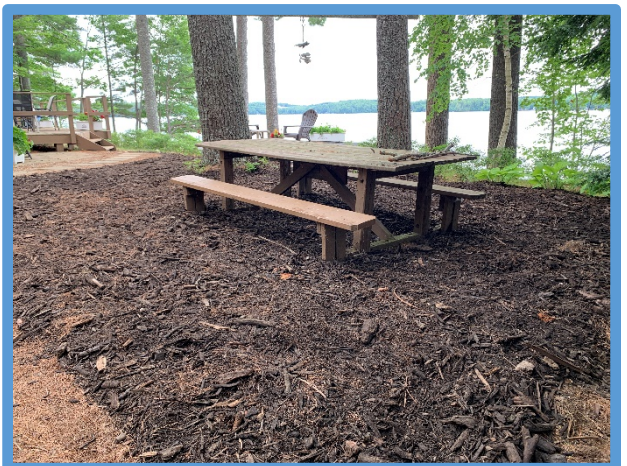
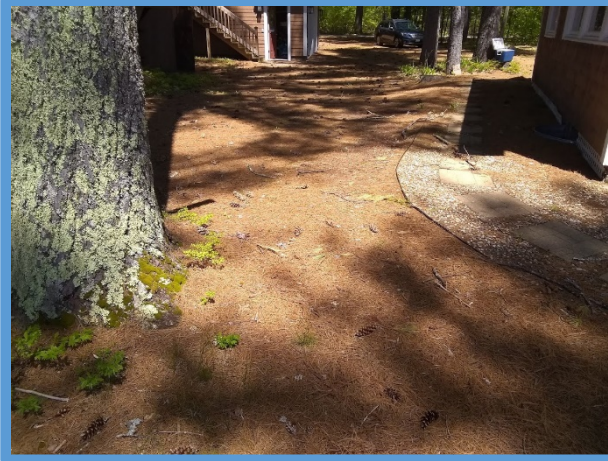
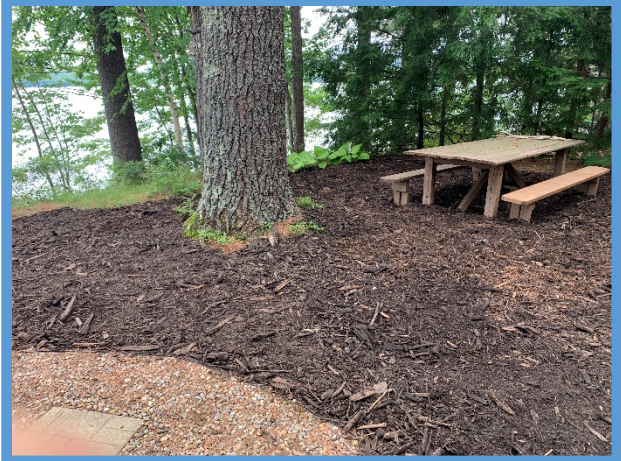
Ellen & Dean Musser

The Musser's property was another perfect site for the crew this year. While they didn't have a steep slope like some other projects, they did have a wide-open area with little native vegetation, which is a prime circumstance for sheet erosion to occur. Water from the road and surrounding yard had only one place to go and it was down their cement stairwell and into the water.

For this site we installed a large infiltration trench between their boat house and the edge of their deck. This and the addition of lots of erosion control mulch in the surrounding area were vital to the improvement of the erosion problem area. Then to top the site off we filled in all their low spots in and around their picnic and grilling area. This was important because it served as a first line of defense against the rushing water that came from a passing storm.

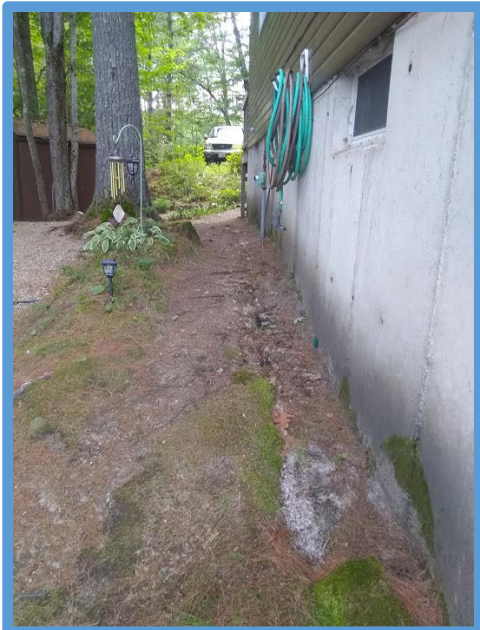
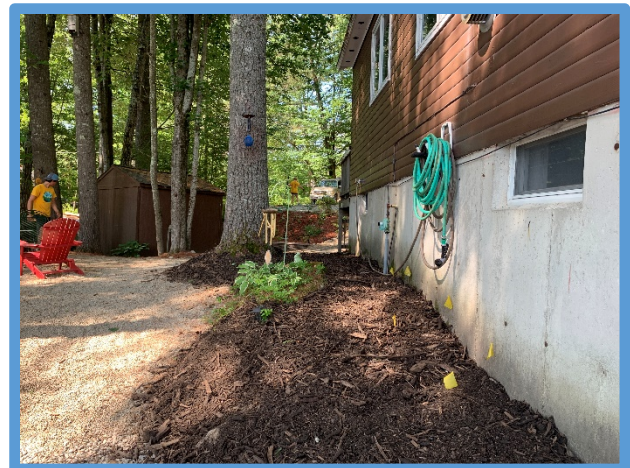
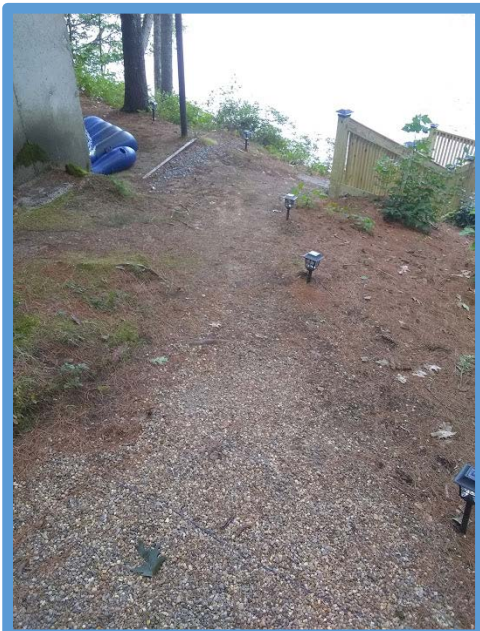
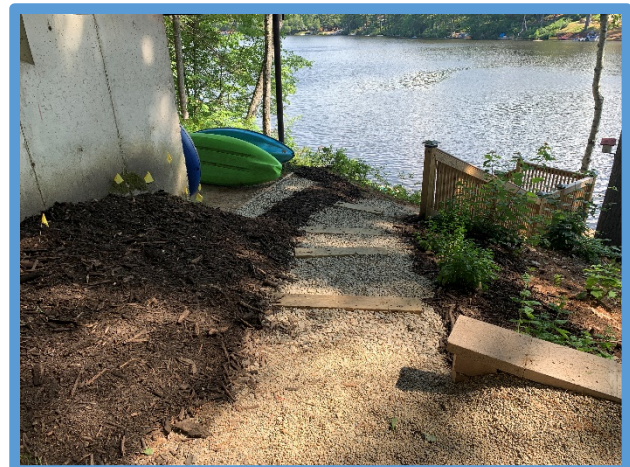
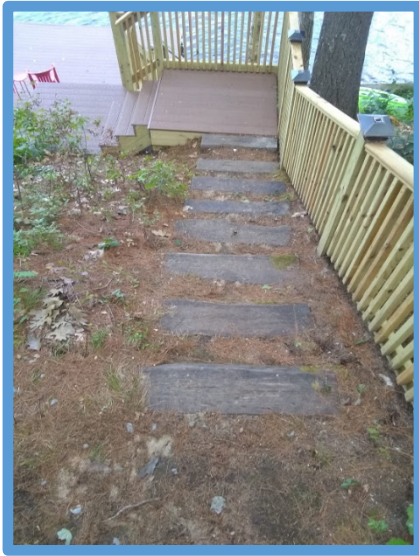
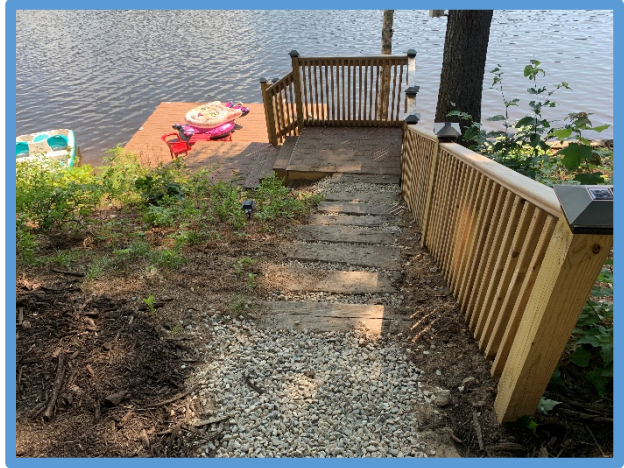
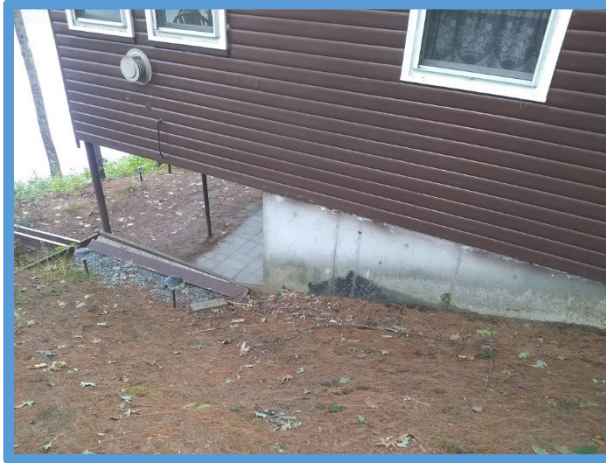
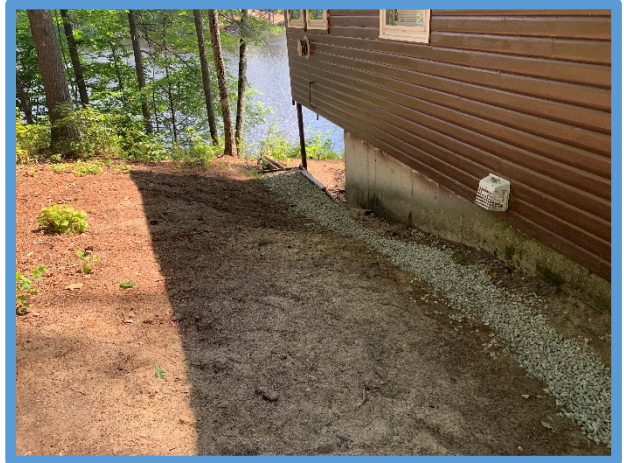
Cheryl Gifford

Belleau is another lake that AWWA has been eager to conduct more YCC projects on and this site was a step in that direction. We installed many BMP's at this site that all had a major role in slowing down soil erosion and pollution entering the lake. As a first line of defense we installed a rubber razor at the top of the driveway to divert water into a drywell/forested area surrounding the driveway. Next, we laid down erosion control mix alongside a pathway leading to the water. We then installed a large infiltration pathway that included four waterbars to break up the flow of water even further. Further down the path there were existing steps which we retrofitted with crushed stone. Finally, we installed a dripline trench alongside the house to capture roof runoff. This allowed water to seep into the ground instead of running down the steep bank and into the water.

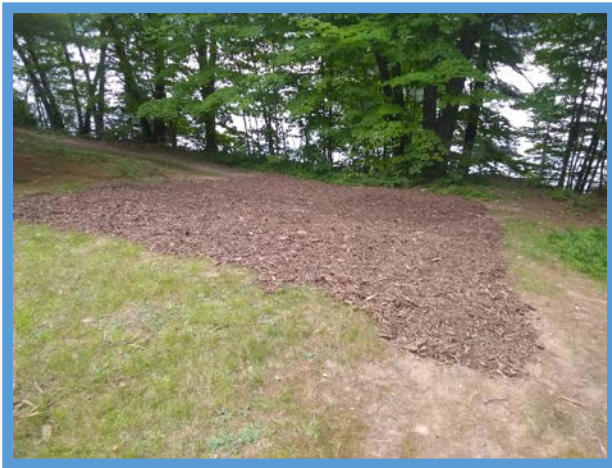
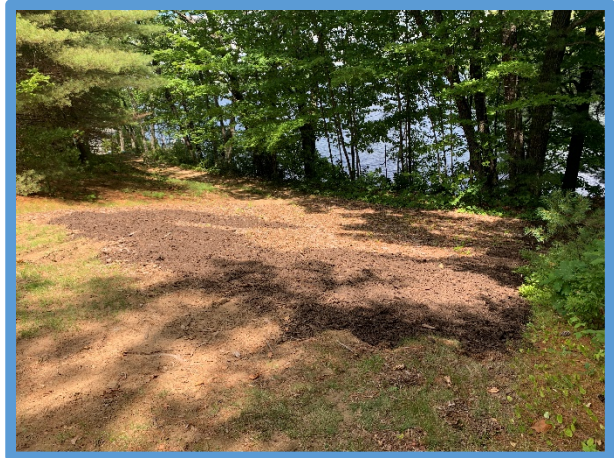
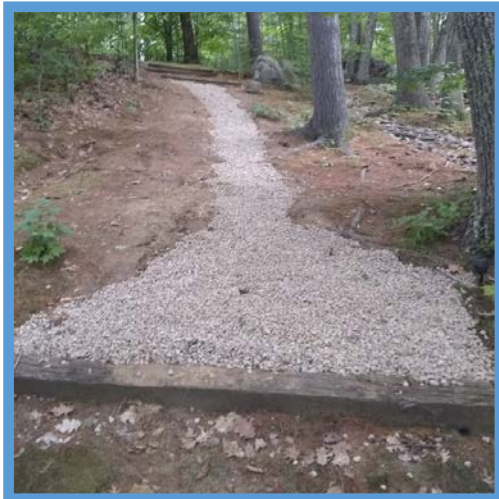
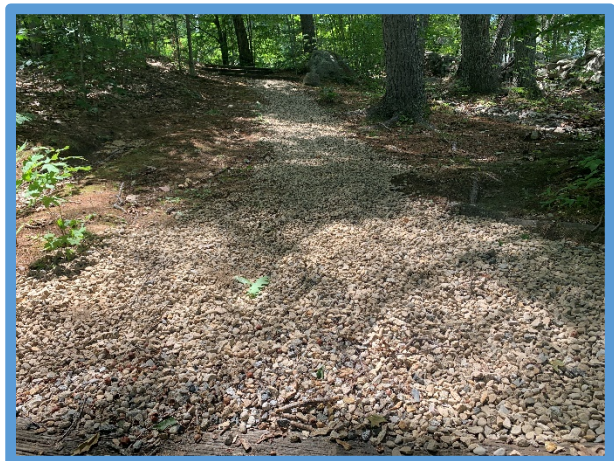
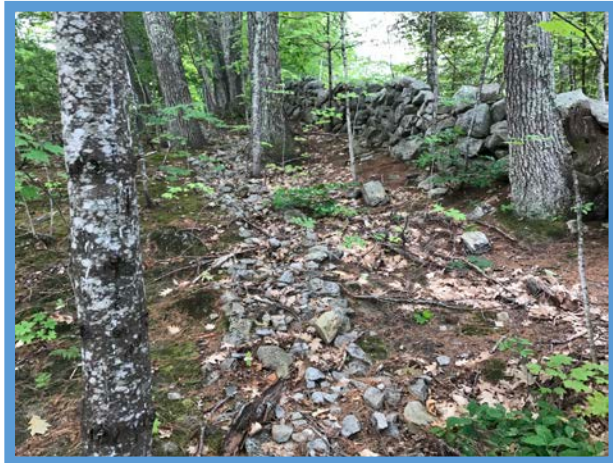
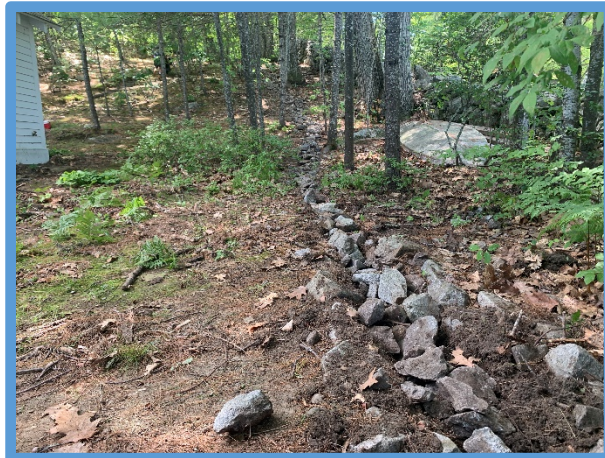
Nick Mourginis

Nick had a YCC project on his property previously. He has a very steep slope that leads to the water. This year we reinforced the erosion control mix in this area, because it had slowly eroded over a year of intense storms. We also used crushed rock to retrofit some existing waterbars placed around an infiltration trench installed a few years previous. To top off the project we cleaned out an existing rip rap trench down the side of his property as it had become filled with sediment from years of rain and runoff.

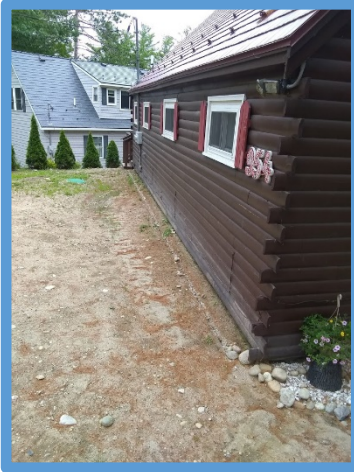
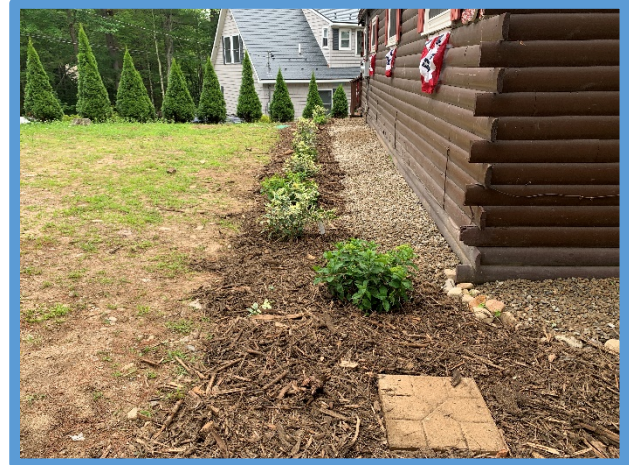
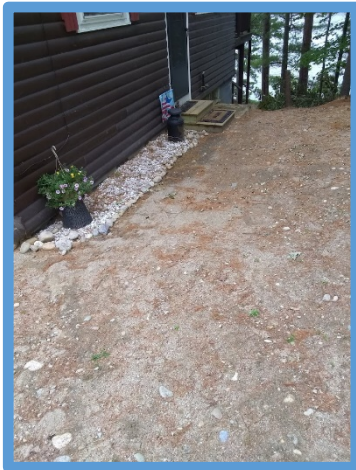
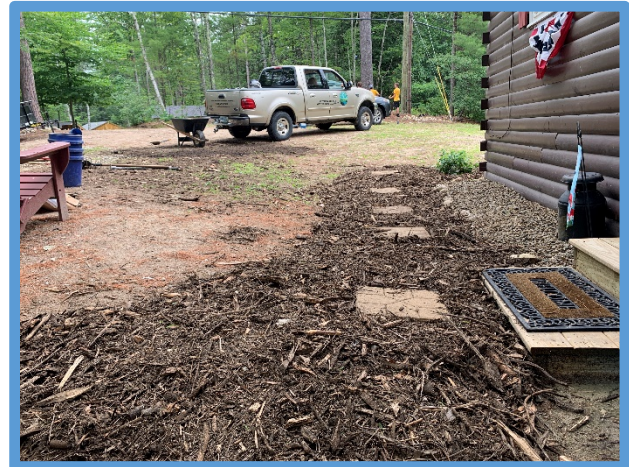
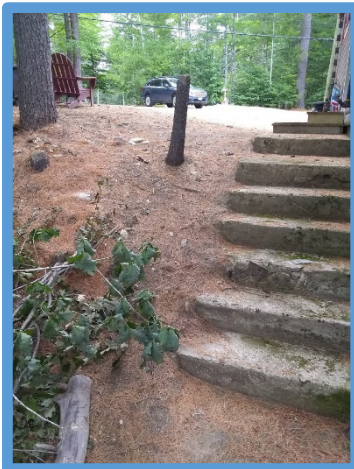
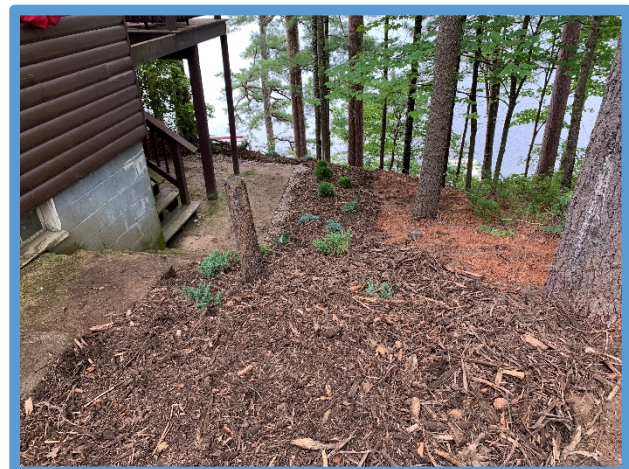
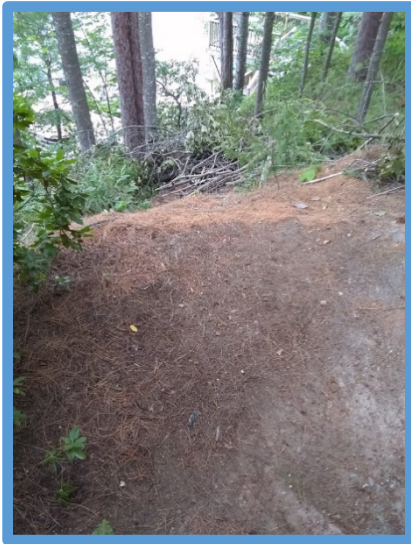
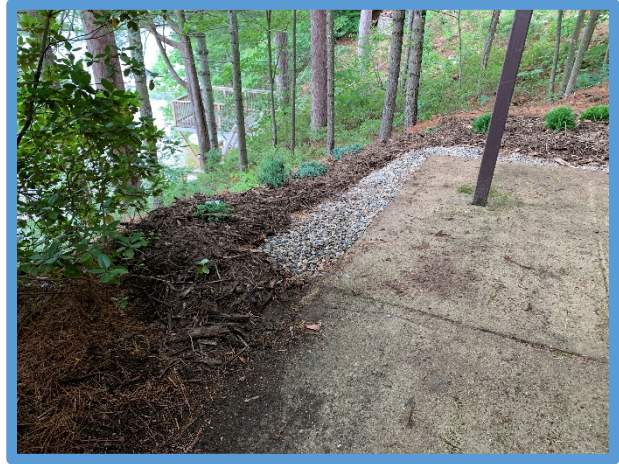
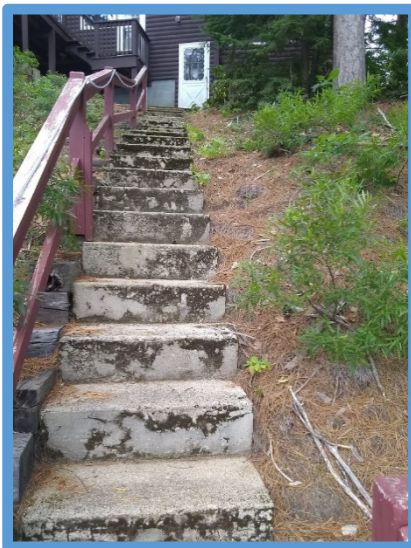
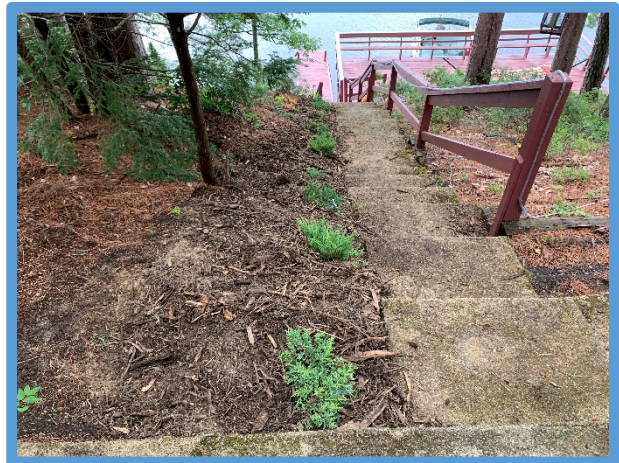
Samantha Stone

This site was the second one on Pine River Pond this season and we were very excited to see that word was spreading of our work. For this site we installed a dripline trench along the entire front of the house and edged the trench with erosion control mix. We continued by digging three infiltration trenches in front of the entry way and down the slope of the hill a few yards. All three of these were edged with erosion control mix. Finally, running down the side of their steps to the water we planted native vegetation and laid down erosion control mix.

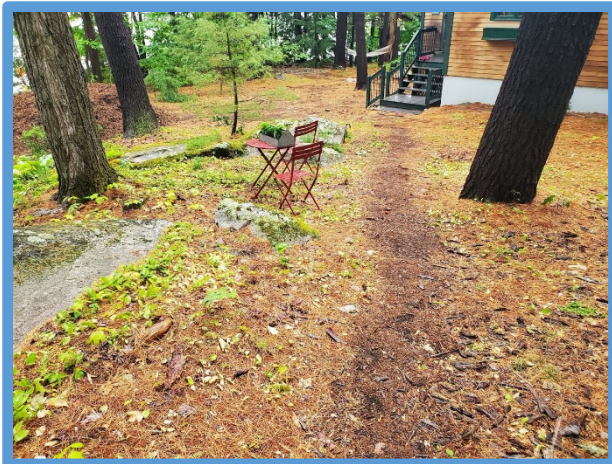
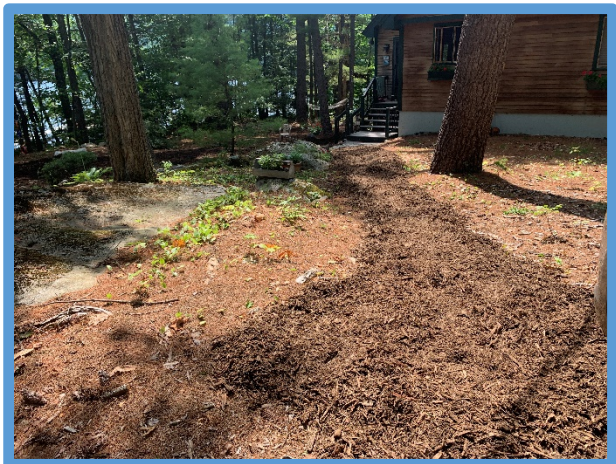
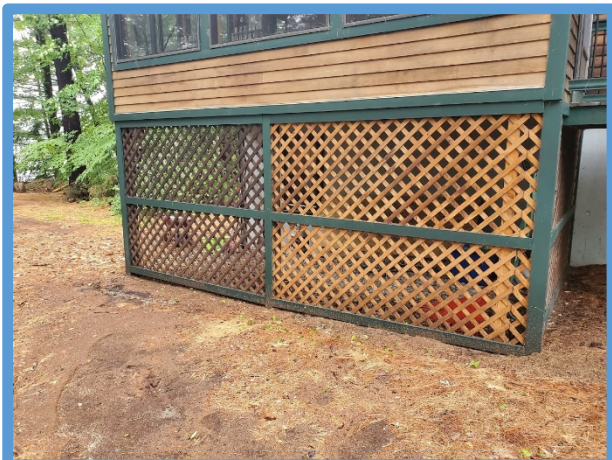
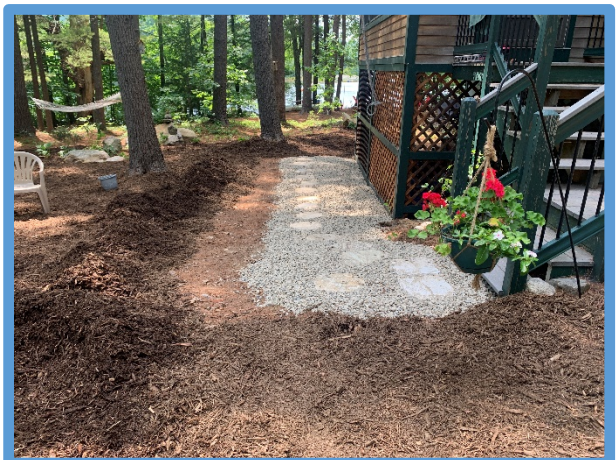
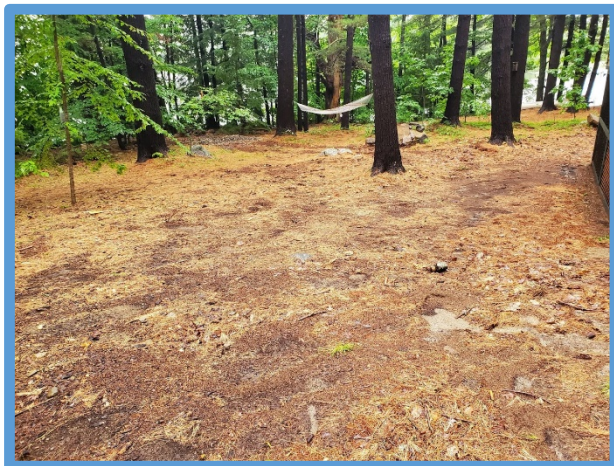
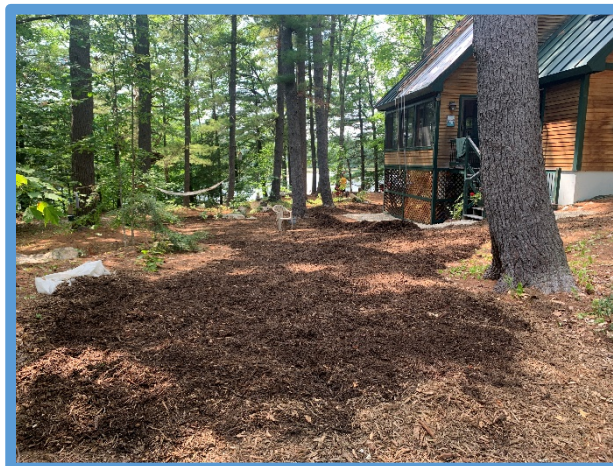
Horn Pond – Acton, ME

This was an excellent site for our crew this year. There was not a big slope but rather a long gradual slope leading from the road to the water. This allowed for significant sheet and gully erosion to occur. We installed a few BMP's on this site; the first being a dripline trench. We installed it under the eaves of the house right next to a walking path. Because of this we integrated a pathway into the trench that included steppingstones provided by the homeowner. To top this section off we mulched around the trench. We also mulched in and around the large flat area as well as their walking path up to the driveway itself. Finally, we left a berm for the homeowner to later plant native vegetation next to the pathway.

Total Number of BMPs	Approximate Cost to Landowner
6	\$415
Tons of Sediment Reduced	Pounds of Phosphorus Reduced
3.0	2.6
Crew Hours	Crew Value
22.5	\$617.50
BMPs Installed and Maintained	Materials Used
Erosion Control Mulch	EMC – 10 yards
Dripline Trench	Crushed Stone – 1 yard

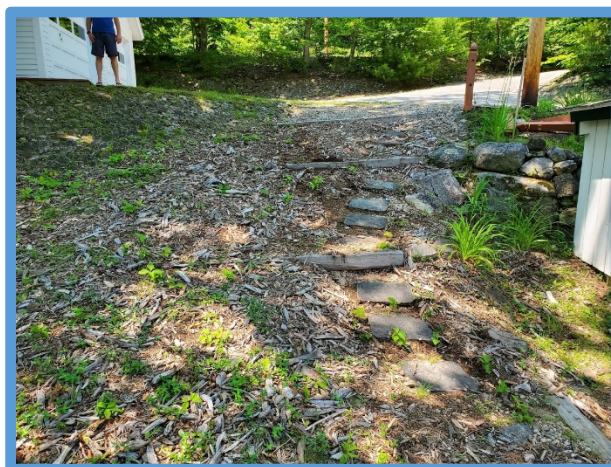
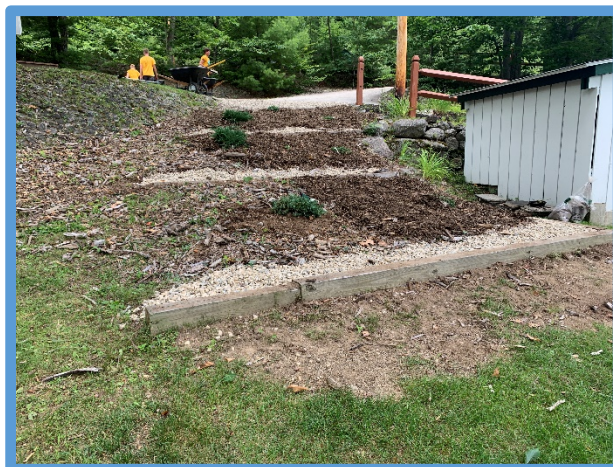
Anusia Hirsch

This was a straight-forward job for the crew. Instead of starting new BMP's on the site we fixed up old ones that had been constructed many years prior. The BMP's were in disrepair from several major storms that had occurred recently and it was our job to make sure they were working again. For this site, we retrofitted three existing water bars and then mulched and planted native vegetation in between them. This allowed the water to infiltrate into the ground instead of passing over the full waterbars. We also removed a stone path from the area to reduce foot traffic and allow this area to act solely as stormwater management.

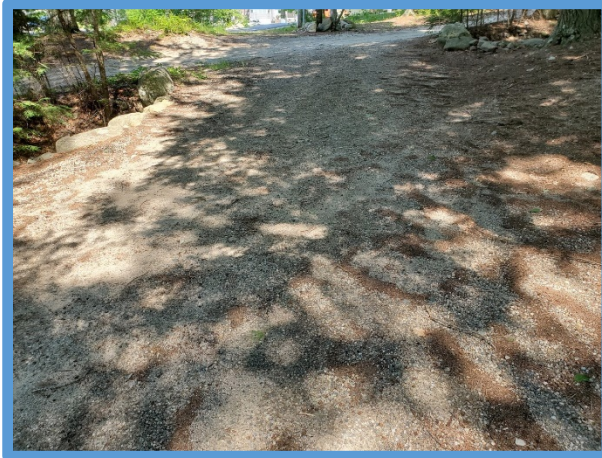
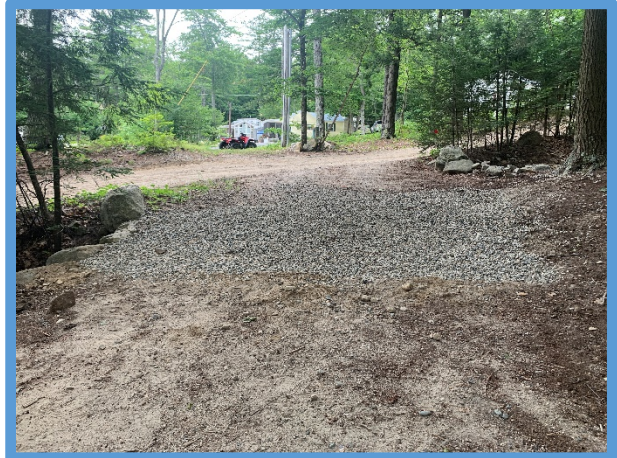
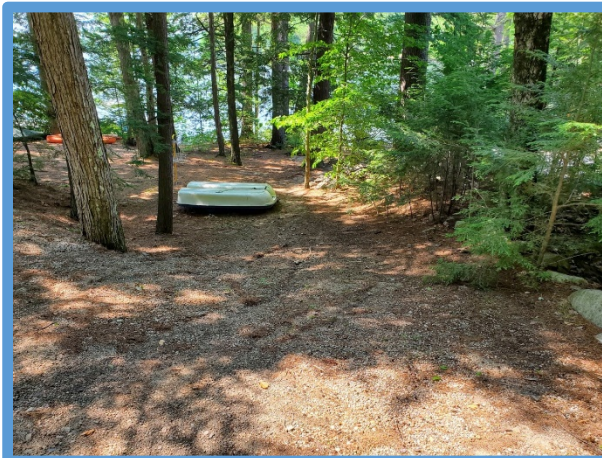
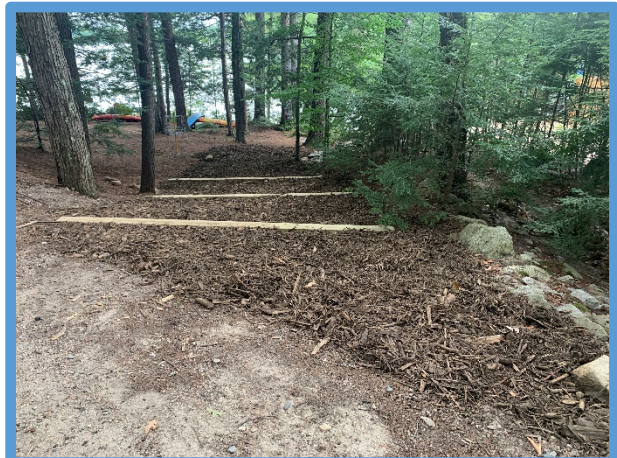
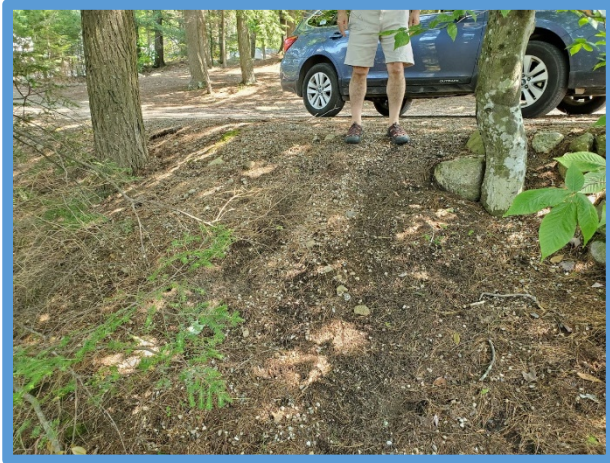
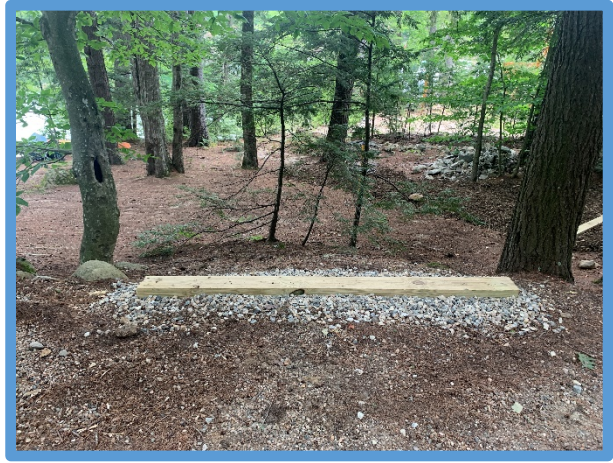
Mary Beth Giffune

This was an excellent site for AWWA and its YCC crew. Stormwater runoff would rush down the boat launch adjacent to the Giffune’s driveway, carrying sediment as it came. The sediment would run down the driveway and across the side of their house, ultimately making it to the lake. To solve this problem, we decided to first dig an infiltration trench across the length of the driveway itself. Then alongside the driveway and down the slope we laid four waterbars in two different locations. Their aim was to trap and divert water along with the help erosion control mulch spread around the waterbars.
