The Acton Wakefield Watersheds Alliance

Youth Conservation Corps

2020 Season Report

December 2020

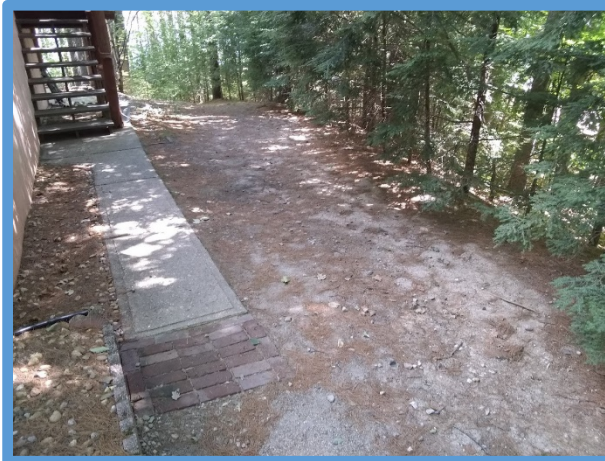
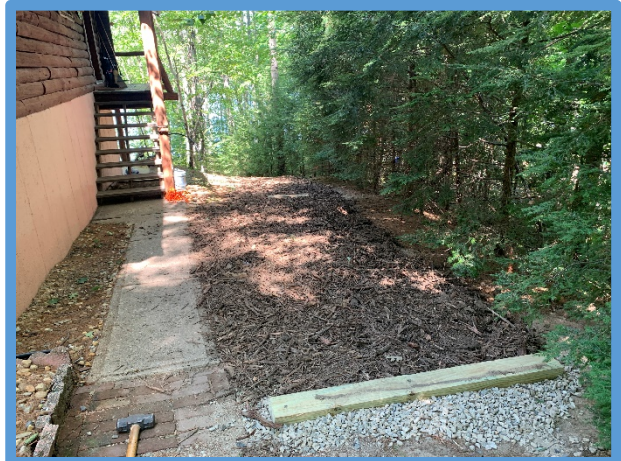
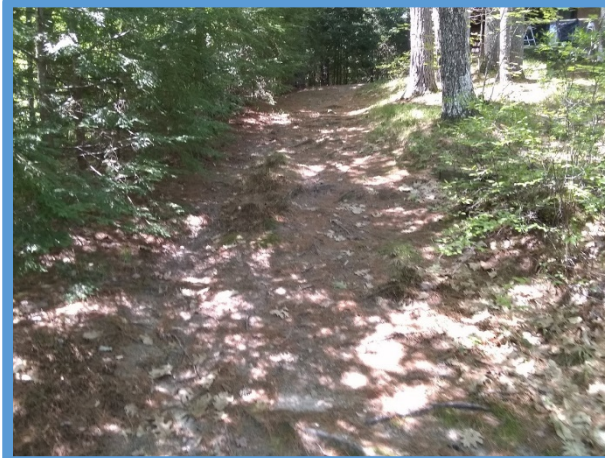
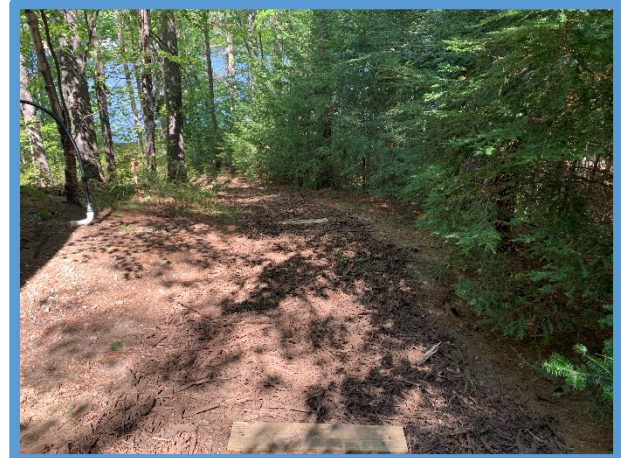
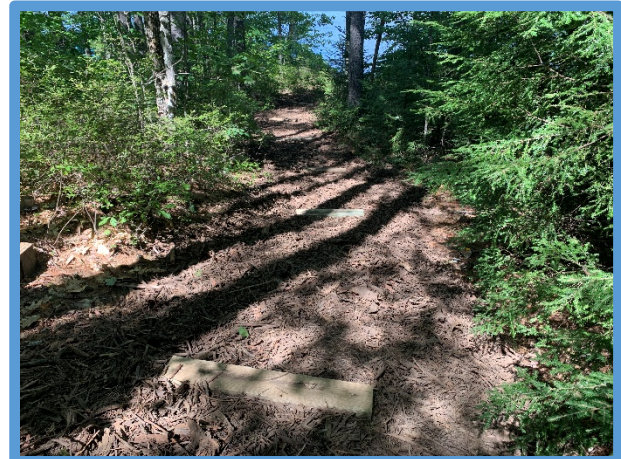
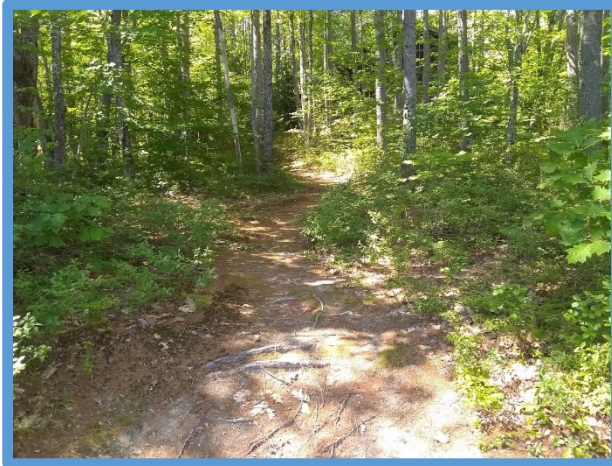
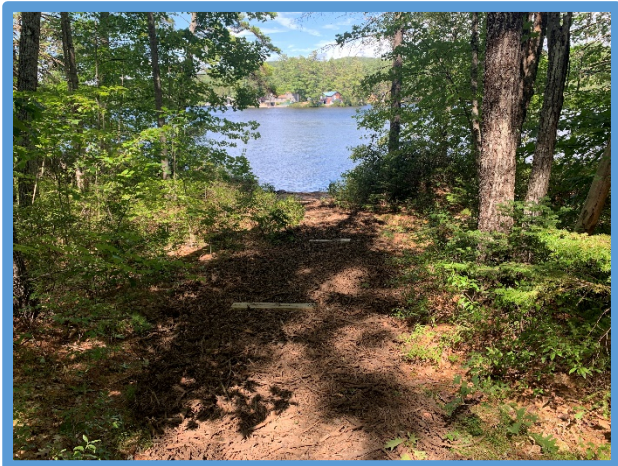
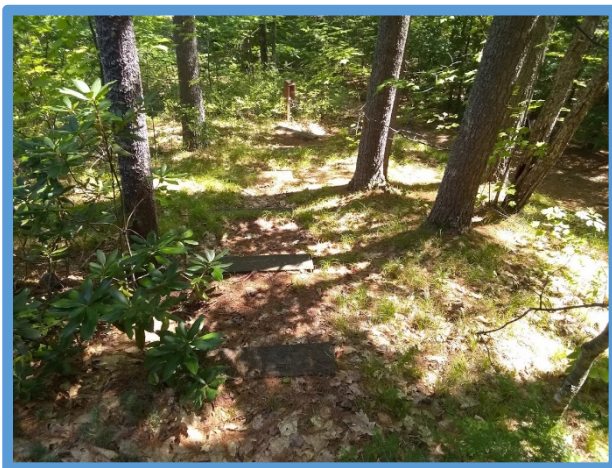
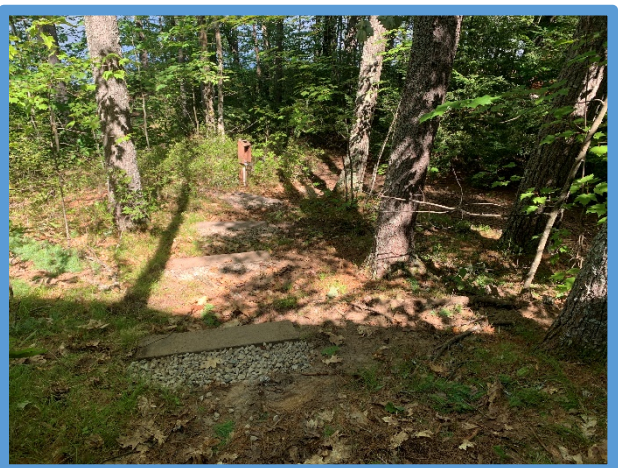
Belleau Lake – East Wakefield, NH

This site was probably the most extensive of the season. Massive amounts of water and sediment were reaching the lake from a steep 150' path from the house to the dock. The pathway was relatively skinny in width, which allowed us to easily divert water into the native vegetation surrounding the path. To do this we installed fourteen waterbars along the path and laid down erosion control mix around the waterbars. There was also a secondary path that had pre-existing waterbars, which we retrofitted with stone to make sure they were doing their job.

Total Number of BMPs	Approximate Cost to Landowner
23	\$657
Tons of Sediment Reduced	Pounds of Phosphorus Reduced
3.1	2.7
Crew Hours	Crew Value
48	\$1,120.00
BMPs Installed and Maintained	Materials Used
Waterbars	EMC – 11 yards
Erosion Control Mulch	Crushed Stone – 3 yards
Retrofit Waterbars	6x6 Pressure Treated Lumber – 48 feet
	Rebar – 90 feet

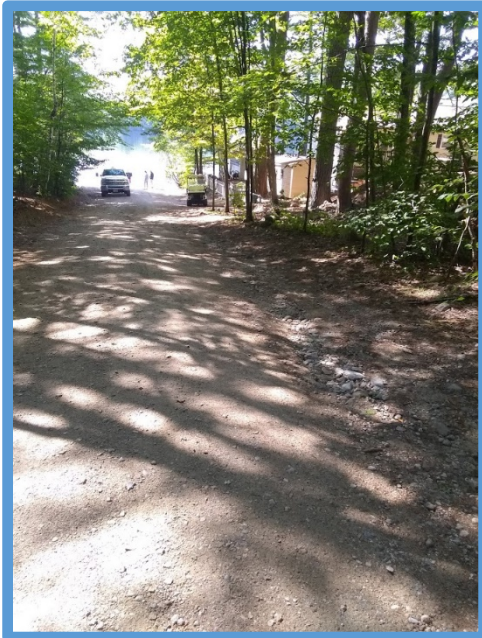
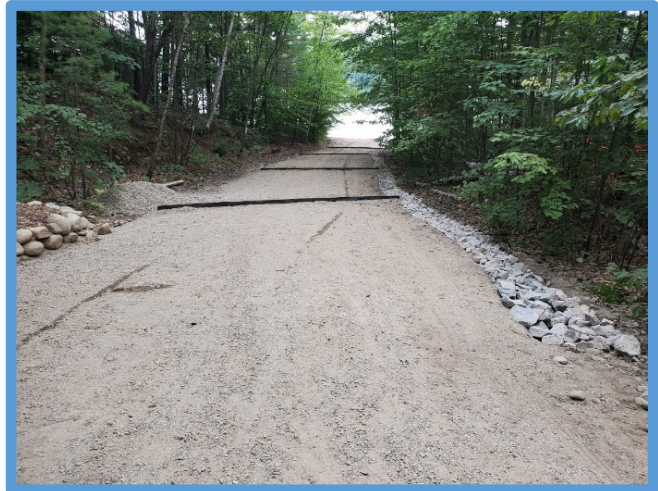
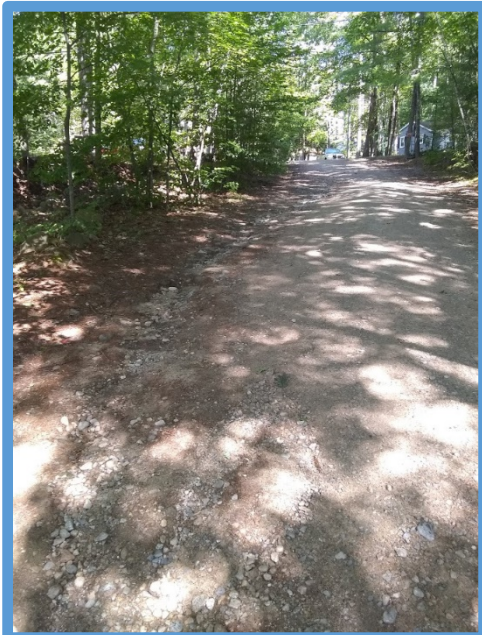
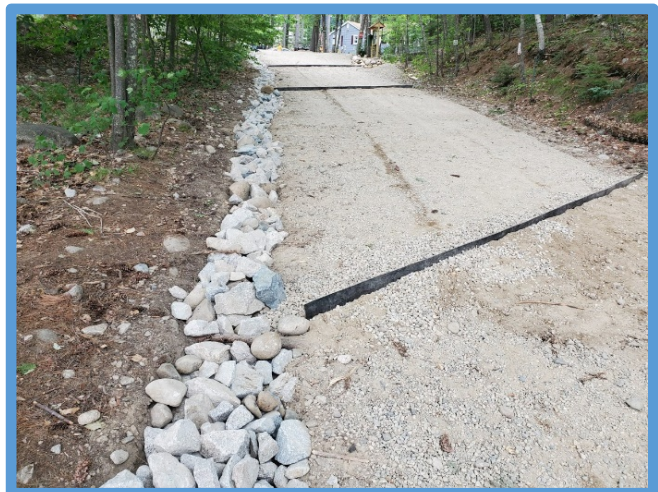
Pine River Association Boat Launch

This project was a little different from any project we did this year. It was a straight, gradual slope leading directly into the water. For this site we decided that four rubber razors and a very large rip rap trench would be perfect. Down the right side of the boat launch we dug a rip rap trench that lead almost to the bottom of the boat launch itself. Then, at a thirty-degree angle sloping downhill, we put in three rubber razors. The fourth and final rubber razor we placed facing the opposite way leading to a drywell, that is used to store water and better allow it to infiltrate into the ground.

It is worth noting that there is an immense amount of stormwater that comes down this path. More extensive stormwater management is needed at the top of the launch to prevent the problem from persisting.
