# The Acton Wakefield Watersheds Alliance

## Youth Conservation Corps

### 2024 Season Report

December 2024

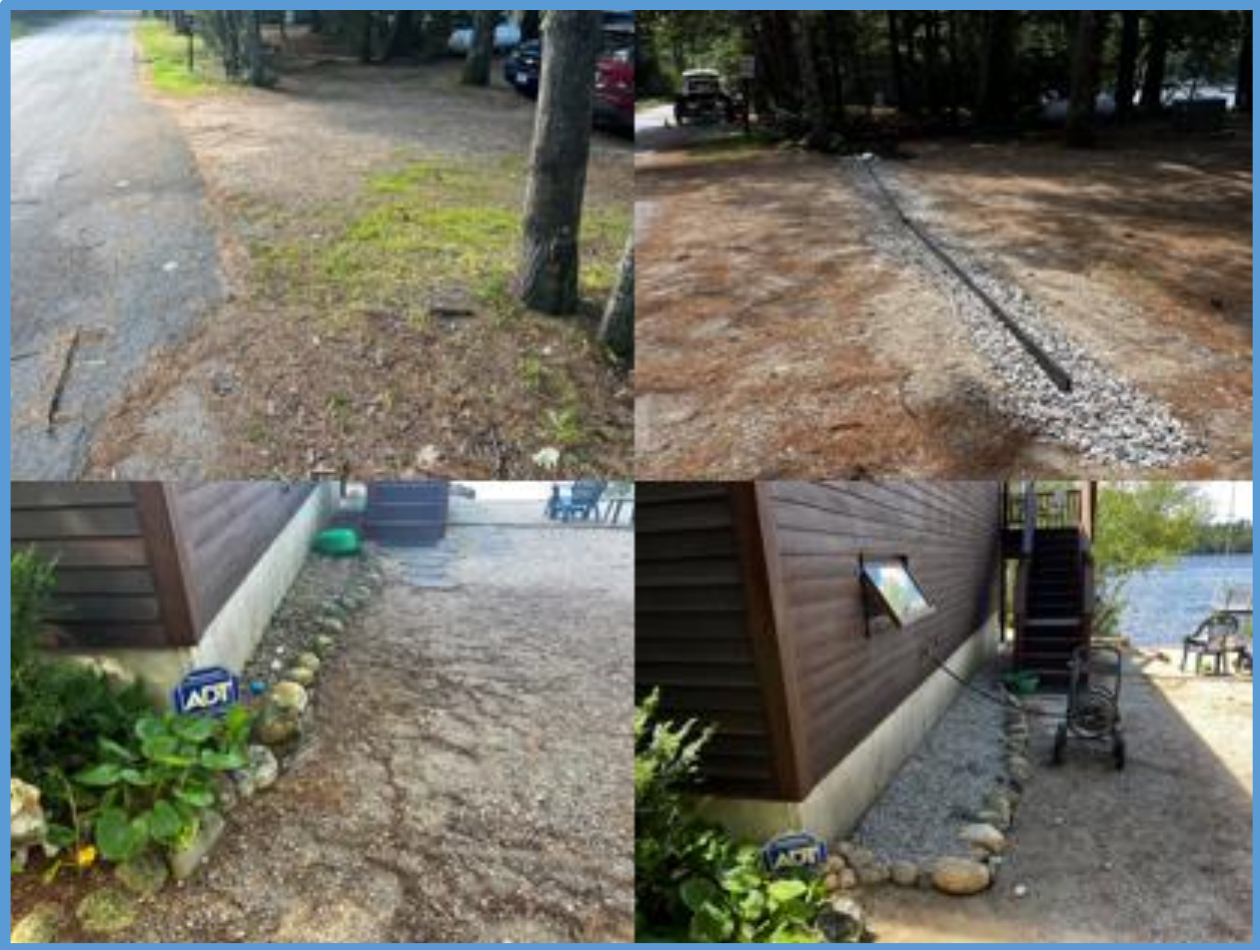
# John Varone Project Before and After Photos

This was the crew’s first site of the season. This year was a little different than last as most of the crew were completely new to the job. With that came a lot of learning. Our crew leader Jaden spent much of the first few projects ensuring the crew could complete projects effectively and efficiently. It didn’t help that this project ended up being one of our most difficult. The crew installed a rubber razor across the front of the driveway to help divert runoff coming from the road. Along with the razor, the crew also installed a drywell and a large rain garden in the surrounding area. Around the house, the crew installed Erosion Control Mulch (ECM) and multiple dripline trenches. There were remnants of old dripline trenches that had been installed incorrectly as much of the water flowed outside of the trench.

<b>Total Number of BMPs</b>	<b>Approximate Cost to Landowner</b>
12	\$529.00
<b>Tons of Sediment Reduced</b>	<b>Pounds of Phosphorus Reduced</b>
.5	.4
<b>Crew Hours</b>	<b>Crew Value</b>
143.5	\$2,500.00
<b>BMPs Installed</b>	<b>Materials Used</b>
Rain Garden	ECM – 3 yds
Drywell	Stone – 6 yd
Dripline Trenches	Lumber – 40 ft
Rubber Razor	Rubber – 20 ft

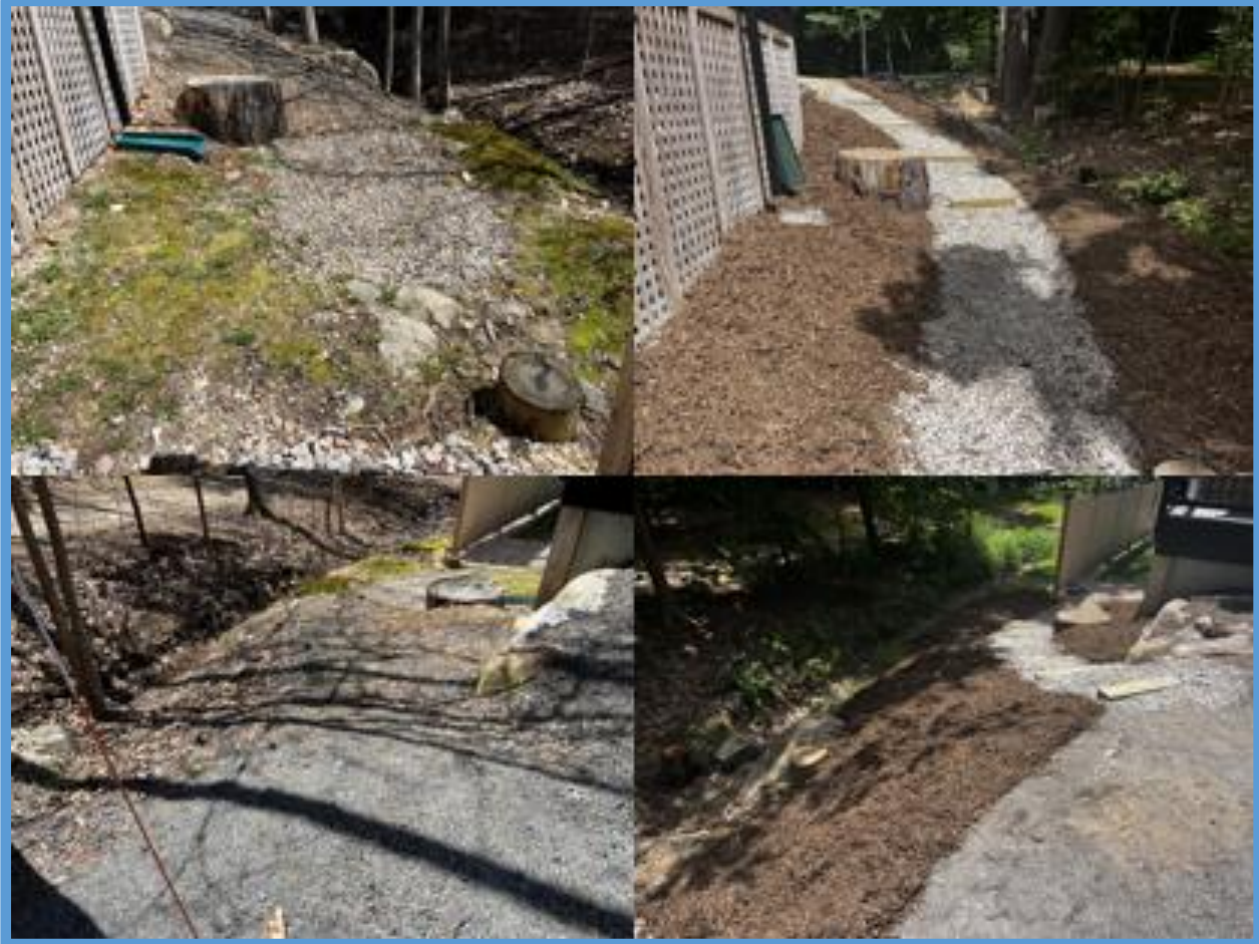
# Tracy Gaudet Project Before and After Photos

Our second project of the year was much shorter than the first. The crew was still getting to know each other but were working hard, nonetheless. They installed multiple waterbars along a hillside that doubled as a walking path. Crushed rock was installed throughout the waterbars to help with infiltration. Finally, the crew added ECM around the pathway to help hold the remaining bare soil together. It was a great second project for the crew as they were able to move at a slightly slower pace and get to know each other.

Total Number of BMPs	Approximate Cost to Landowner
9	\$254.00
Tons of Sediment Reduced	Pounds of Phosphorus Reduced
1.5	1.3
Crew Hours	Crew Value
36	\$750.00
BMPs Installed and Maintained	Materials Used
Infiltration Pathway	ECM – 2 yds
Waterbars	Stone – 2 yds
Erosion Control Mulch	Lumber – 15 ft
	Rebar – 10 ft

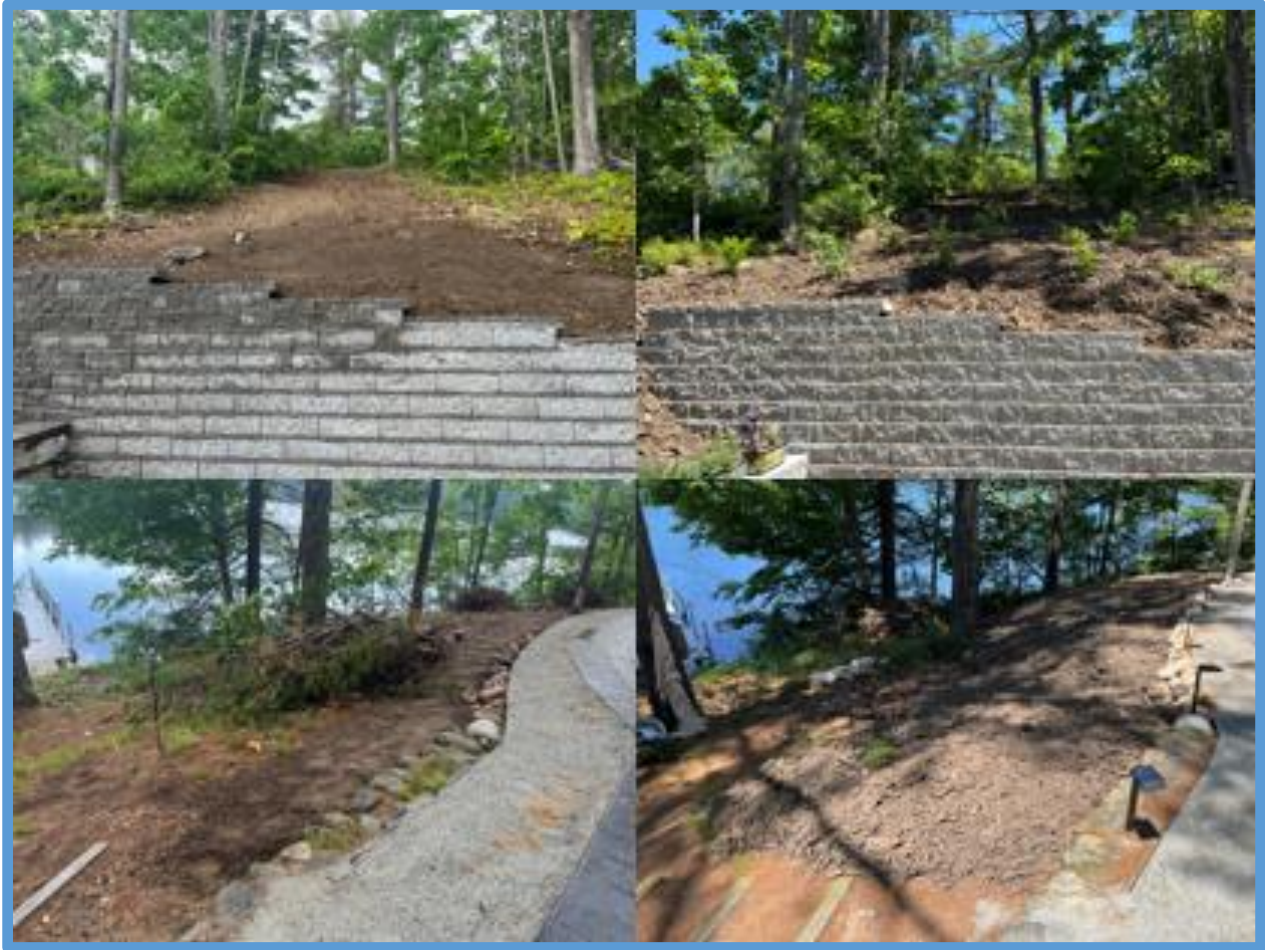
## Ed Suleski Project Before and After Photos

For our third project, the crew moved over to Balch Lake where the crew dealt with one of their more difficult projects. The house was situated closer to the water at the bottom of a large hill. This made it impossible to get any of the materials delivered directly to the location. Instead, the crew had to use buckets and wheelbarrows to cart many yards of mulch down a 35-degree slope or down a long set of stairs. Luckily, the only material we were using on this project was ECM, so the going was slightly easier than if they were moving rock. Nonetheless, the crew did an excellent job installing native plants and ECM where needed, and in a timely manner. Because of the difficulty of this project, the crew really started to work well together and produce some of their best work.

<b>Total Number of BMPs</b>	<b>Approximate Cost to Landowner</b>
13	\$950.00
<b>Tons of Sediment Reduced</b>	<b>Pounds of Phosphorus Reduced</b>
5.6	4.8
<b>Crew Hours</b>	<b>Crew Value</b>
73	\$1,000.00
<b>BMPs Installed and Maintained</b>	<b>Materials Used</b>
Native Vegetation	Plants - 10
Erosion Control Mulch	Erosion Control Mulch – 13 yds

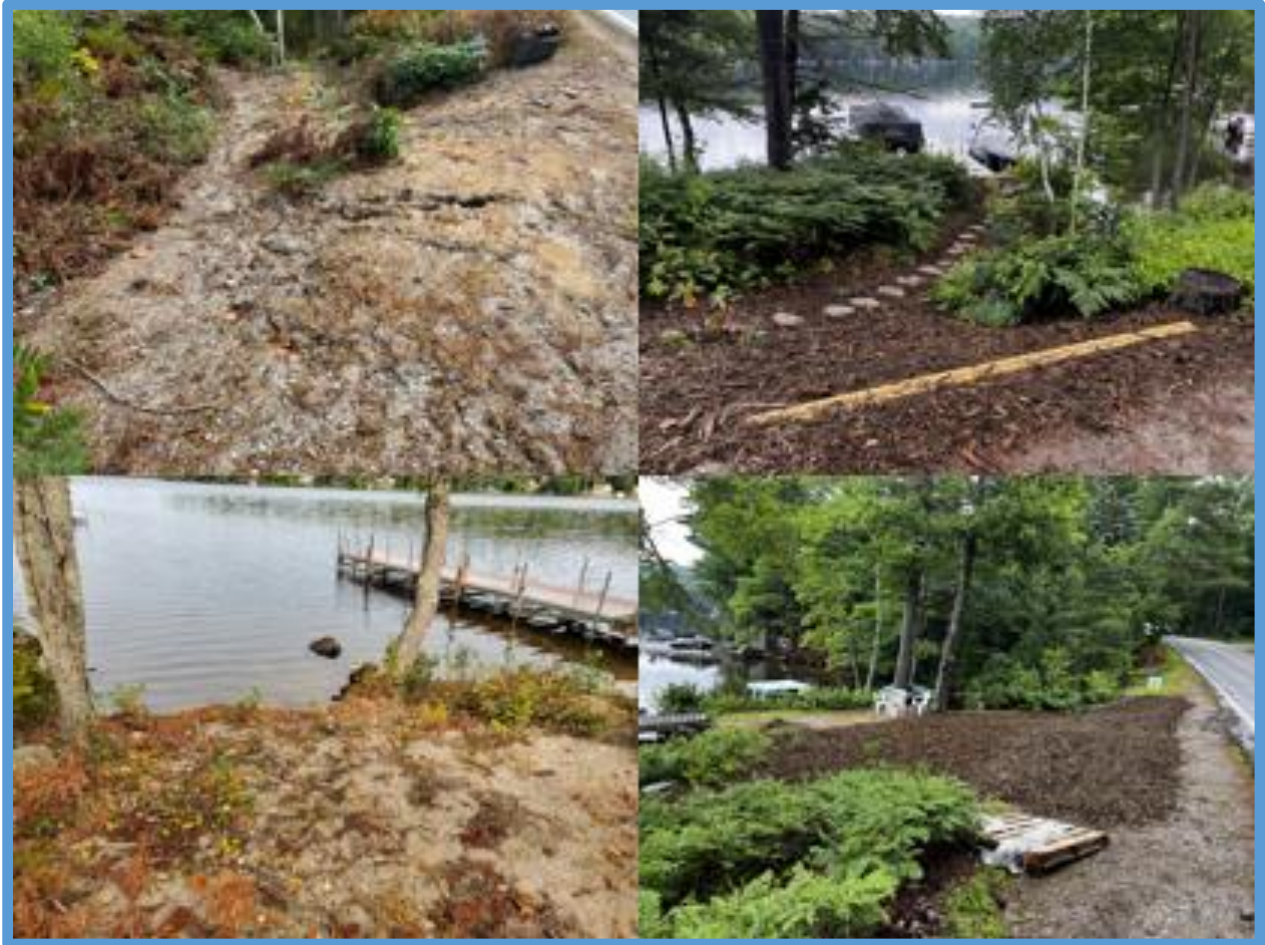
## Lake Points of View Project Before and After Photos

The Lake Points of View project was our first and only project on a shared access property this summer. We worked with the members of the Lake Points of View Property Owners Association that use the area for lake access to come up with a design that still allowed for easy access to the various docks and beaches, while also reinforcing the thinning vegetative buffer and protecting the lake. In the end, the crew installed ECM on all of the major pathways with pavers to help with foot traffic. They also installed ECM on the main section of the access area. There were a few bumps in the road throughout the project, but the crew handled them gracefully and produced a result that left everyone at Lake Points of View satisfied.

<b>Total Number of BMPs</b>	<b>Approximate Cost to Landowner</b>
10	\$478.00
<b>Tons of Sediment Reduced</b>	<b>Pounds of Phosphorus Reduced</b>
5.6	4.8
<b>Crew Hours</b>	<b>Crew Value</b>
60	\$1,000.00
<b>BMPs Installed and Maintained</b>	<b>Materials Used</b>
Vegetated Buffer	Plants - 10
Waterbar	ECM – 13 yds
Erosion Control Mulch	Lumber – 10 ft
	Rebar – 3 ft

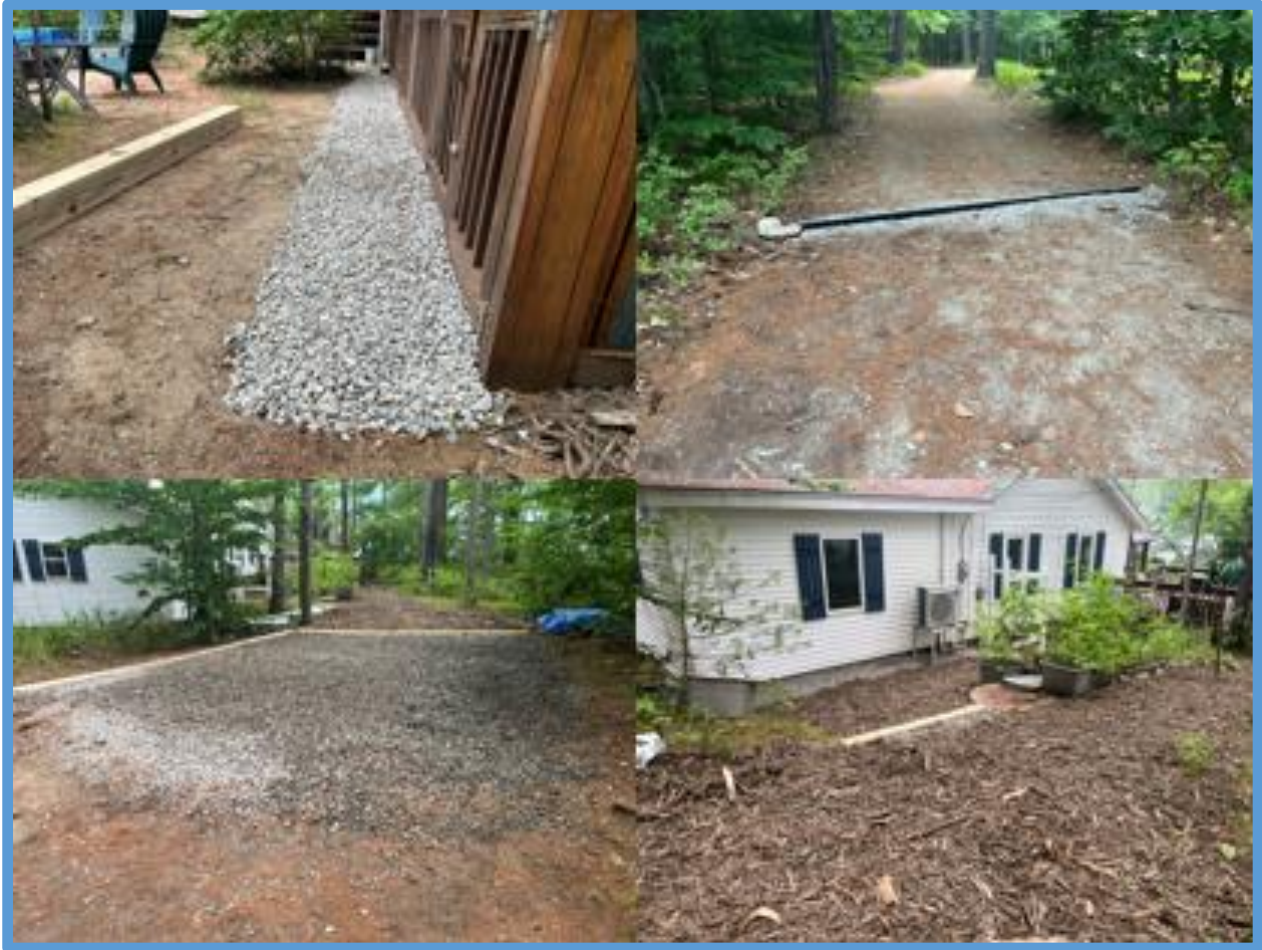
## Chuck Shimer Project Photos

The Shimer project was one of the most time-consuming projects of the year. It was just down the road from a project we completed last year and was a continuation of the issues that affected the adjacent property. Runoff made its way down the camp road and pooled at the Shimer’s front door before making its way around both sides of the house and into the lake. Our solution was to first install a rubber razor in the driveway diverting much of the runoff into the surrounding woods. Next, we installed ECM in the area where the runoff would pool, in hopes that it would help soak up any of the remaining water. The crew also installed dripline trenches and more ECM around the entire house.

Total Number of BMPs	Approximate Cost to Landowner
16	\$716.00
Tons of Sediment Reduced	Pounds of Phosphorus Reduced
2.5	2.1
Crew Hours	Crew Value
87	\$1,750.00
BMPs Installed and Maintained	Materials Used
Dripline Trenches	ECM – 7 yds
Waterbars	Stone – 5 yds
Rubber Razor	Lumber – 72 ft
Erosion Control Mulch	Rubber – 12 ft
	Rebar – 14 ft
	Nails – 1 Box

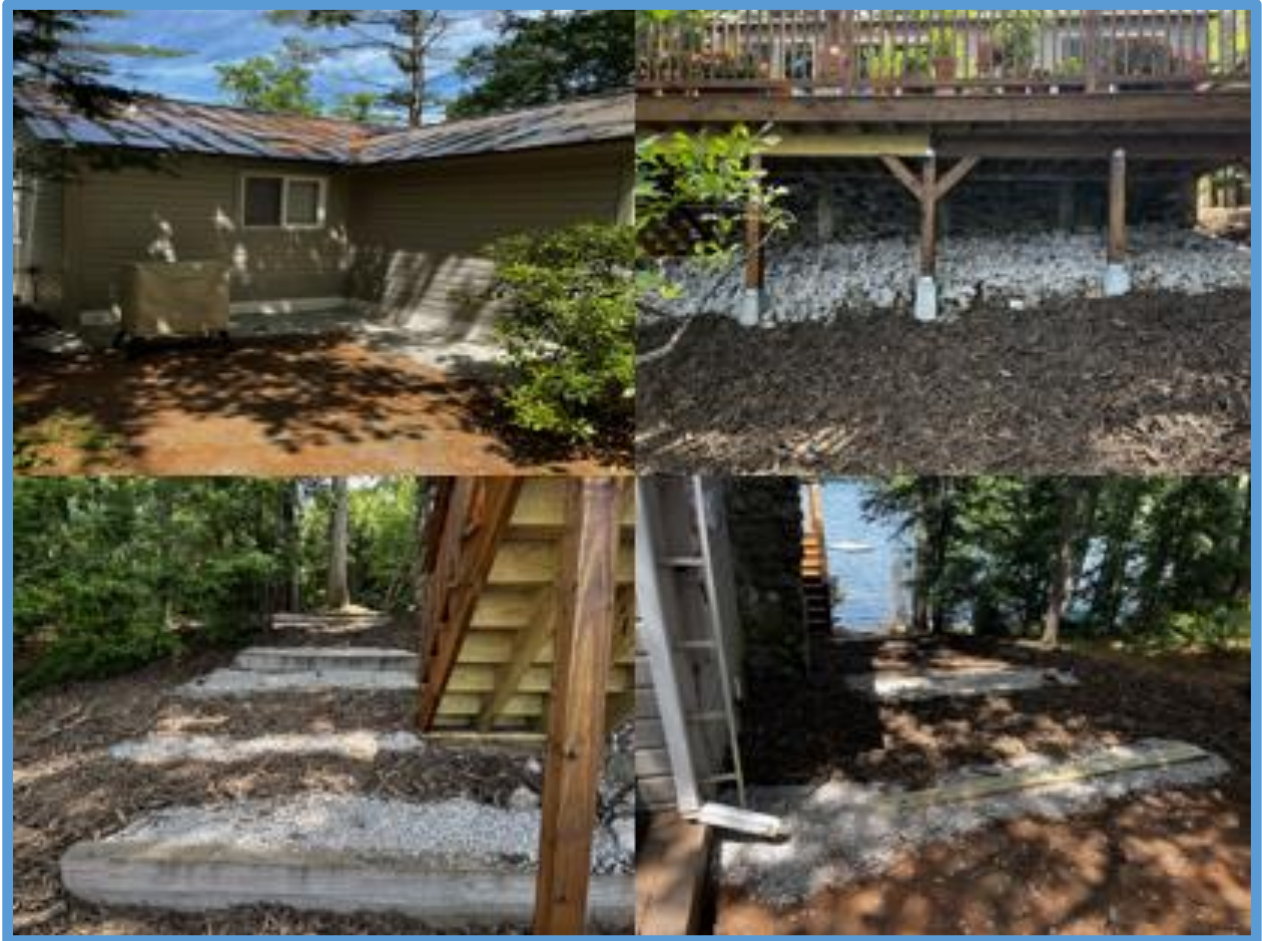
## Simon Delekta Project Photos

For the project itself, the crew retrofitted multiple waterbars going down the side of the house. The retrofitting coupled with refreshed ECM covered the bare soil that had eroded over many years. On the left side of the house, the crew installed more ECM to cover bare slope leading down to the water. The area used to be used for walking, but I was able to convince the homeowner to stick to one side of the house unless absolutely necessary to help the area renaturalize. For the final step of the project, the crew installed a dripline trench along the front of the house to catch the rainwater coming off the roof.

<b>Total Number of BMPs</b>	<b>Approximate Cost to Landowner</b>
10	\$516.00
<b>Tons of Sediment Reduced</b>	<b>Pounds of Phosphorus Reduced</b>
2.5	2.1
<b>Crew Hours</b>	<b>Crew Value</b>
63	\$1,250.00
<b>BMPs Installed and Maintained</b>	<b>Materials Used</b>
Dripline Trench	Erosion Control Mulch – 9 yds
Waterbars	Crushed Stone – 5 yds
Erosion Control Mulch	Lumber – 8 ft
	Rebar – 3 ft

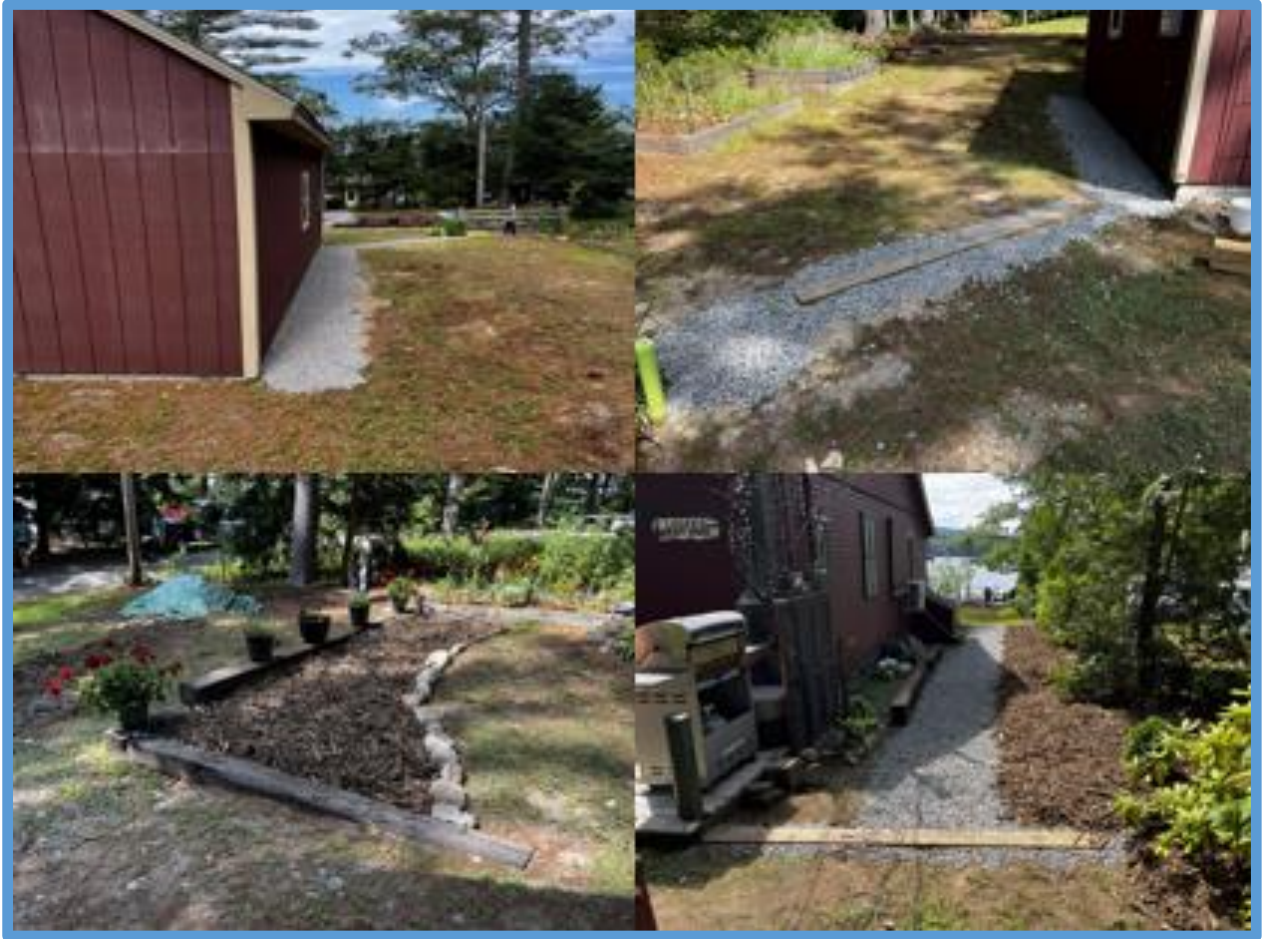
# Timothy Legere Project Photos

The Legere project was another exemplary project for the crew, and what was considered to be their best work of the summer. The homeowners were having two different stormwater issues that culminated in a torrent of sediment filled water running along the side of their house. The first issue came from the garage and grassy area across the street from the house. To fix this issue the crew installed two dripline trenches under the overhang of the roof. This, coupled with a waterbar and ECM on the steeper section of the hill, prevented the stormwater runoff from crossing the road and reaching the house. The second issue was the road itself. Runoff came down the side of the road and found a way into the Legere’s yard. To solve this issue the crew installed ECM alongside the road, and a large infiltration pathway down the side of the house. This added a large storage area for the runoff to pool while seeping into the ground. A waterbar at the top and bottom and ECM around the side helped tie the project together and add some aesthetic value on top of the already highly functional project.

<b>Total Number of BMPs</b>	<b>Approximate Cost to Landowner</b>
8	\$792.00
<b>Tons of Sediment Reduced</b>	<b>Pounds of Phosphorus Reduced</b>
4.7	4
<b>Crew Hours</b>	<b>Crew Value</b>
82.5	\$1,500.00
<b>BMPs Installed and Maintained</b>	<b>Materials Used</b>
Infiltration Trench/Pathway	Erosion Control Mulch – 6 yds
Waterbar	Crushed Stone – 7 yds
Erosion Control Mulch	Lumber – 16 ft
	Rebar – 4 ft

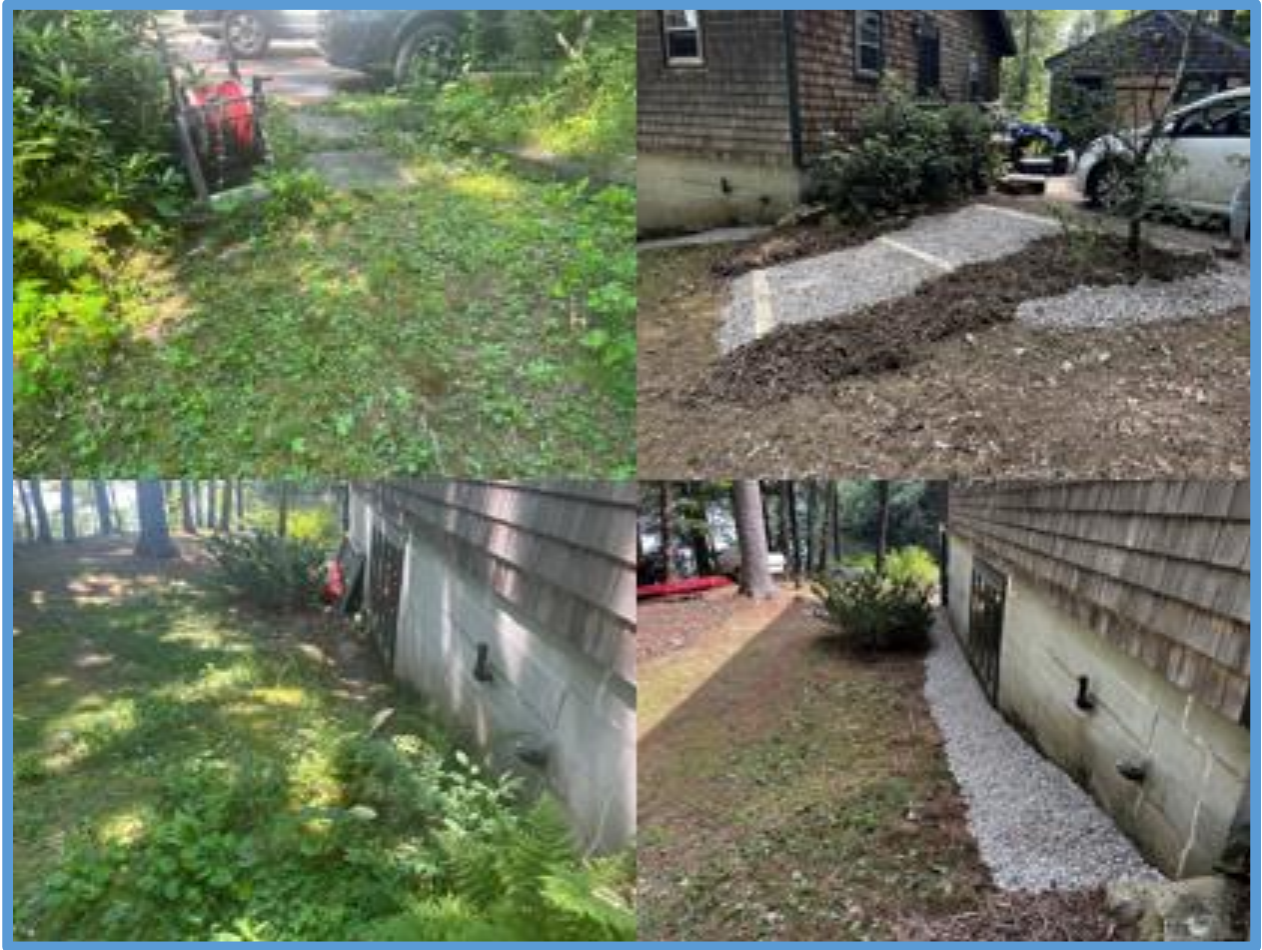
## Carol Jaque Project Before and After Photos

Carol Jaque’s project was our first and only project on Great East Lake for the year. Carol had runoff coming down her paved driveway and making its way around the left side of the house. To combat this, we installed a firehose diverter and a drywell on the driveway. This helped divert runoff. We also installed multiple waterbars and crushed rock to collect and allow runoff to infiltrate. To finalize the project, we installed ECM on the bare soil. This project ended up working out great and the homeowner loved the work we did. After the project was complete, we gave them a few lake-friendly suggestions they could implement, such as establishing a no-mow and no-rake zone and an area where they could plant native wildflowers to help bring pollinators to their yard.

Total Number of BMPs	Approximate Cost to Landowner
10	\$453.00
Tons of Sediment Reduced	Pounds of Phosphorus Reduced
.7	.6
Crew Hours	Crew Value
36	\$640.00
BMPs Installed and Maintained	Materials Used
Infiltration Pathway	Erosion Control Mulch – 3 yds
Vegetated Buffer	Stone – 4 yds
Erosion Control Mulch	Firehose – 14 ft
Firehose Diverter	Lumber – 25 ft
	Rebar – 6ft

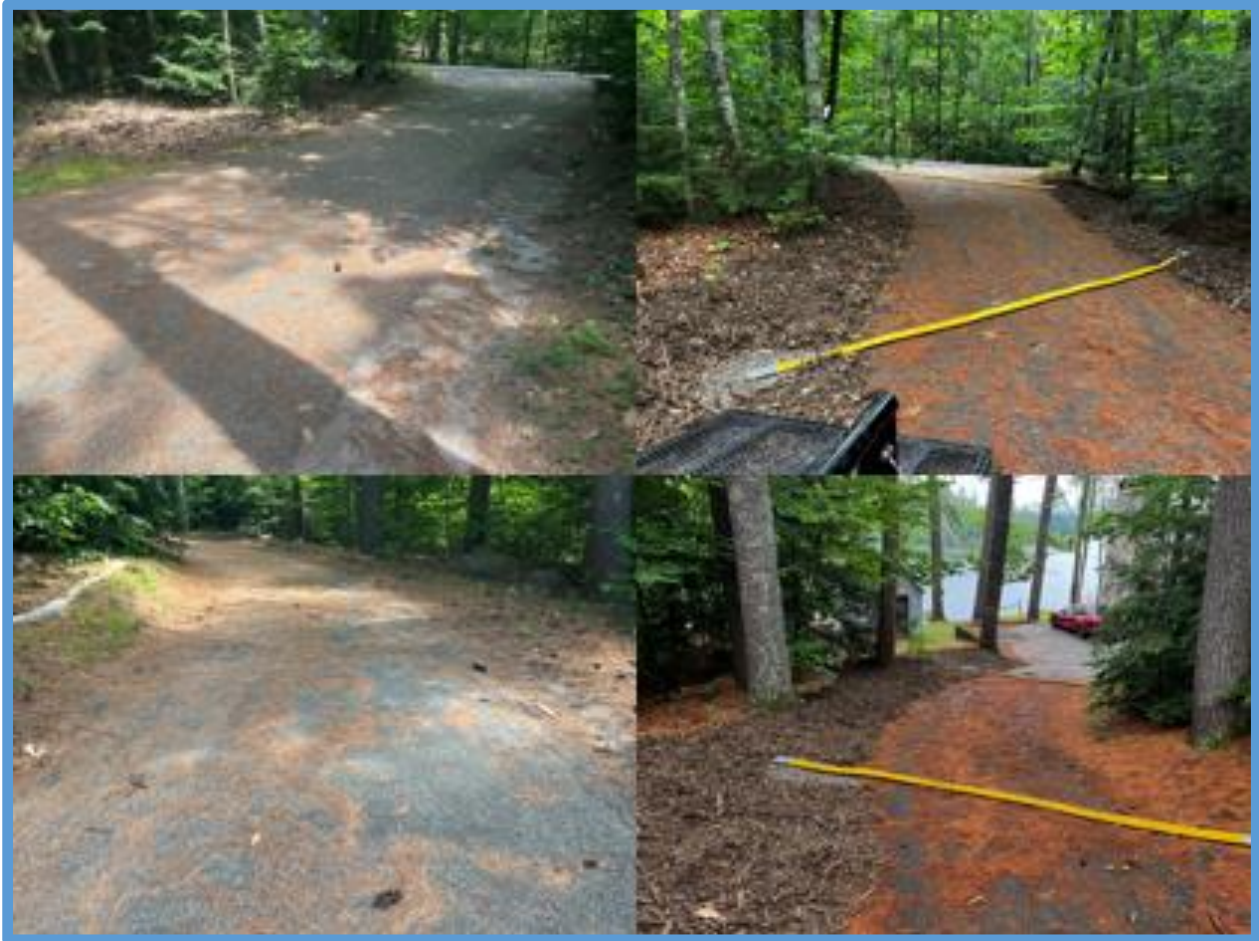
# Jillian Darling Project Before and After Photos

The Darling project was one of our quicker projects for the year. The homeowner had runoff coming down her driveway, so the crew installed multiple firehose diverters coupled with drywells. We also installed ECM alongside the long driveway to help slow down some of the diverted runoff. The crew worked hard and finished the project in about a day.

<b>Total Number of BMPs</b>	<b>Approximate Cost to Landowner</b>
10	\$410.00
<b>Tons of Sediment Reduced</b>	<b>Pounds of Phosphorus Reduced</b>
1.3	1.1
<b>Crew Hours</b>	<b>Crew Value</b>
72	\$1,400.00
<b>BMPs Installed and Maintained</b>	<b>Materials Used</b>
Firehose Diverter	Erosion Control Mulch – 12 yds
Drywell	Crushed Stone – 1 yds
Erosion Control Mulch	Firehose – 56 ft

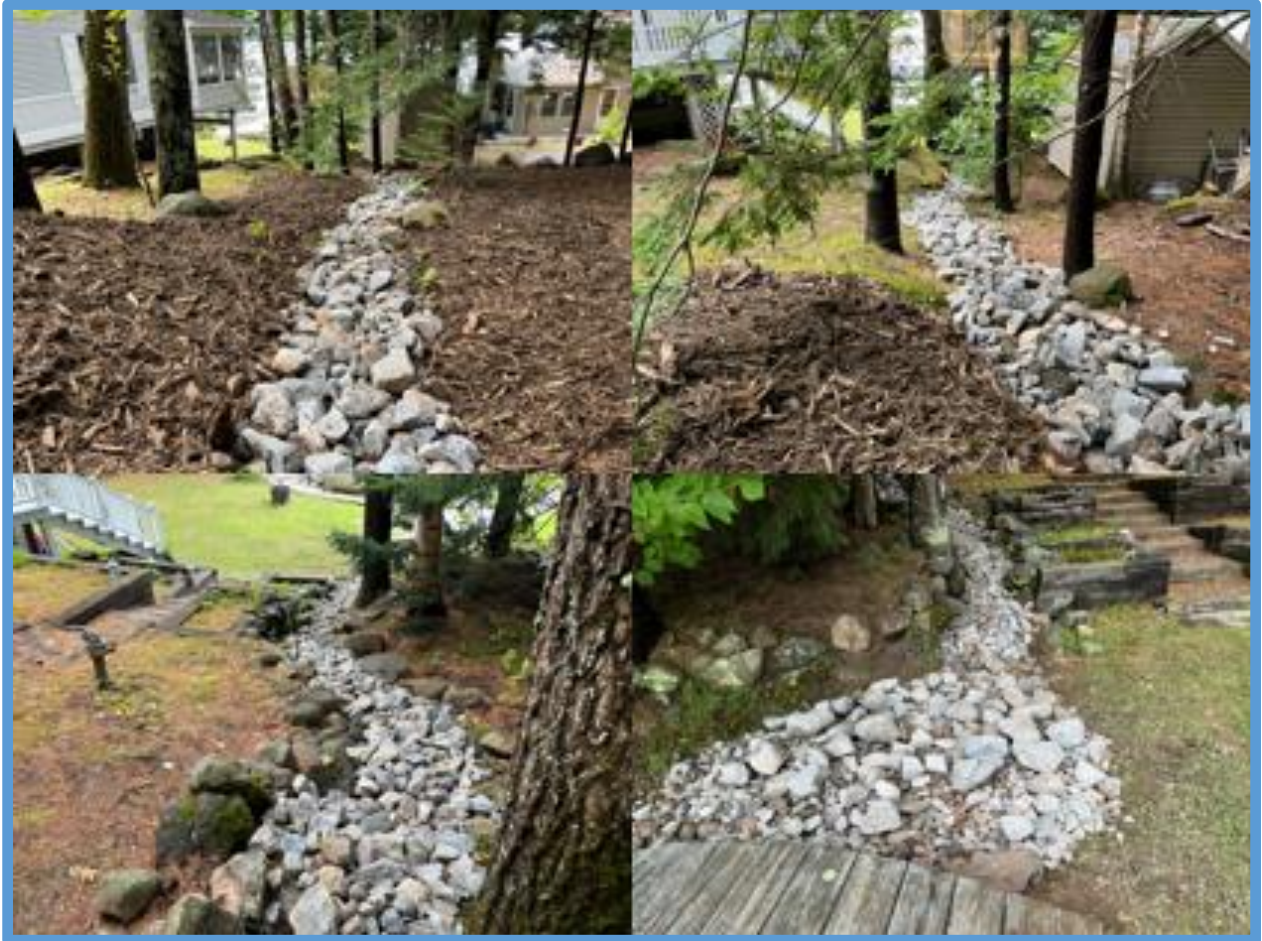
## Kathy White Project Photos

Kathy White’s project was slightly different from our normal project scope but nonetheless helped reduce the amount of sediment-filled stormwater that was entering Lovell Lake. The crew retrofitted an existing rip rap trench that had long been overwhelmed by sediment. The crew installed ECM uphill of the trench to help stop any sediments from reaching the trench and prolong its effectiveness. While the YCC crew was working, the Wakefield Highway Department came by and installed a large detention basin above our rip rap trench. We were very pleased to see this as it will help store runoff during rain events and reduce the stress on our trench.

Total Number of BMPs	Approximate Cost to Landowner
8	\$437.00
Tons of Sediment Reduced	Pounds of Phosphorus Reduced
3.7	3.2
Crew Hours	Crew Value
84	\$1,600.00
BMPs Installed and Maintained	Materials Used
Rip Rap Trench	Erosion Control Mulch – 7 yds
Erosion Control Mulch	Stone – 6 yds

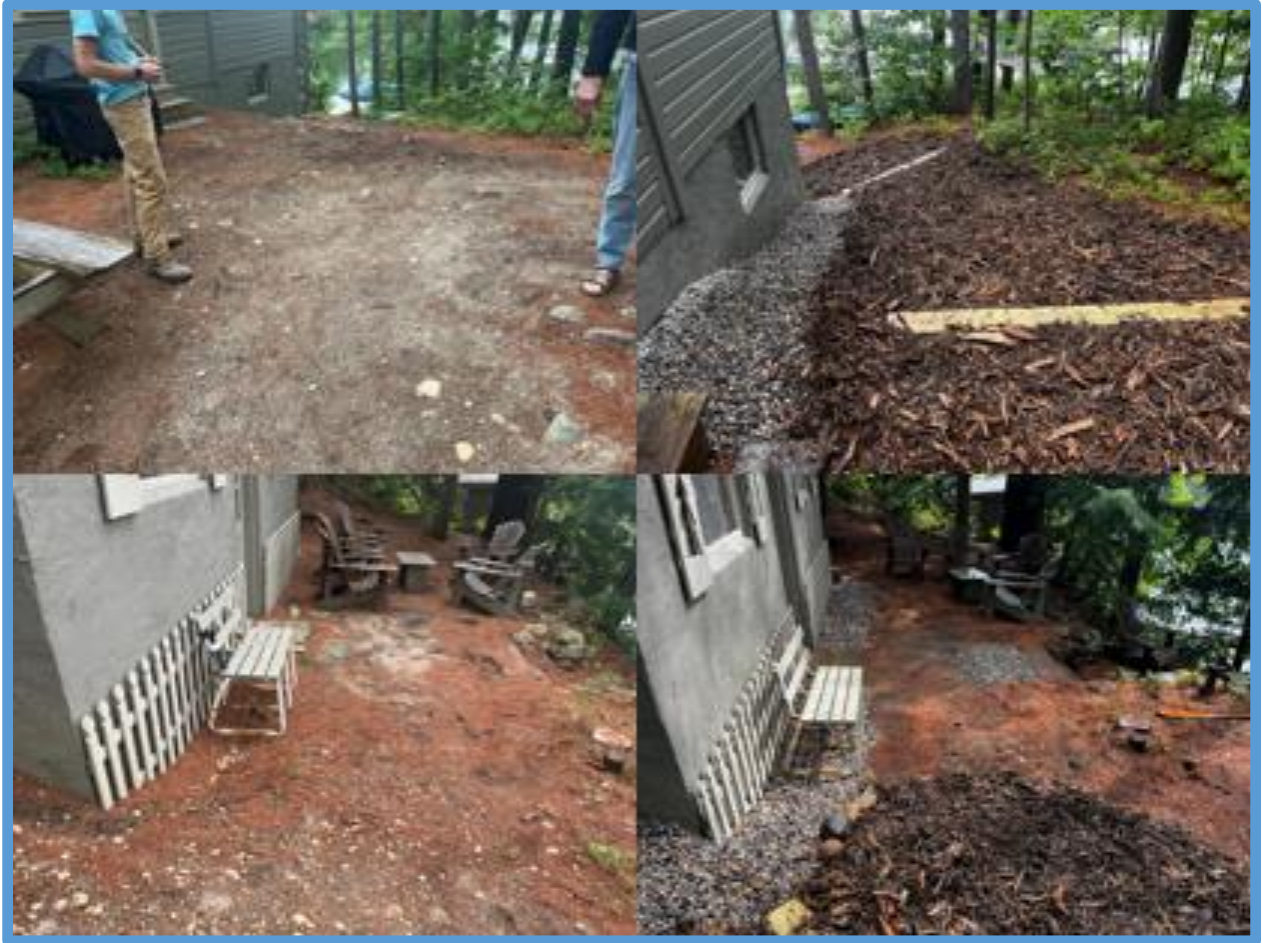
## Janet Rogers Before and After Photos

Janet Roger’s project was our final project on Balch for 2024. The homeowner had a large bare area next to the house, which turned into a torrent of sediment-filled runoff when it rained. To solve this issue the crew installed a large dripline trench that spanned the entire length of the house. In the rest of the bare area, the crew installed ECM. Two waterbars were added on the slope to help hold the soil together and act as a block for any stormwater runoff. Due to their hard work, the homeowner decided to cook the crew lunch. The crew was able to interact with the homeowner more than they would at a normal project.

<b>Total Number of BMPs</b>	<b>Approximate Cost to Landowner</b>
10	\$472.00
<b>Tons of Sediment Reduced</b>	<b>Pounds of Phosphorus Reduced</b>
6.7	5.7
<b>Crew Hours</b>	<b>Crew Value</b>
76	\$1,500.00
<b>BMPs Installed and Maintained</b>	<b>Materials Used</b>
Dripline Trench	Erosion Control Mulch – 8 yds
Waterbars	Crushed Stone – 3 yds
Erosion Control Mulch	Lumber – 16 ft
	Rebar – 6 ft

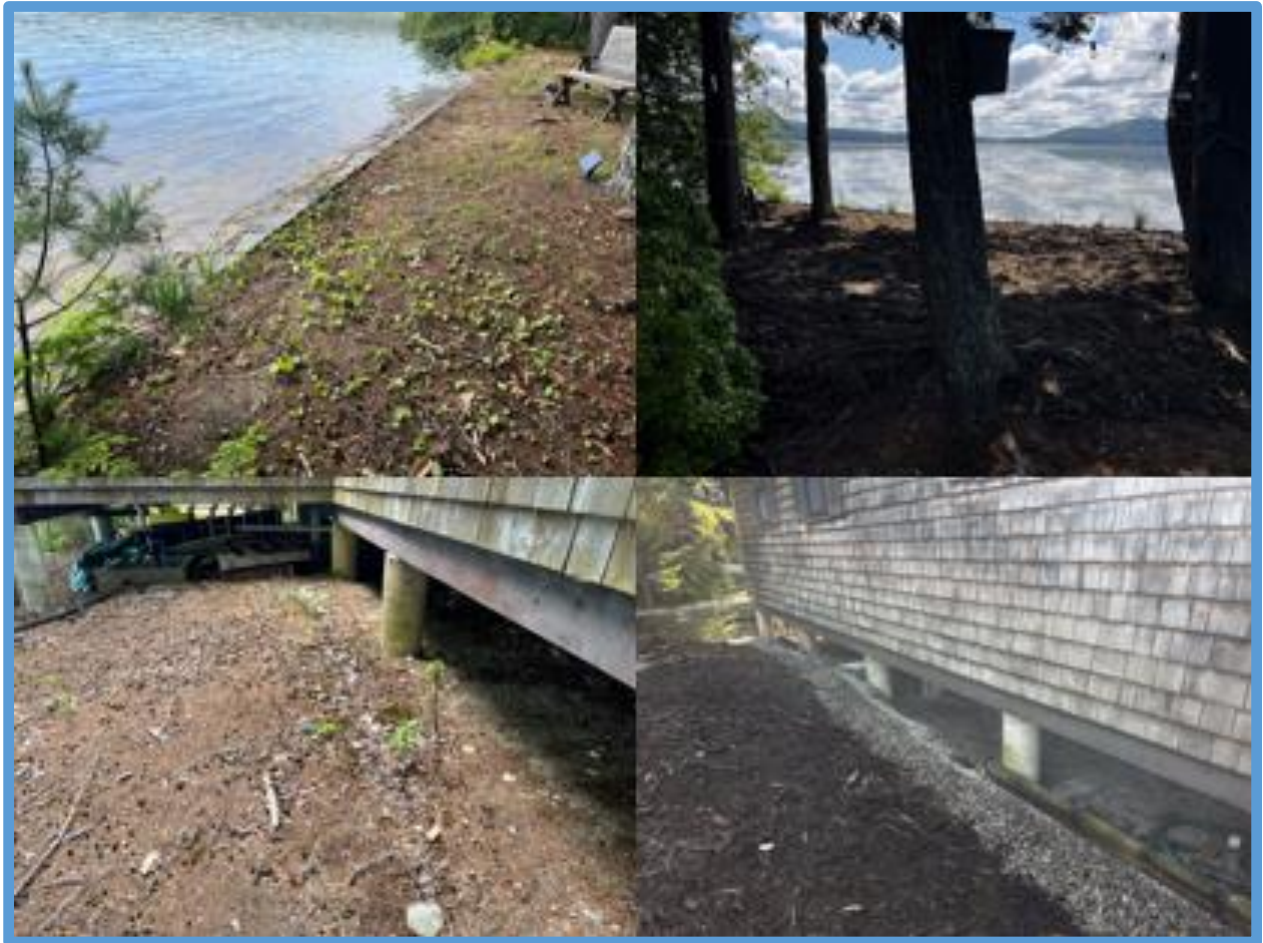
## Marcia Fletcher Before and After Photos

The crew traveled up to Province Lake for the Fletcher project, where they installed a large, vegetated buffer. The homeowner was having issues with erosion from the lake side through wave action and from the land side through sheet flow runoff, so we decided to install ECM on the steeper parts of the bank and lots of native plants up on the flatter section on the shoreline. The crew did a great job spreading the thick layer of mulch across the entire shoreline giving it the protection it needed. To help stop runoff from reaching the shoreline, the crew installed two dripline trenches and two yards of ECM around them. The homeowner was pleased with the project and shared some pictures of the project and crew on the Province Lake Facebook page.

Total Number of BMPs	Approximate Cost to Landowner
15	\$1,048.00
Tons of Sediment Reduced	Pounds of Phosphorus Reduced
.4	.4
Crew Hours	Crew Value
88	\$1600.00
BMPs Installed and Maintained	Materials Used
Vegetated Buffer	Erosion Control Mulch – 30 yds
Dripline Trench	Crushed Stone – 1 yds
Erosion Control Mulch	Plants - 15

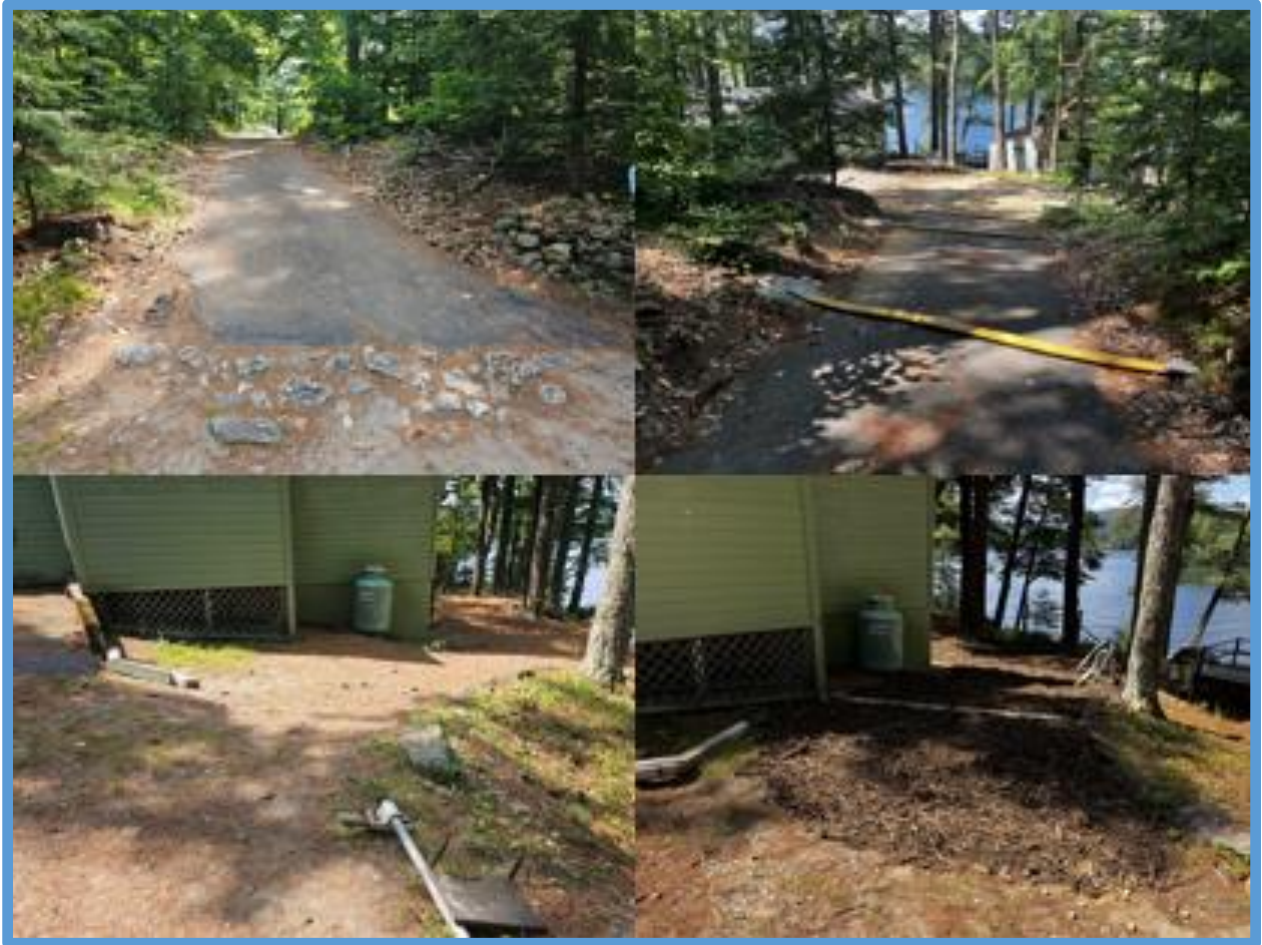
## Valerie Perkins Before and After Photos

Next, the crew moved over to Lovell Lake where they would spend the rest of the season. The homeowner was having issues with stormwater running down her driveway and between the two houses that were on the property. To solve this, the crew installed multiple firehose diverters in the driveway coupled with drywells. The firehoses diverted the runoff into the drywells and woods beyond. Next, the crew moved downhill and installed a waterbar and ECM at the top of a slope leading to the lake. This would cover bare soil as well as provide a block or barrier for any stormwater runoff making its way past the firehose diverters. The homeowner was pleased with the result of the project and recommended us to her neighbor who subsequently requested a site visit.

Total Number of BMPs	Approximate Cost to Landowner
10	\$469.00
Tons of Sediment Reduced	Pounds of Phosphorus Reduced
.2	.2
Crew Hours	Crew Value
48	\$1,000.00
BMPs Installed and Maintained	Materials Used
Firehose Diverters	Erosion Control Mulch – 7 yds
Drywells	Stone – 2 yds
Waterbar	Firehose – 46 ft
Erosion Control Mulch	Lumber – 8 ft
	Rebar – 6 ft

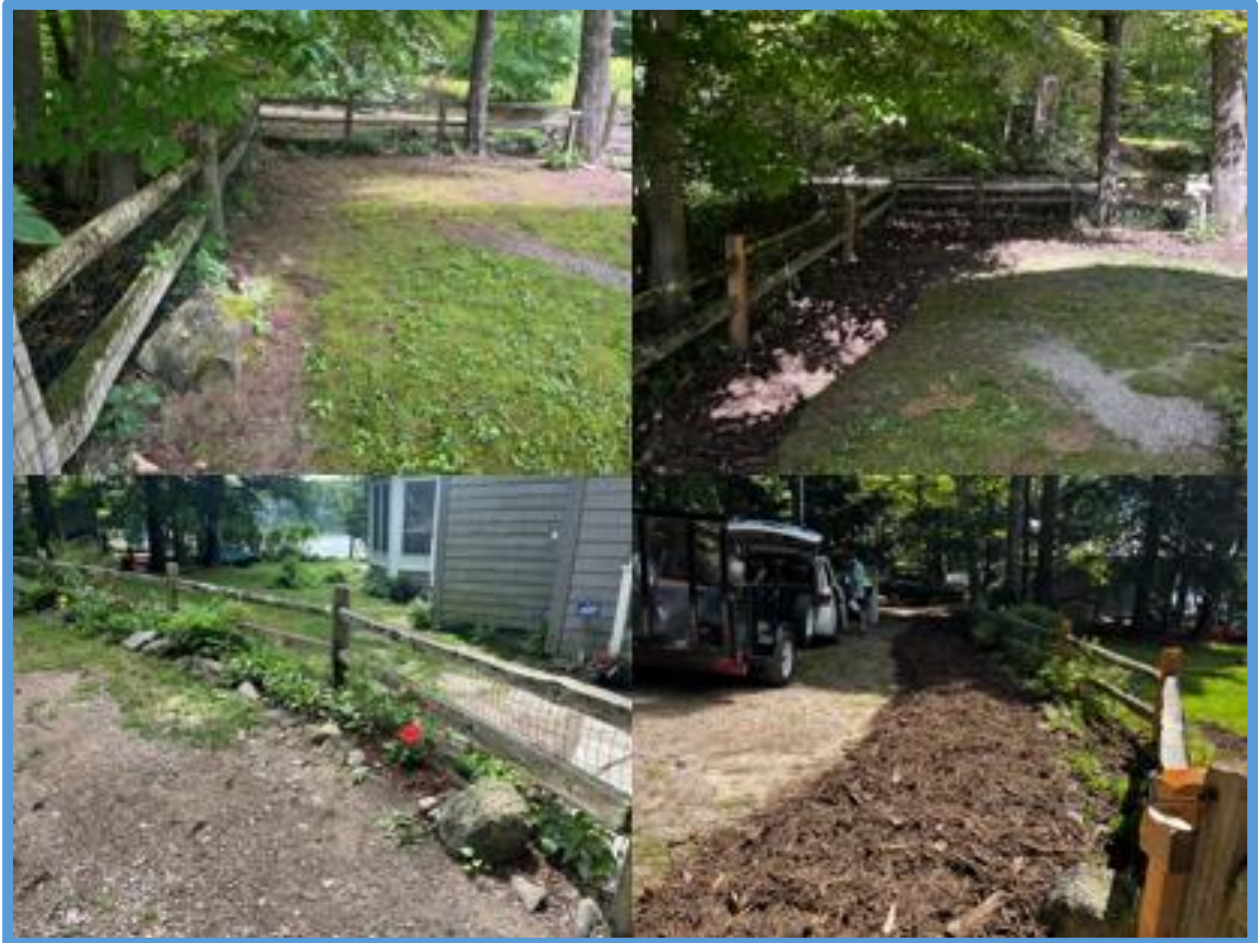
## Stanley Davis Before and After Photos

The Davis project was our smallest of the year, but no less important. The homeowner was having issues with runoff coming from the camp road and making its way through their front yard. The crew installed a strip of ECM along the fence and in the exposed soil area below. The crew managed to finish the project in just a few hours and moved on to our final project of the year.

<b>Total Number of BMPs</b>	<b>Approximate Cost to Landowner</b>
5	\$347.00
<b>Tons of Sediment Reduced</b>	<b>Pounds of Phosphorus Reduced</b>
.3	.2
<b>Crew Hours</b>	<b>Crew Value</b>
36	\$750.00
<b>BMPs Installed and Maintained</b>	<b>Materials Used</b>
Erosion Control Mulch	Erosion Control Mulch – 9 yds
Infiltration Trench	Crushed Stone – 1 yds

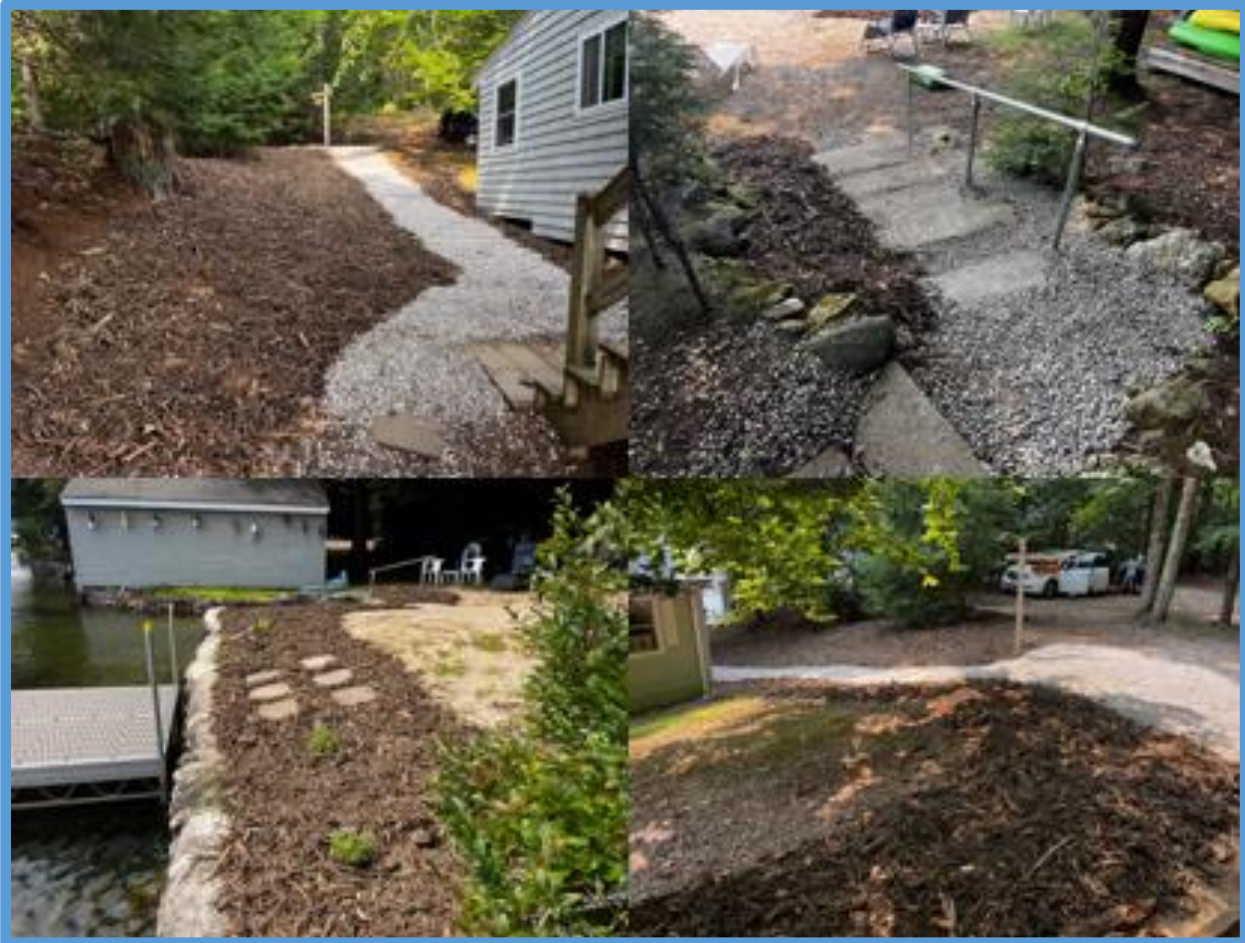
# Area Princi After Photos

The Princi project was the last project of the year for the crew. AWWA had done a YCC project here in the past but with increased rain events and the severity of the issue, the old project had failed. To fix the issues the crew first reinforced an already existing vegetated buffer and extended it around thirty feet. Next, the crew extended and retrofitted the existing infiltration pathway with more crushed stone. This allowed for more water storage during rain events as well as covering more exposed soil. Around the pathway, the crew installed fresh ECM to cover the remaining bare soil. The crew worked hard right up to the last minute to complete their final project of the year.

Total Number of BMPs	Approximate Cost to Landowner
12	\$734.00
Tons of Sediment Reduced	Pounds of Phosphorus Reduced
2.9	2.4
Crew Hours	Crew Value
96	\$1,800.00
BMPs Installed and Maintained	Materials Used
Infiltration Steps	Plants – 15
Vegetated Buffer	Erosion Control Mulch – 8 yds
Waterbar	Stone – 5 yds
Erosion Control Mulch	Lumber – 8 ft
	Rebar – 6 ft
