Youth Conservation Corps Project

A Final Report to

The New Hampshire State Conservation Committee

December 31, 2008

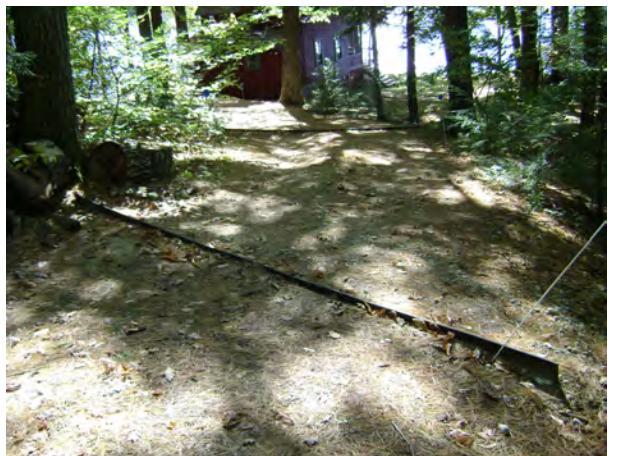
Alan served as a project host at the end of the 2007 season. Large ruts were cut into the driveway due to the high velocity of the runoff. Four rubber razors had been installed to divert the runoff coming from the paved road above the driveway. The rubber razors slowed and diverted the runoff into nearby vegetation. However, over the course of the fall, winter, and spring, ruts had reappeared and it became obvious that the rubber razors we had installed were not operating correctly due to some improper installations. It was the responsibility of the YCC to return to the site, amend the previously installed BMPs, and install an additional rubber razor to fully remediate the site. The crew re-sank the two rubber razors at the top of the driveway to place them flush with the driveway surface so that runoff would be diverted by the rubber and not the lumber anchor. The two rubber razors at the bottom of the driveway had their angles reversed so that they diverted water to the opposite side of the driveway where the runoff could be more effectively controlled by the receiving vegetation. A fifth rubber razor was installed in the middle of the driveway above the parking area to divert any remaining runoff into nearby vegetation. This project was important in demonstrating the YCC's commitment to the quality of our work and the desire to provide a quality service focused on sustainability and effectiveness.

Alan Heacock Before

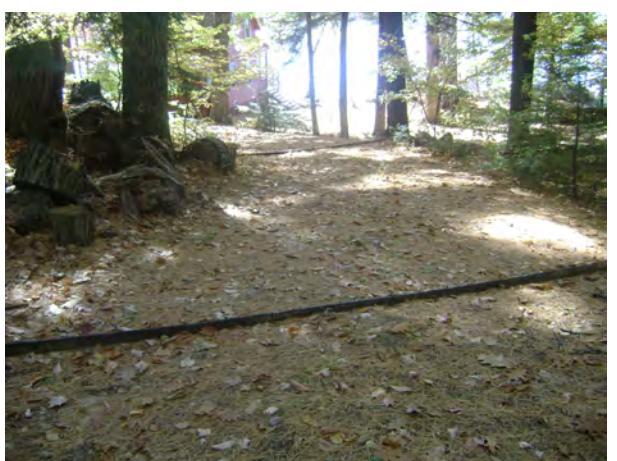
Alan Heacock After

BMPs installed:	Rubber Razors
Total Number of BMPs:	1
Ton of Sediment Prevented:	1.3
Pounds of Phosphorus Prevented:	1.1
Cost to Landowner: Crew Man Hours:	\$0.00 (landowner already owned materials) 28.5 hours 1 day (3 crew + crew leader)

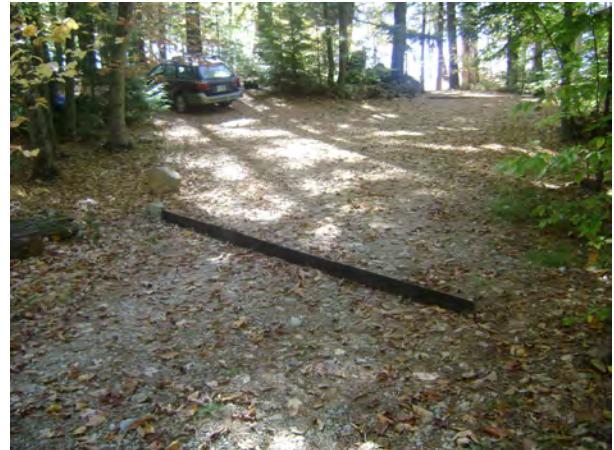
Alan Heacock New Rubber Razor

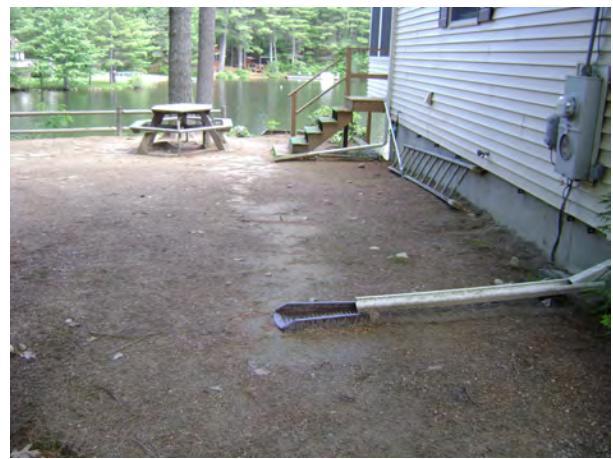
gullies where the sand had been eroded into the lake. Rain barrels were originally recommended to be placed at the downspouts to collect the runoff, but they were difficult to find and expensive to purchase. Additionally, the rain barrels would not be able to contain the entire amount of runoff from the roof during even minor precipitation events. It was then recommended that a rain garden be installed on one side of the house to collect the roof runoff from the downspouts on that side. Also, the rain garden would help to stabilize the ground surface, protecting it from any other surface runoff. Both downspouts led to the large rain garden, sized to contain large quantities of water and infiltrate it into the ground and feed the native vegetation planted inside. A buffer strip was added as a last line of defense between the property and the final steep slope leading to the lake. This buffer would capture any runoff that was not contained by the rain garden and infiltrate it into the ground as well. The downspouts on the other side of the house were redirected to vegetated areas with high absorption capacities where the soil had not been compacted by vehicle or foot traffic.

Will Collier Before

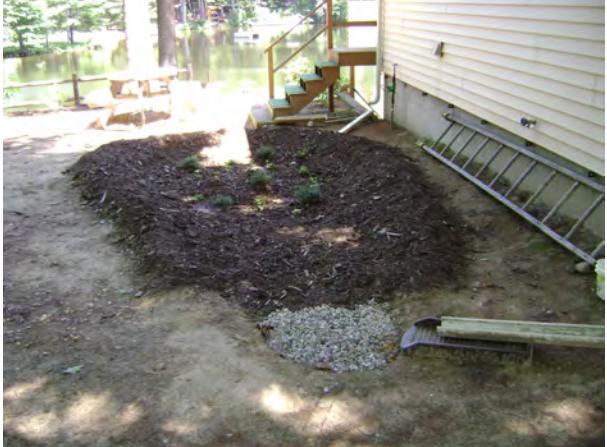
Will Collier After

3. Public Launch	Great East La	ake	East Wakefield, NH
Cost to Landowner: Crew Man Hours:	\$550.00 25 hours	1 day	(2 crew + crew leader)
Pounds of Phosphorus Prevented:	0.1		
Ton of Sediment Prevented:	0.1		
Total Number of BMPs:	2		
BMPs installed:	Rain Garden Buffer Strip

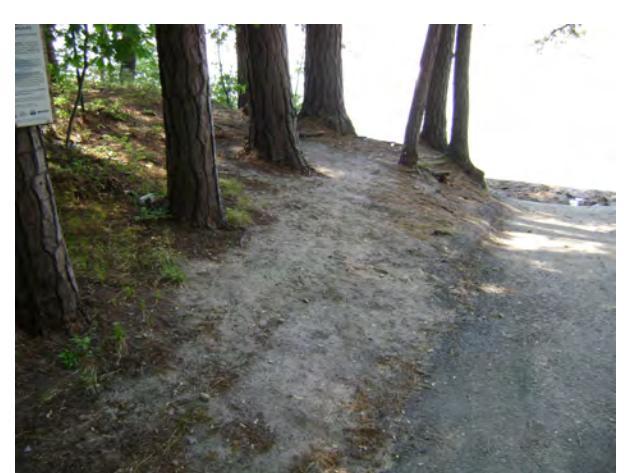
ramp is paved with asphalt before turning back to dirt at the waterline. The eroded access surface is punctuated with tree roots and large rocks, making the installation of diverters nearly impossible. Additionally, there is no place to divert the runoff to as the access is the lowest property in the area. It was decided that the most severely eroded part of the property, the slope adjacent to the paved section, should be stabilized in order to curb any further erosion, and absorb and infiltrate any runoff entering it. The severity of the slope demanded a solution that would hold on to the surface and not easily erode away, even with frequent inundations. Erosion control mix was utilized for these exact reasons. It will adhere to very steep slopes, it will not float or wash away easily, and it will absorb runoff and control it while it infiltrates into the ground. The erosion control mix also improved the overall aesthetics of the property by filling and stabilizing the bare landscape with a uniform covering.

Public Launch Before

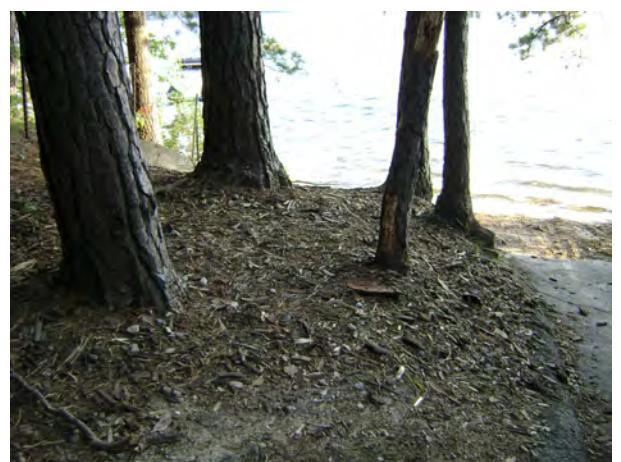
Public Launch After

BMPs installed:	Erosion Control Mix
Total Number of BMPs:	1
Ton of Sediment Prevented:	3.2

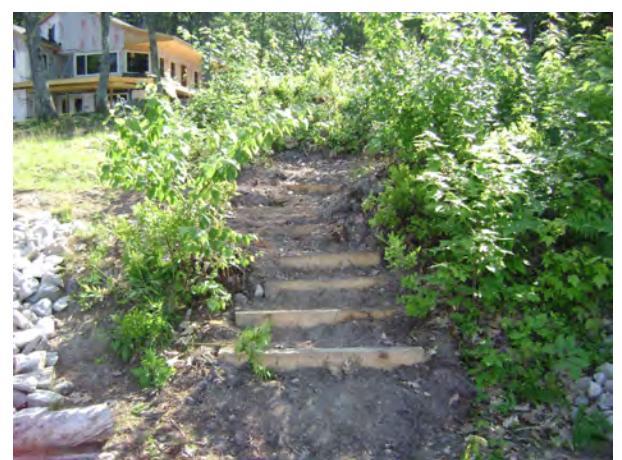
washing into the top portion of the property. This inflow eventually weaves its way over the property and finally down a slope into the lake. During the 2007 YCC season, the crew installed many BMPs to successfully control the runoff at the top part of the property where the runoff first enters the site. The BMPs include waterbars and drywells that we cleaned out and revitalized this season to ensure proper working order. On the lower portion of the site, adjacent to the lake, the crew had previously installed simple timber steps to provide access to the lake. However, we learned over the past year, that local residents wanted more sure-footed access. We also knew that we were capable of constructing a better solution to the erosion problems occurring on the slope. This was the first test of the crew's abilities to install a more technically advanced BMP. We removed the old steps and constructed a large staircase of infiltration steps that were capable of collecting as much runoff as the site could provide. These steps also created a wide, deep, stable platform for easy access to the lakefront. The staircase tied in with stabilizing riprap the crew previously installed to make a complete barrier for runoff interception. Above the stairs, the crew better defined the walkway leading through the property to dissuade residents from trespassing onto adjacent properties. Along this path, timber waterbar steps were installed to divert water off the trail into vegetation and provide better traction along the steeper portions. The new BMPs proved to be a dramatic improvement over the previous design, and boosted the crew's confidence in their construction abilities.

Municipal Property Before

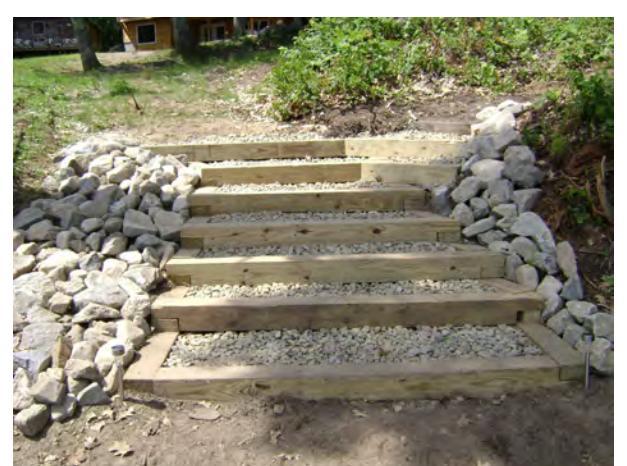
Municipal Property After

BMPs installed:	Infiltration St Paths & Walk Waterbars Riprap	eps tways	
Total Number of BMPs:	4		
Ton of Sediment Prevented:	3.4		
Pounds of Phosphorus Prevented:	2.9		
Cost to Landowner: Crew Man Hours: Total:	\$539.09 (with 142.5 hours 15 hours 157.5 hours	a projects #3 ar 4 ¼ days 1 day 5 ¼ days	nd #4 above) (3 crew + crew leader) (2 crew)

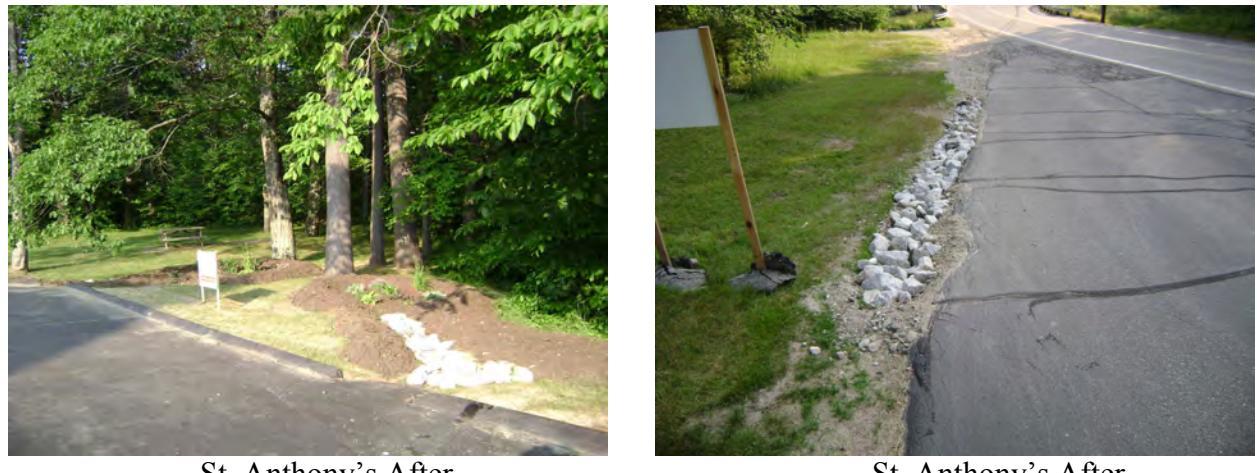
The YCC installed two rain gardens and an infiltration trench to this site in 2007 in order to collect and control the massive amounts of runoff created by the large paved driveway surrounding the church. Further compounding the challenge was the asphalt berm bordering the driveway, concentrating the runoff to inconvenient areas, and the small portion of workable land between the berm breaks and the Branch River. Also, winter sand was used liberally on the site and never cleaned up. The two rain gardens and infiltration trench that were installed worked very efficiently. However, a year's worth of sediment had accumulated in them and the site needed maintenance that the priest was not able to perform. The YCC returned this season to clean the sediment out of the infiltration trench and the rain gardens, returning them to their original functioning condition. Next year, a volunteer crew from the congregation will be trained and utilized to perform these maintenance procedures. Additionally, it has been recommended that the winter sand be removed from the site in the spring to minimize the impact on the BMPs.

St. Anthony's After

BMPs installed:	Infiltration Trench (maintenance) Rain Garden (maintenance)
Total Number of BMPs:	2
Ton of Sediment Prevented:	sheet erosion, could not measure
Pounds of Phosphorus Prevented:	could not calculate
Cost to Landowner: Crew Man Hours:	\$0.00 (no materials involved) 24 hours $\frac{3}{4}$ days (3 crew + crew leader)

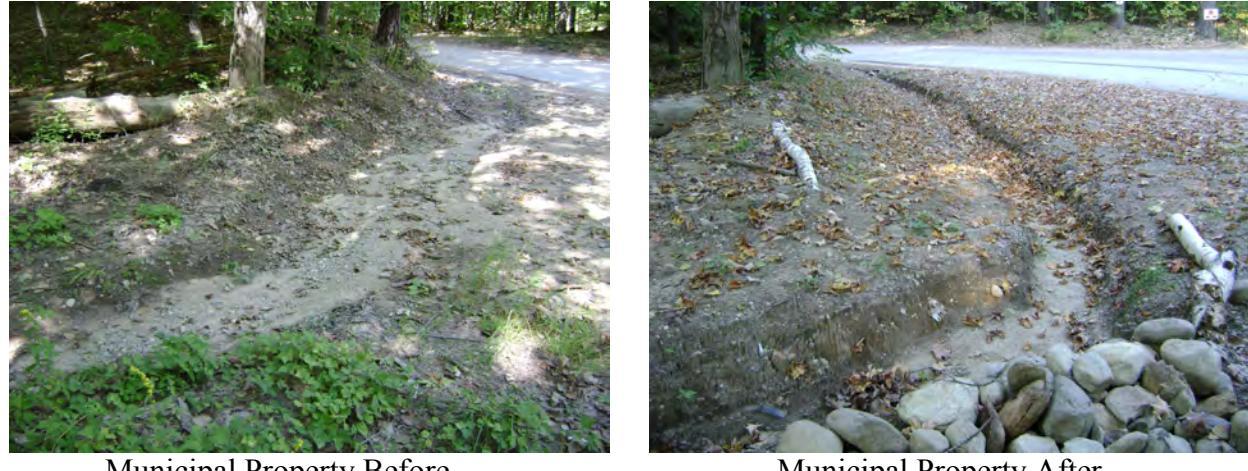
Water coming down Robinson Road is shed off the road surface and runs along the side of the road as it opens to a turnaround area. Ordinarily, water would flow across this flat, gravel open area, pick up sediment, cross paved Canal Road and subsequently flow into the Great East Lake/Horn Pond canal. An infiltration trench already existed on this site to intercept the runoff as it initially flowed off of Robinson Road, but it was not functioning property. It had filled with sediment and could no longer collect road runoff and transport it. A new infiltration trench was installed by the YCC. The trench was deeper and wider and led to a new part of the property that could adequately control the runoff. At the terminus of the trench, we installed a drywell to collect and infiltrate the water before it could enter the canal. The trench provides a complete barrier to the flat area at the corner of Robinson and Canal Road where stormwater would ordinarily collect sediment and gain velocity before crossing Canal Road and flowing into the canal. The drywell now properly allows for complete infiltration of the runoff into the ground. The system has proven to be a very effective stormwater control measure. This project was an example of the true benefit of the YCC to the community. With no out-of-pocket expenses and the use of only on-site materials, a dramatic alteration of the site was accomplished and a highly effective system of BMPs was installed to properly control stormwater.

Municipal Property Before

Municipal Property After

BMPs installed:	Infiltration T Drywell	rench	
Total Number of BMPs:	2		
Ton of Sediment Prevented:	0.6		
Pounds of Phosphorus Prevented:	0.5		
Cost to Landowner:	\$0.00 (no ma	terials involved)
Crew Man Hours:	25 hours	1 day	(2 crew + crew leader)
	18.5 hours	½ day	(3 crew + crew leader)
Total:	43.5 hours	$1 \frac{1}{2} \text{ days}$

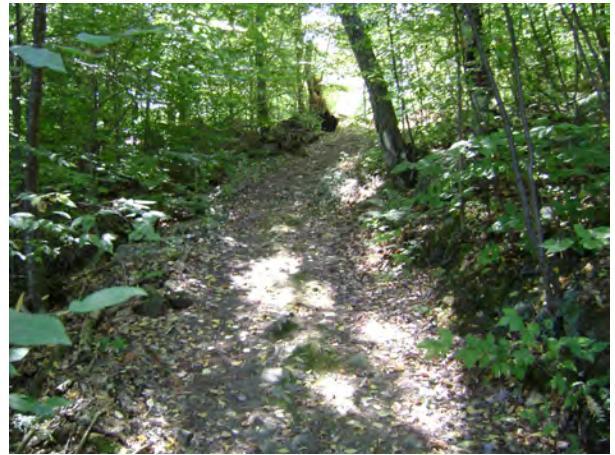
rocky soil combine to create a serious erosion problem as well as difficulties accessing the lake. The solution for the upper part of this property was to install timber waterbars periodically along the sloped trail to regularly break up water flow to reduce velocity and divert the water off of the path into adjacent vegetation. The waterbars also serve as steps for added traction while walking on the trail. The trail surface was then covered with a layer of erosion control mix to absorb and further slow runoff from the parking lot. The erosion control mix, combined with the waterbars, has helped to stabilize this pathway and improve lake access.

Community Property Before

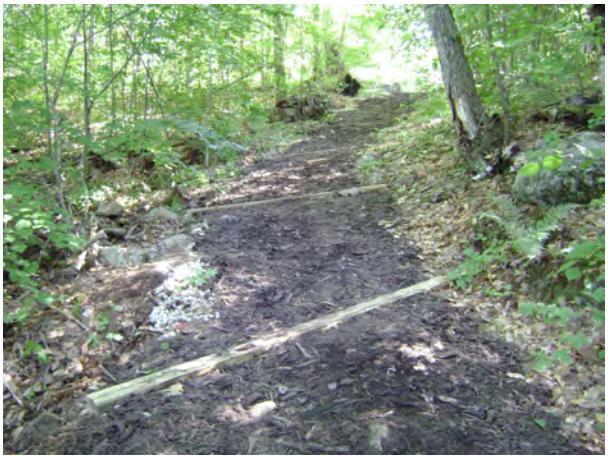
Community Property After

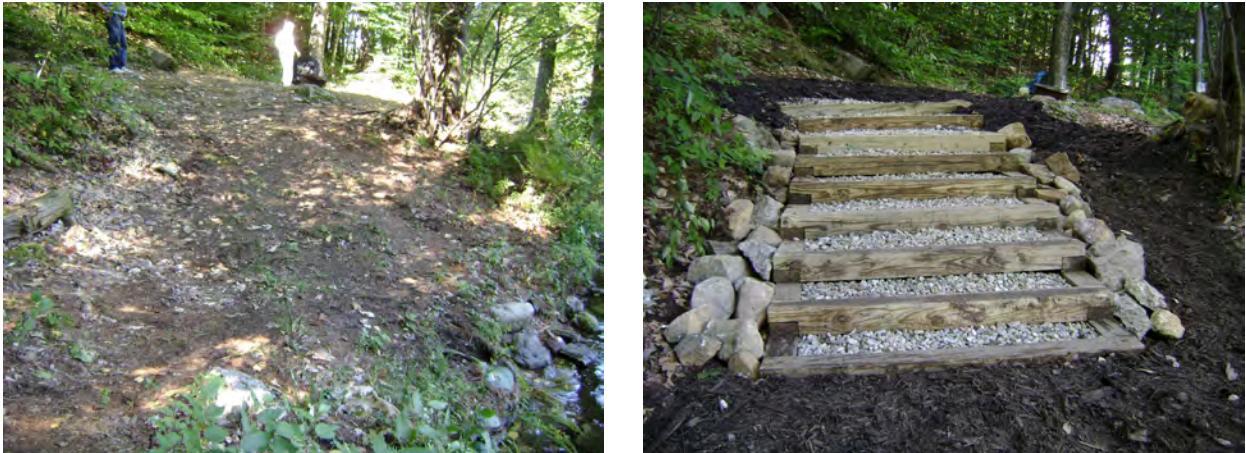
The bottom area of the community property opens to a flat area perched above the lake to the left of the bottom of the trail. This flat area leads to a dock. To the right of the bottom of the trail, the property dips down to a small flat area just above the level of the lake. The small slope is used to access the lake for swimming, while the perched flat area is used for sitting and dock access. To provide better access to the lower area with direct access to the lake, a series of infiltration steps were installed for better traction on the slope. The infiltration steps also collect any residual runoff from the upper property. Erosion control mix was continued from the upper portion of the site and spread over the perched flat area, on the slope around the infiltration steps, and on the lower flat area close to the lake. The erosion control mix has stabilized the entire area and the infiltration steps now provide sure access to the lake.

Community Property Before

Community Property After

BMPs installed:	Erosion Control Mix Infiltration Steps
Total Number of BMPs:	2
Ton of Sediment Prevented:	sheet erosion, could not measure
Pounds of Phosphorus Prevented:	could not calculate
Cost to Landowner: Crew Man Hours:	\$1,038.33 (with project #8 above) see Project #8

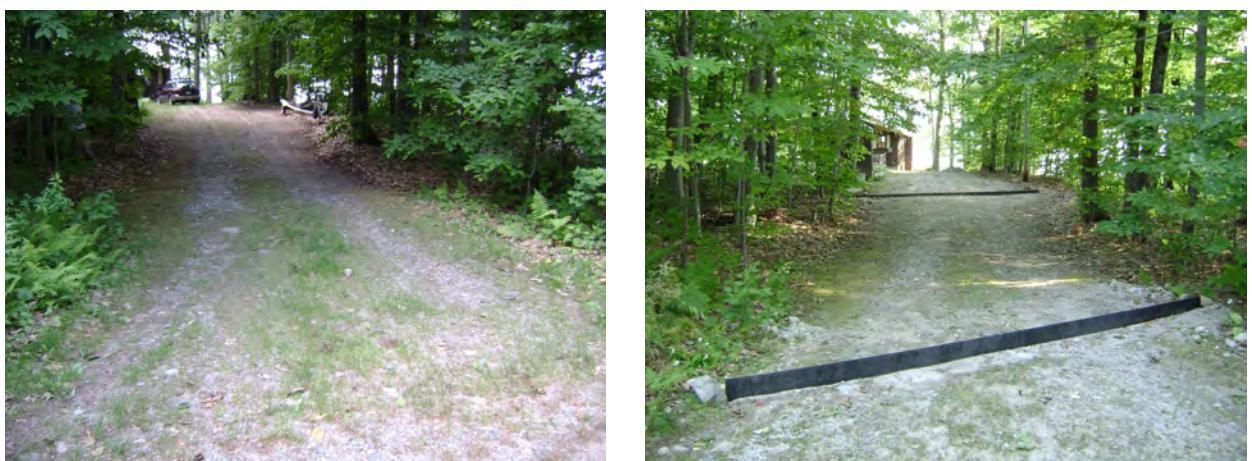
This site was another large project that required a lot of the crew's time and expertise. The property is situated at the beginning of a gravel camp road just off of a paved road and adjacent landscape sloping towards it. Runoff comes down the paved road, turns into the camp road, and escapes down the driveway of the Wings' property. Addressing this driveway portion of the property was the first project on the site. The runoff needed to be diverted off of the driveway and into the abundant vegetation. This would prevent it from forming gullies in the driveway, gaining velocity, and transporting sediment downhill into the lake. Two rubber razors were installed across the driveway, one close to the top and another above the parking area. These razors effectively divert water off of the driveway surface and the adjacent vegetation adequately infiltrates the runoff.

Barbara Wing Before

Barbara Wing After

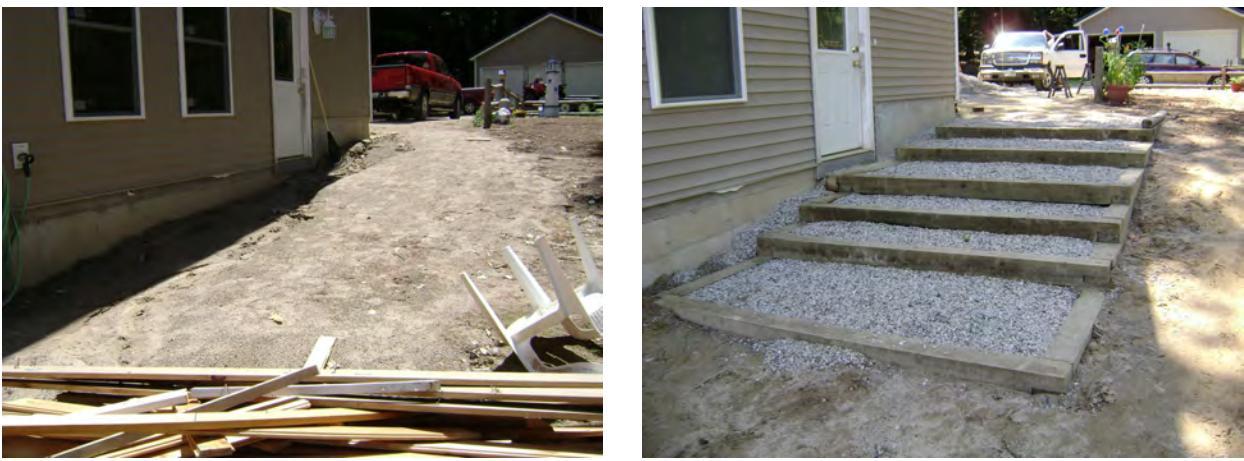
majority of the erosion, and the landowner is responsible for adding native vegetation and erosion control mix to complete the project.

Bob Grant Before

Bob Grant After

BMPs installed:	Infiltration Ste Dripline Trene	eps ch	
Total Number of BMPs:	2		
Ton of Sediment Prevented:	0.6		
Pounds of Phosphorus Prevented:	0.5		
Cost to Landowner: Crew Man Hours: Total:	NA 32.5 hours 25 hours 40 hours 97 5 hours	1 day 1 day 1 day 3 days	(3 crew + crew leader) (2 crew + crew leader) (4 crew + crew leader)

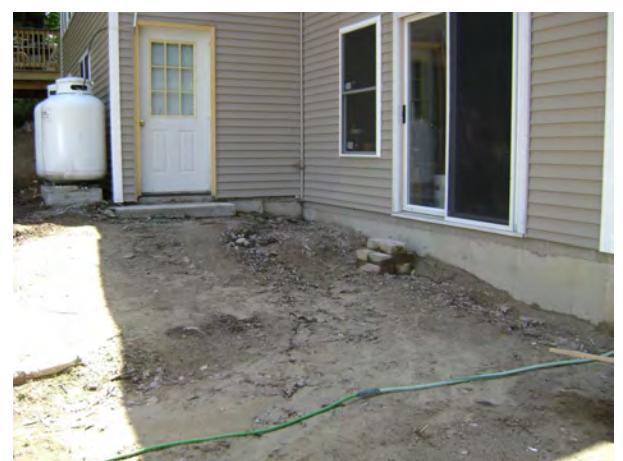
but proved to be quite successful. The underlying dripline trench still functioned effectively and did not compromise the stability of the stairs. Finally, on the path leading to the dock, there was a series of three steps that were retrofitted into infiltration steps. The backfilled soil of the steps had become so compacted that it had become an impervious surface. The soil was removed and replaced with crushed stone to create a porous walking surface where runoff could still be collected. This project concluded with the landowner again pledging to plant native vegetation and spread erosion control mix on the bare soil. Follow up of the landowner's installation will be conducted as outlined under task 6 below.

Bob Grant Before

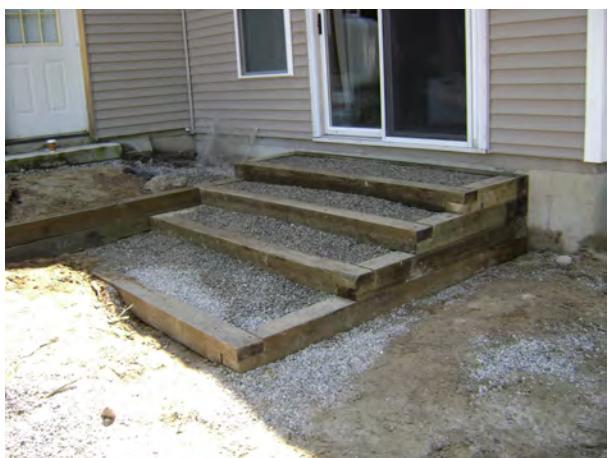
Bob Grant After

BMPs installed:	Dripline Trench Drywell Infiltration Steps Retrofit Infiltration Steps
Total Number of BMPs:	4
Ton of Sediment Prevented:	0.4
Pounds of Phosphorus Prevented:	0.3
Cost to Landowner: Crew Man Hours:	NA see project #12

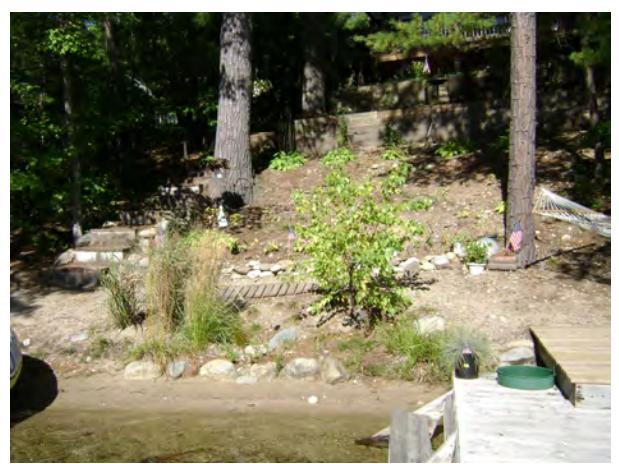
Dee's house is set up atop a steep slope that leads directly down to the lake. Some retaining walls, terracing, and native vegetation had already been established on the slope, but it was inadequate given the amount of erosion the property experiences. At the bottom of the slope, the property flattens slightly for a stretch before eventually reaching the water. Basic cinder block stairs descend the hill to provide access to the lake. At the bottom of the steps, a path has been used to walk along the bottom of the hill to reach the dock. This pathway slopes toward the lake,

consists of bare soil, and does not provide adequate traction for foot travel. This project required the implementation of numerous BMPs in order to properly alleviate the erosion problems. The stairs' back-filling had become compacted and was replaced with crushed stone to retrofit them into infiltration steps. Much of the runoff ran down these stairs and gained enough velocity to erode a considerable portion of the beach. The infiltration steps will collect this runoff and provide better access to the lake. The pathway between the bottom of the stairs and the dock was stabilized with a long infiltration step, leading to two smaller infiltration steps to reach the level of the dock. The long step runs along the bottom of the steep hill and collects any runoff before it can enter the lake. It also provides a flat, level, sturdy walking platform. Buffer vegetation was planted between the infiltration step and the lake to further stabilize the soil and absorb water and nutrients, as well as enhance the waterfront aesthetics of the site. Native vegetation was planted and erosion control mix was spread all over the slope above the infiltration step. This will absorb a lot of the runoff coming from the lot above and significantly reduce the amount of runoff reaching the BMPs at the bottom of the slope. Finally, timber waterbars were installed on the slope adjacent to the retrofit infiltration steps. The waterbars will divert the runoff flowing beside the steps into the local native vegetation and keep the water away from the beach area. This project stabilized a very precarious slope.

Dee Kasprzak Before

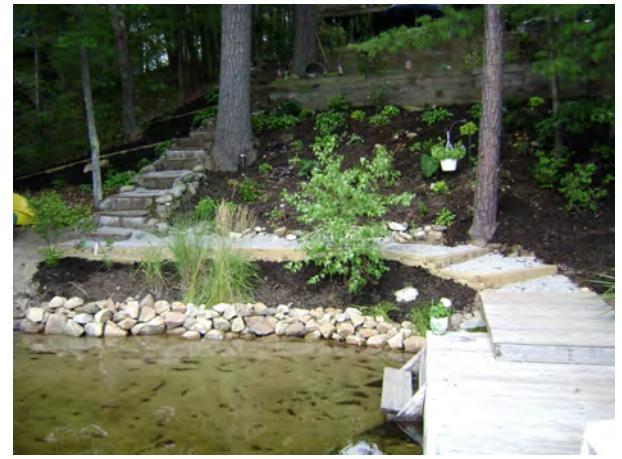
Dee Kasprzak After

BMPs installed:	Waterbars Retrofit Infiltration Steps Erosion Control Mix Infiltration Steps Buffer Strip Native Vegetation		
Total Number of BMPs:	6		
Ton of Sediment Prevented:	0.2		
Pounds of Phosphorus Prevented:	0.2		
Cost to Landowner: Crew Man Hours: Total:	\$840.00 57 hours 11 hours 32.5 hours 100.5 hours	1 ½ day ½ day 1 day 3 days	(4 crew + crew leader) (2 crew + crew leader) (3 crew + crew leader)

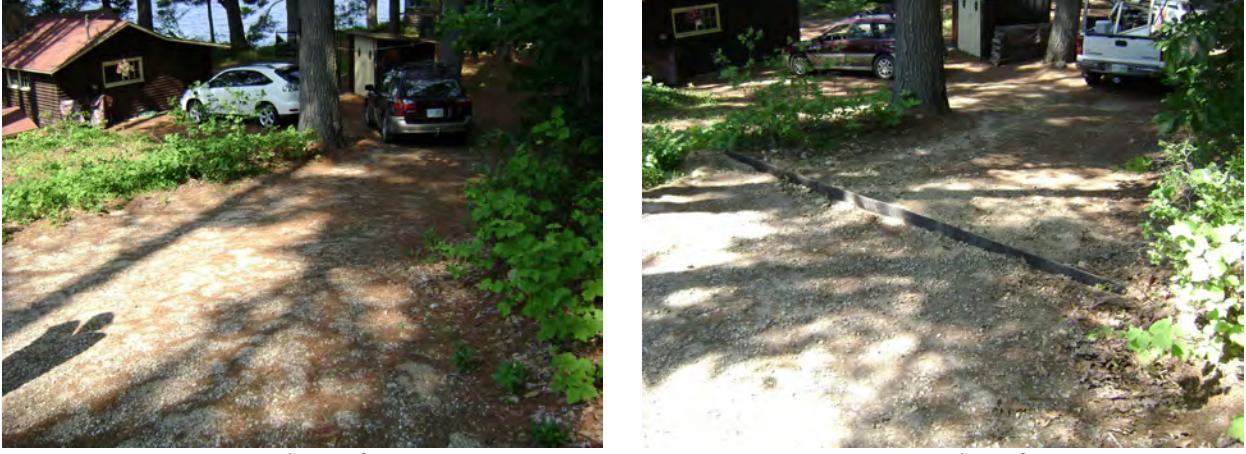
This property has a long, narrow access road through a heavily wooded area to reach the house directly on the lake. Thanks to the heavy wooded vegetation, the only real source of erosion is runoff from the gravel road and driveway. Runoff was carrying sediment from the road surface and depositing it into the lake. The solution to this erosion problem was rather simple: utilize rubber razors to divert runoff away from the road surface and into the abundant native vegetation where it can be controlled and absorbed. The installation was quick, straight-forward, and highly effective.

Sue Cain Before

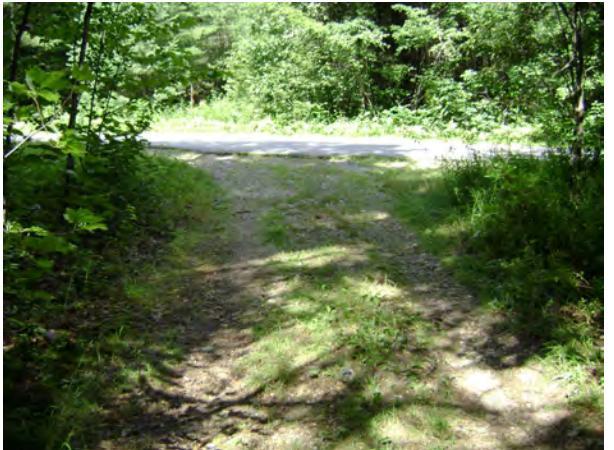
This property serves as a right-of-way for several other backlot residents on the road. Water would travel down the paved road and either run off the shoulder and enter the site from the roadside culvert or flow directly from the road down the driveway access. The driveway is long and sloping towards the lake. Complicating the project are the berms on either side of the driveway, severely limiting the ability to shed water away from the driveway surface. It was determined that the runoff needed to be diverted from the right-of-way as early as possible to prevent the runoff from gaining velocity and further eroding the surface material. Two open-top culverts were constructed and installed in areas where water immediately entered the site so that the water would be instantly captured and diverted. At the terminus of each open-top culvert, a turnout was dug through the berm in order to facilitate the movement of water from the site and into the adjacent vegetation. Diverting the runoff so high on the site eliminated the need for further BMP installations closer to the lake, preserving the aesthetics of the property.

Celia Thibodeau Before

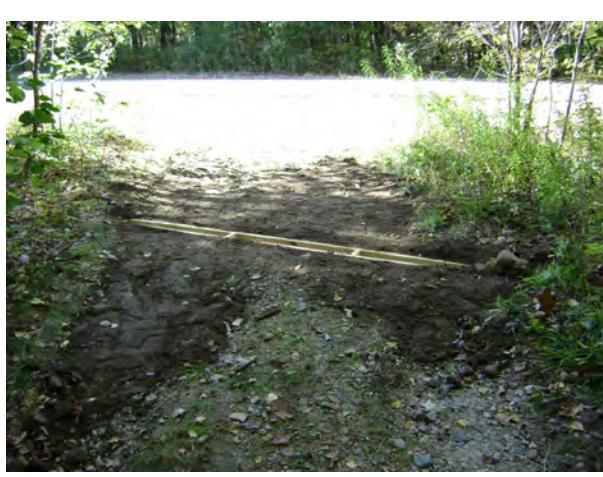
Celia Thibodeau After
