The Acton Wakefield Watersheds Alliance Youth Conservation Corps

2018 Season Report

October 2018

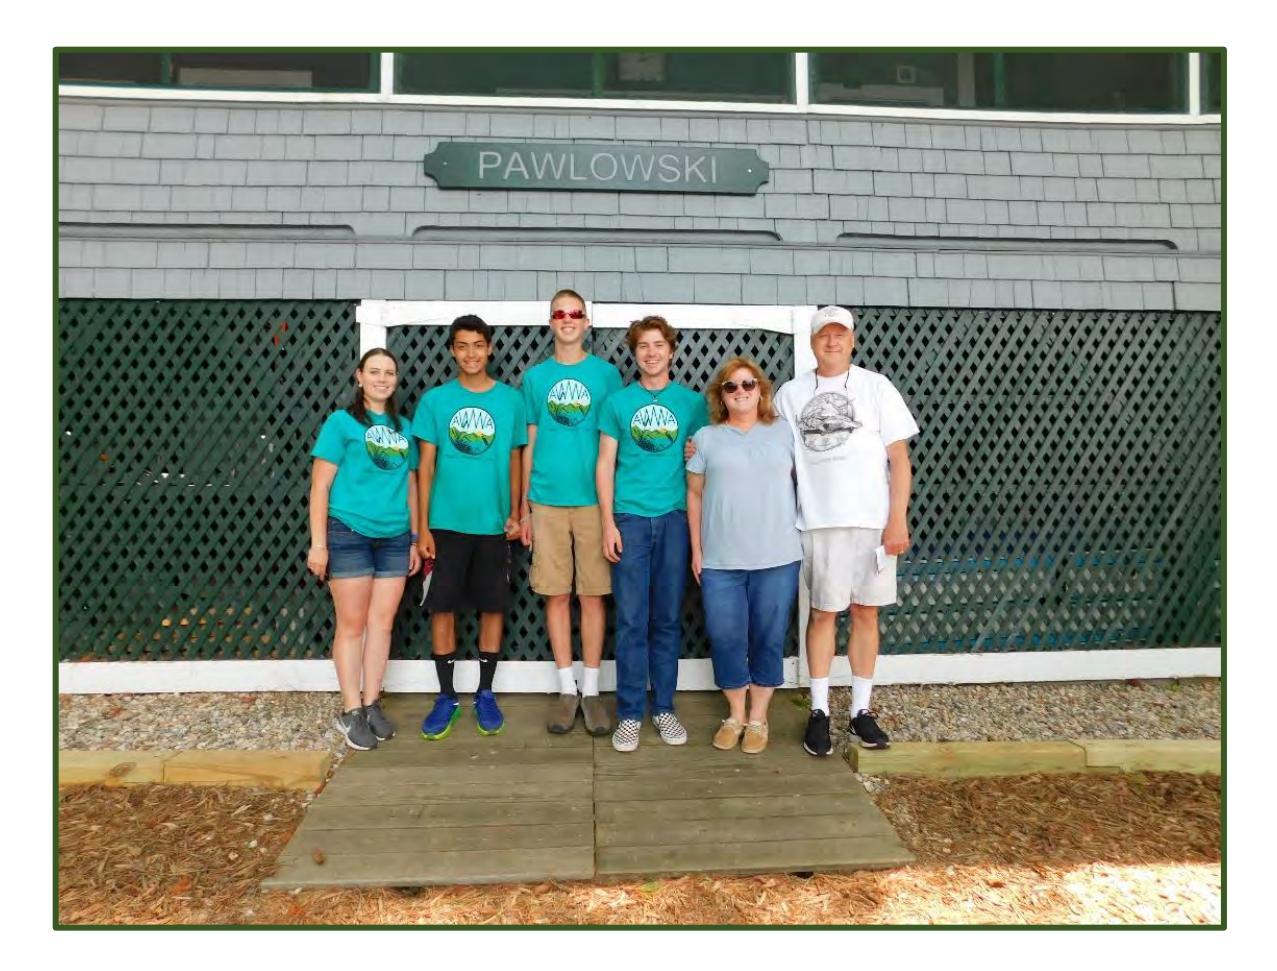
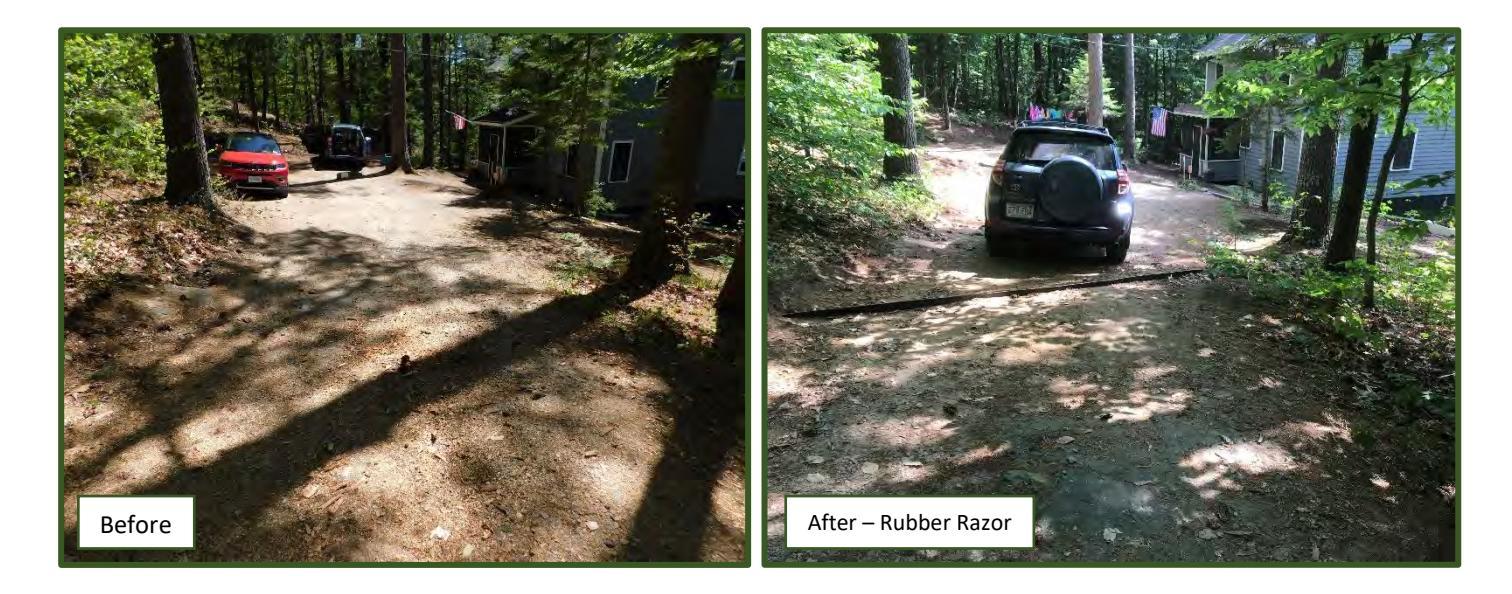
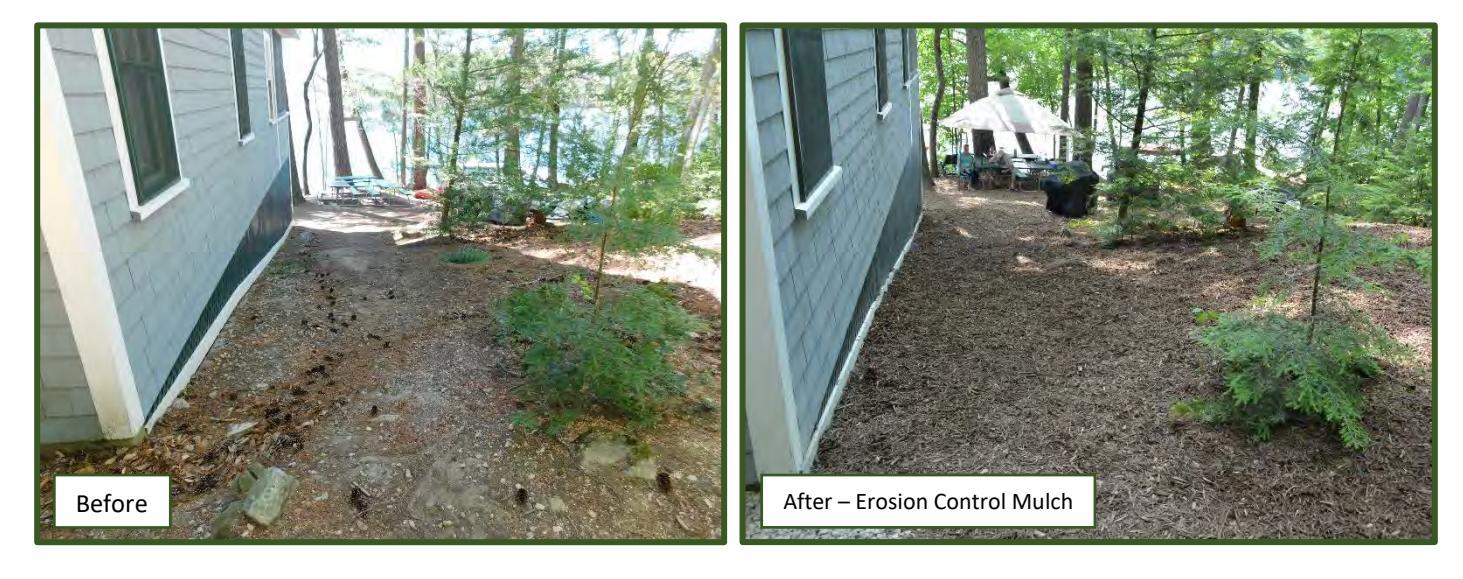
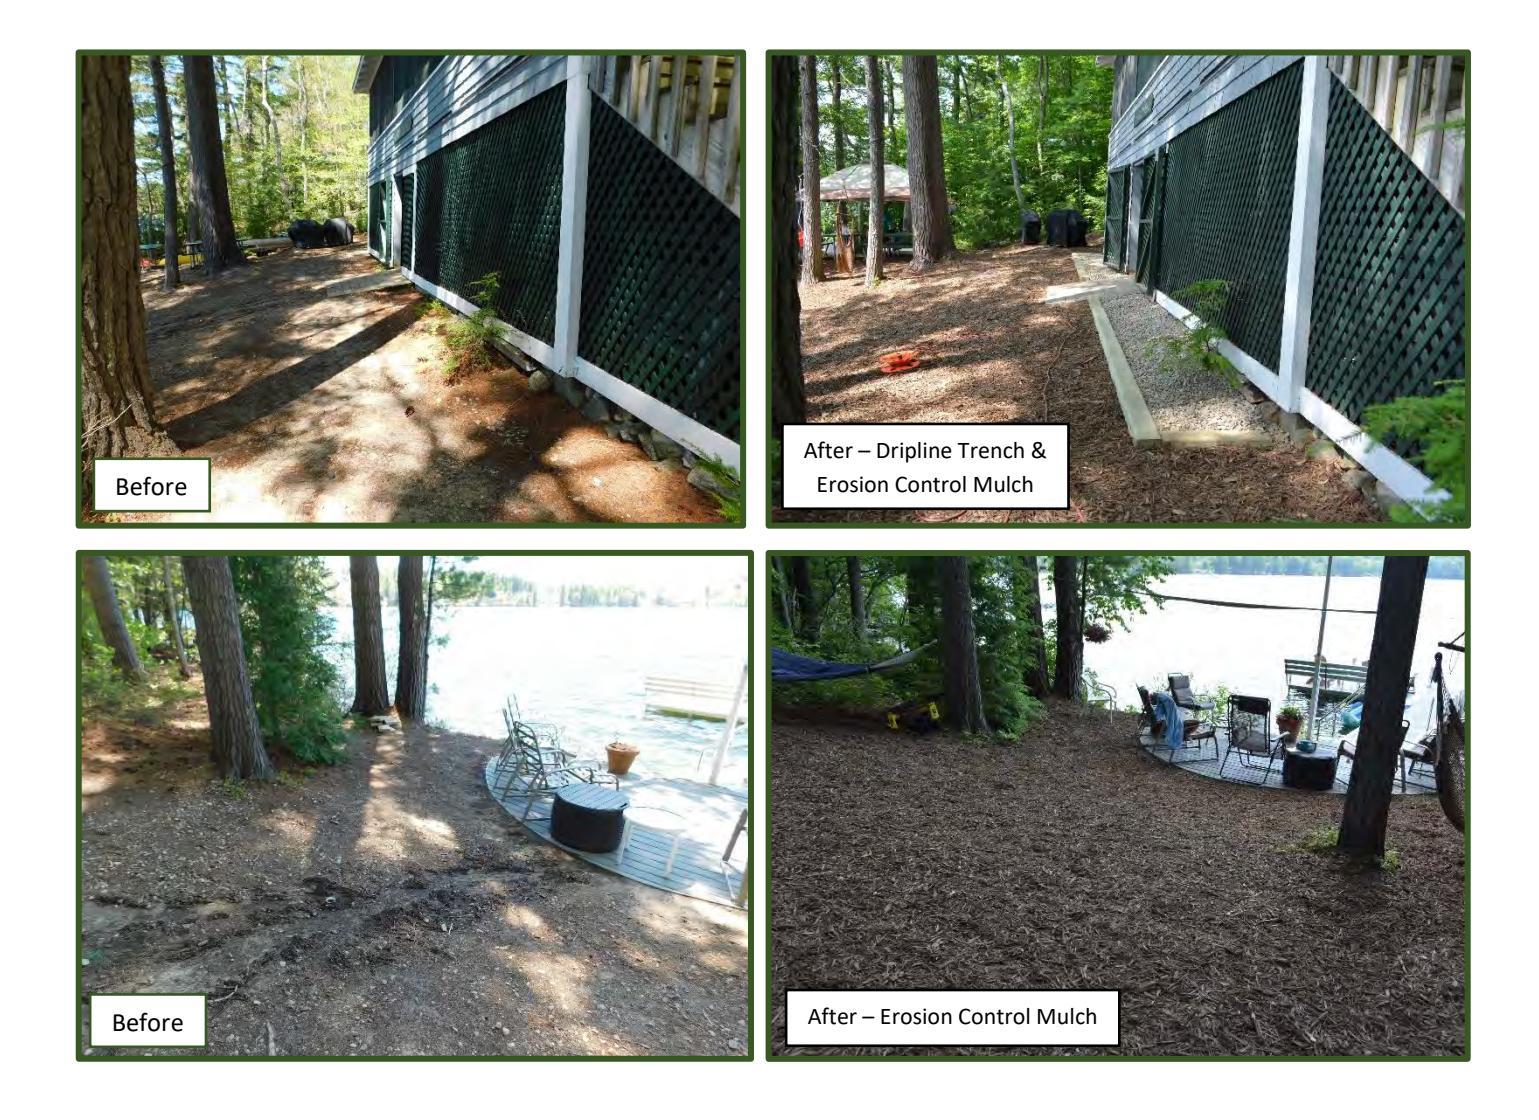
David & Jeri Pawlowski / Susan & Richard Cadogan Lovell Lake – Sanbornville, NH

David and Jeri contacted us in because they wanted to know if there were any improvements that could be done on their property which they co-own with family. When they first called, their initial concern was with runoff from the road flowing down their long driveway and into their yard. In addition to issues in the driveway, we found some other areas around the property that could be improved to allow for better stormwater infiltration. Most of the yard was bare soil with several erosion gullies. This erosion was the result of very little groundcover, which normally helps keep soil in place. Roof runoff was also a large contributing factor causing erosion all around the house.

To address the erosion issues on this property, the YCC installed a few BMPs around the property to help better manage stormwater runoff. The YCC added a rubber razor in the driveway to divert runoff coming from Brackett Road and from their long driveway into a vegetated area. Three dripline trenches were installed under the roof eaves to catch roof runoff before it can flow across the yard. These dripline trenches were boxed in with pressure treated lumber to contain the crushed stone and to allow for more holding capacity. In addition, the YCC crew spread erosion control mulch around the entire yard to prevent the bare soils from washing into Lovell Lake. Since the project was completed, there have been several heavy rainstorms and the project has been working effectively. This project was highlighted on our end of the season project tour.

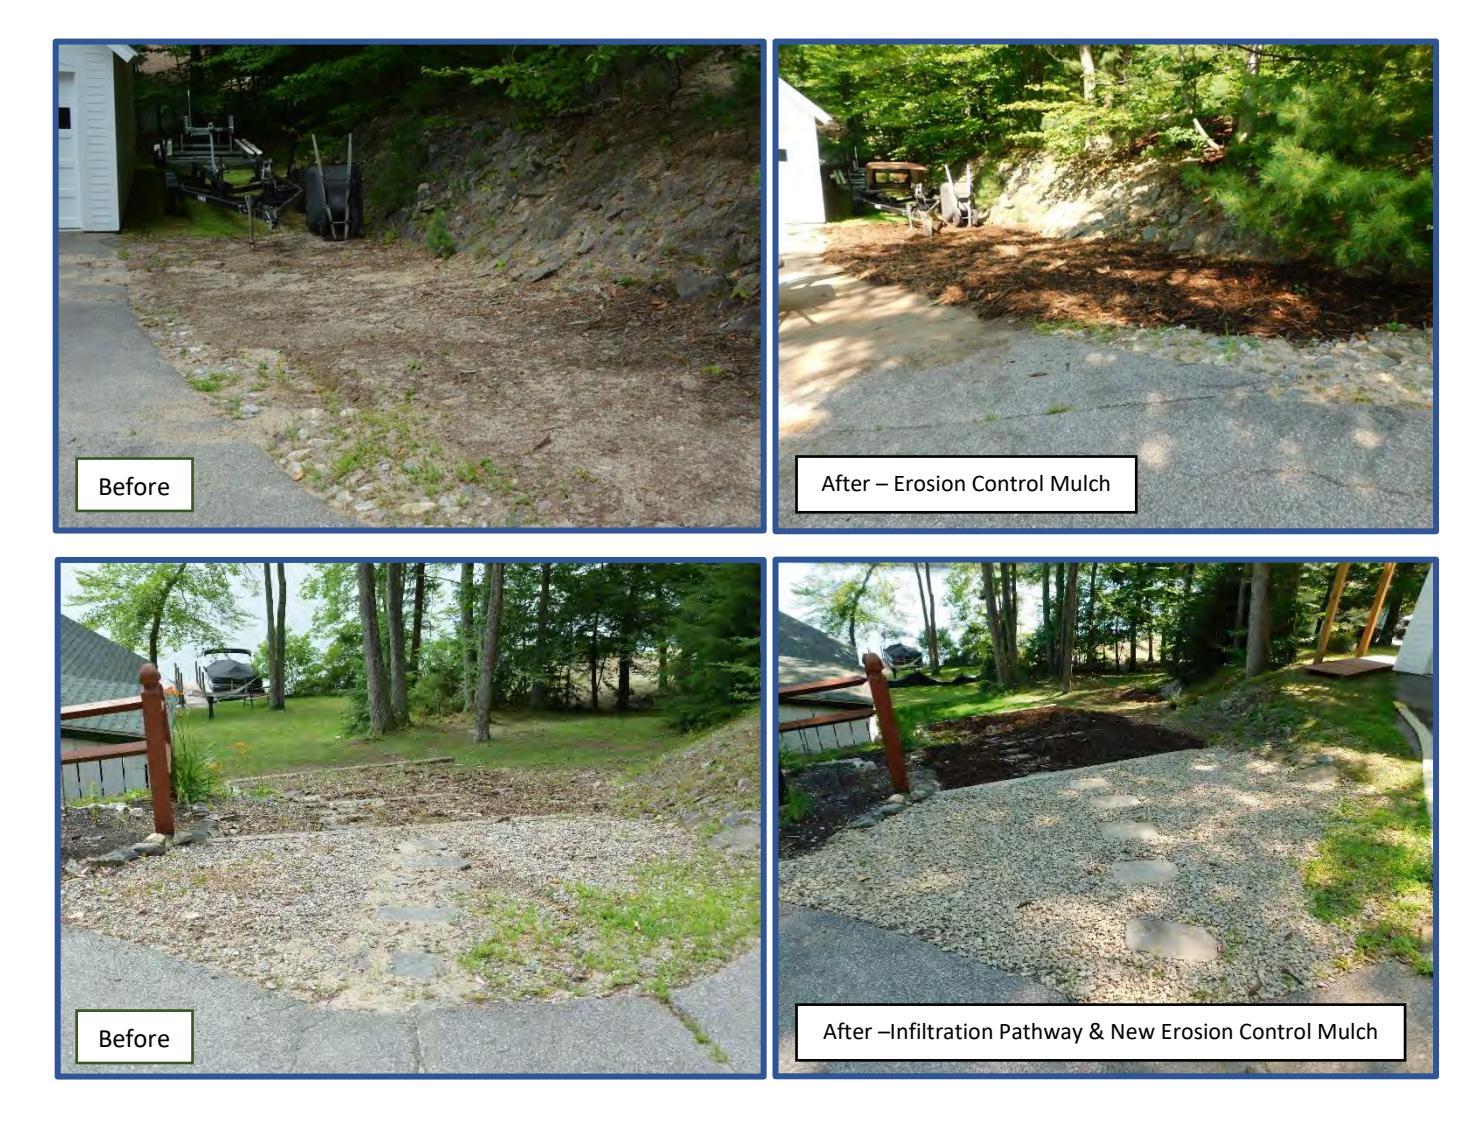
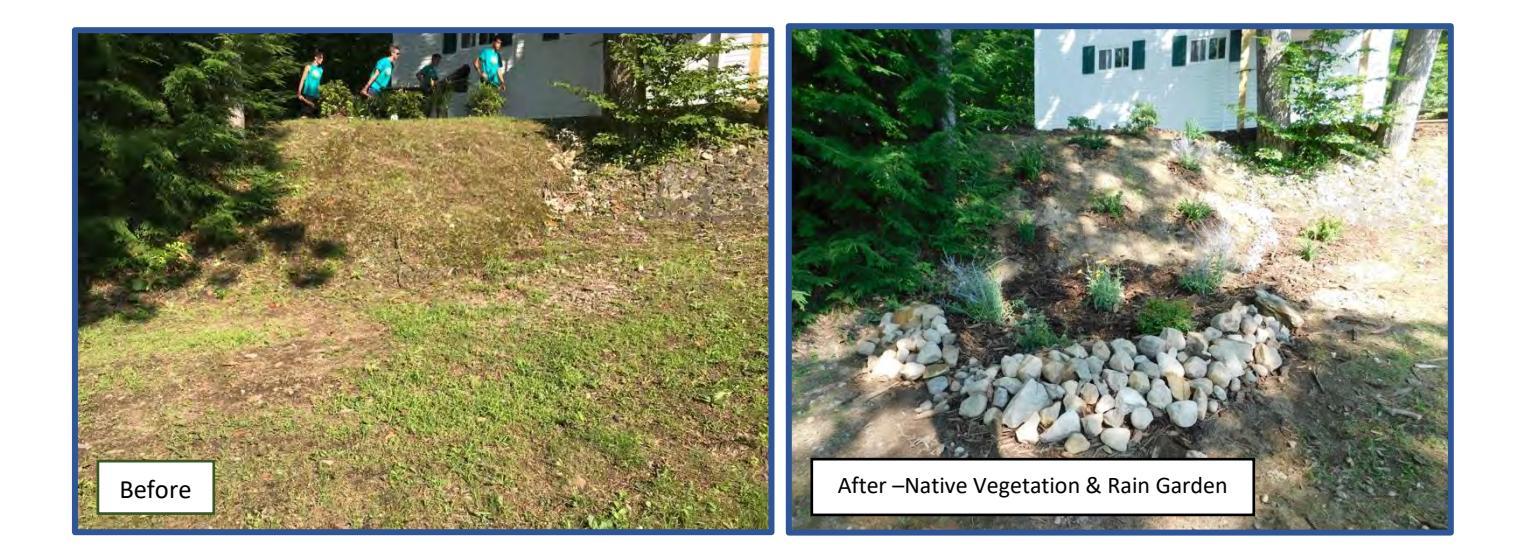
Back in 2010, the YCC installed waterbars, erosion control mulch, an infiltration trench, and a rain garden on Anusia's property. The original project needed to be spruced up, and some additional BMPs were added to better manage stormwater on this property. The pathway that was installed back in 2010 was washing out in one of the corners, and had become clogged with sand over time. In addition, the original erosion control mulch had degraded and needed to be replenished.

This summer, Anusia had some other problem areas she wanted to address. Along the driveway and next to the garage, there were some bare areas that needed to be stabilized. The YCC added erosion control mulch to prevent sediment from washing away. On the other side of the garage there is a steep hill that had some scarce grass on it. The hill leads to the grassy lawn allowing stormwater to flow easily across the yard towards the lake. In addition, a gutter is directed to the area alongside the hill. To catch stormwater coming from the hill and from the gutter, the YCC added some native vegetation, erosion control mulch, and installed a rain garden.

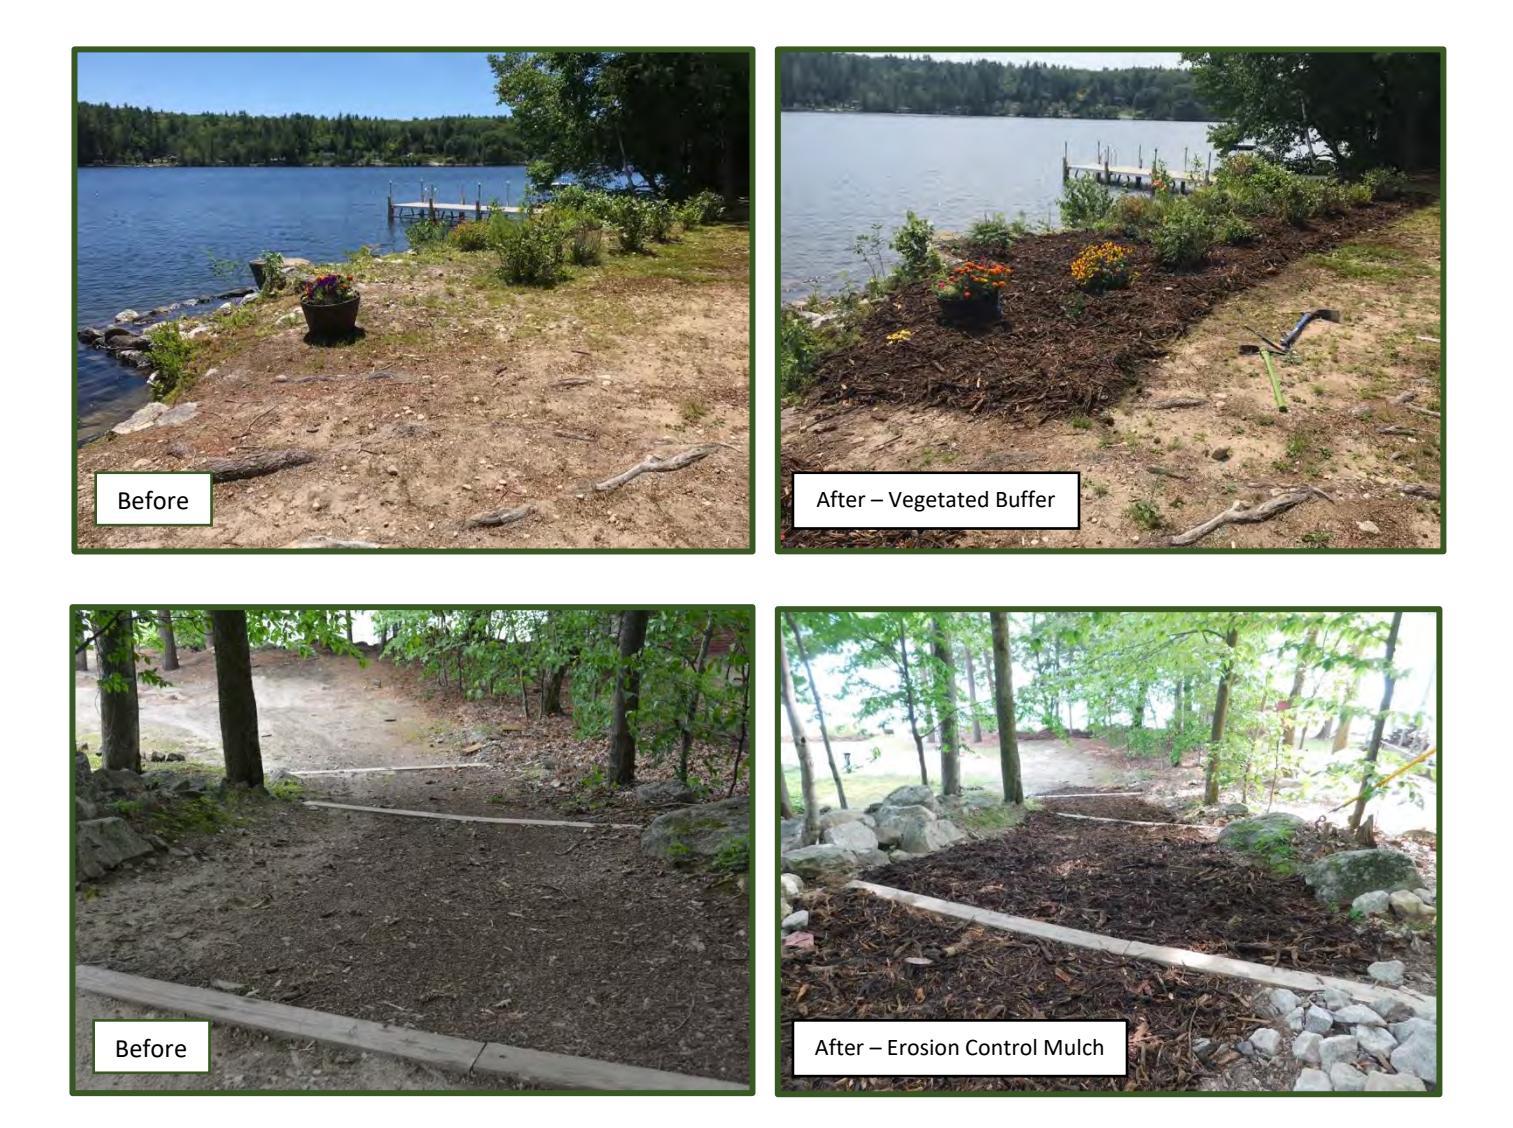
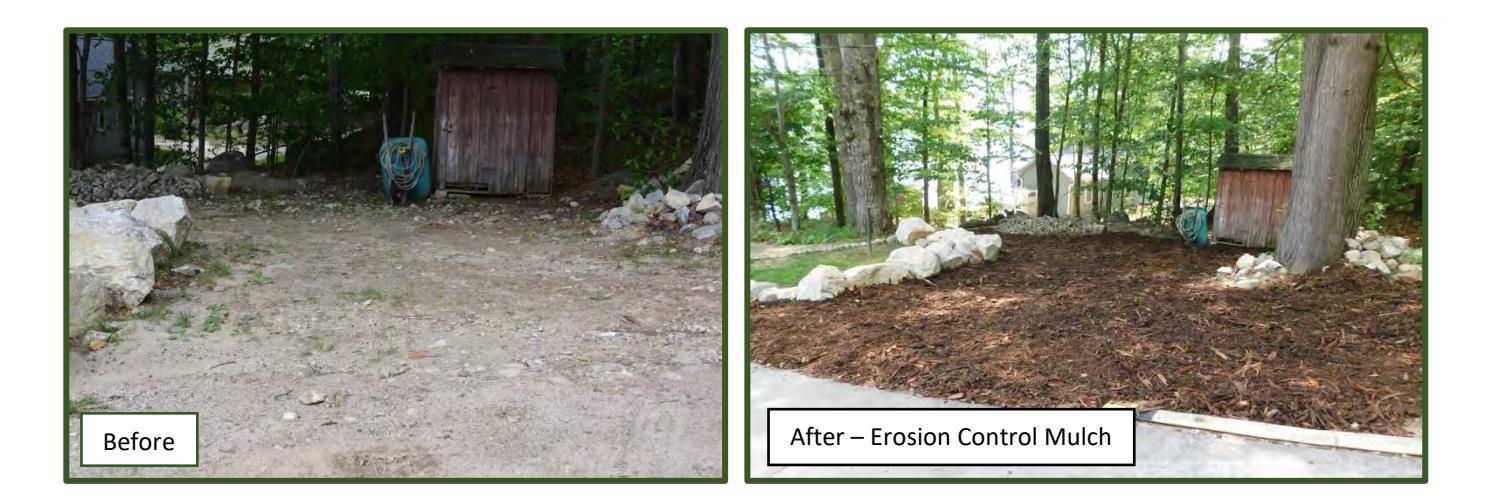
In 2016, the YCC completed a project on Anusia's other property next door to her house. Originally, the YCC installed several BMPs around the property including two rain gardens, an infiltration trench, waterbars and erosion control mulch. This summer, Anusia called AWWA concerned about the water's edge. Along the water there was an existing buffer made of natural plants and plants Anusia has added.

The YCC enhanced the buffer by adding more native plants and erosion control mulch. Plants help filter pollutants out of stormwater before they enter the lake, and they also provide root structure keeping soil in place. Erosion control mulch not only protects underlying soil, but it also improves the soil as it decomposes. In addition to the buffer, the crew spread mulch on an area of bare soil uphill of the lake. Without adding groundcover, the sandy soil would easily wash away. The YCC also replenished the mulch in between the waterbars from the project in 2016.

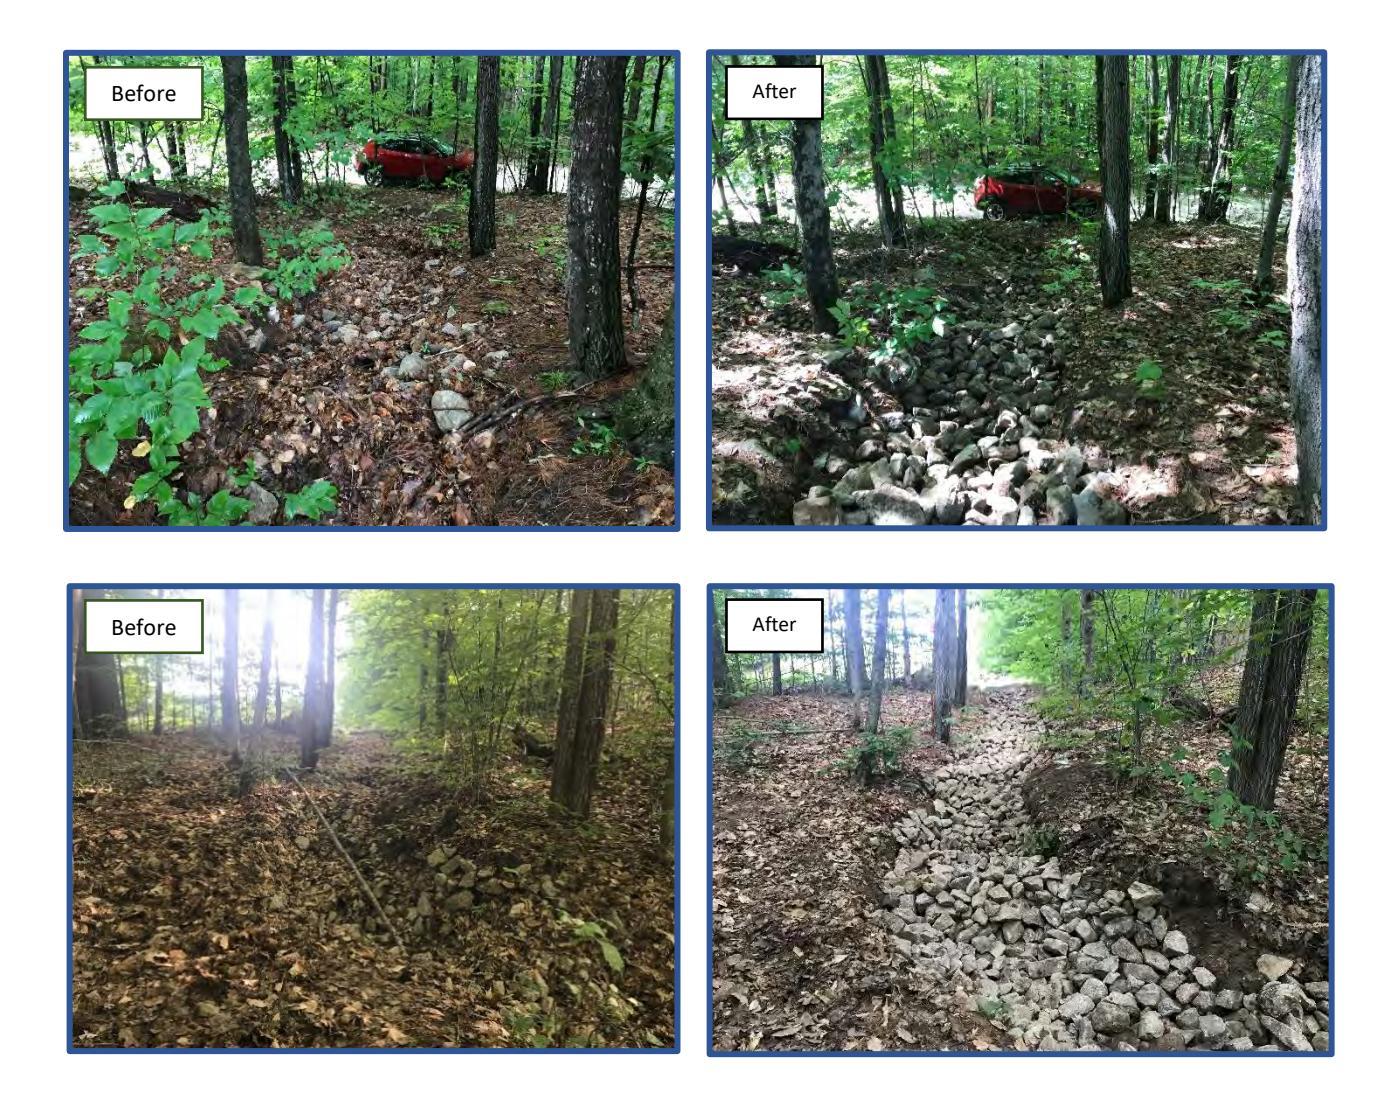
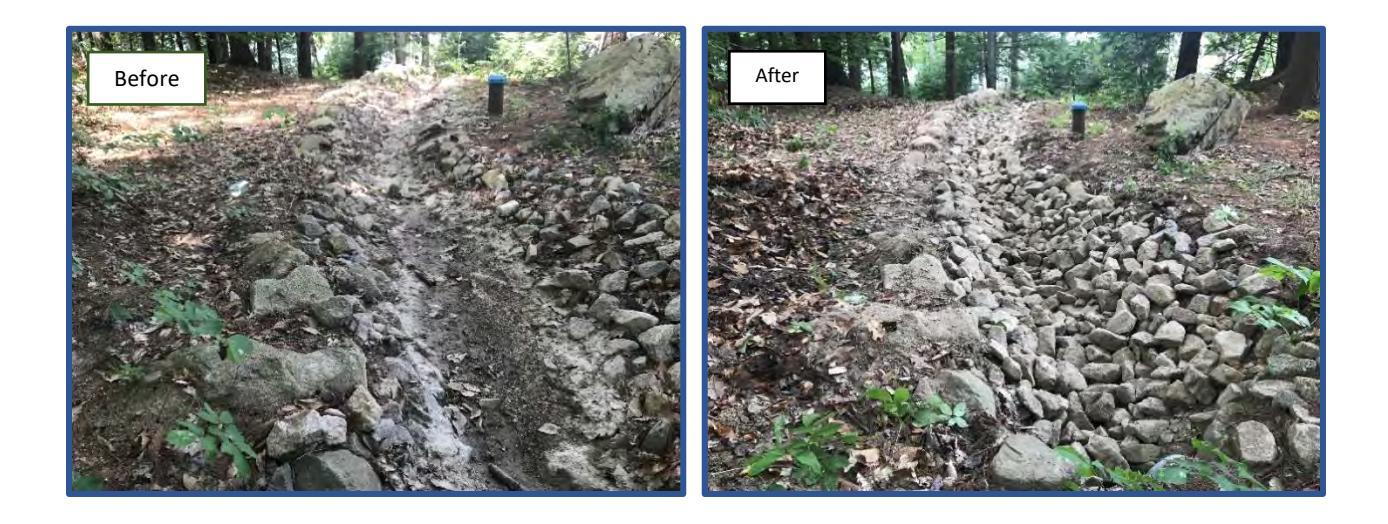
Brackett Road Trenches

In 2014 the YCC installed infiltration trenches on Brackett Road. These projects were done in conjunction with the UNH Stormwater Center and Wakefield DPW as part of the Brackett Road projects. This year, the YCC had some availability and notcied that the trenches could use a cleaning. The crew spent a day cleaning out the trenches and making them more functional.

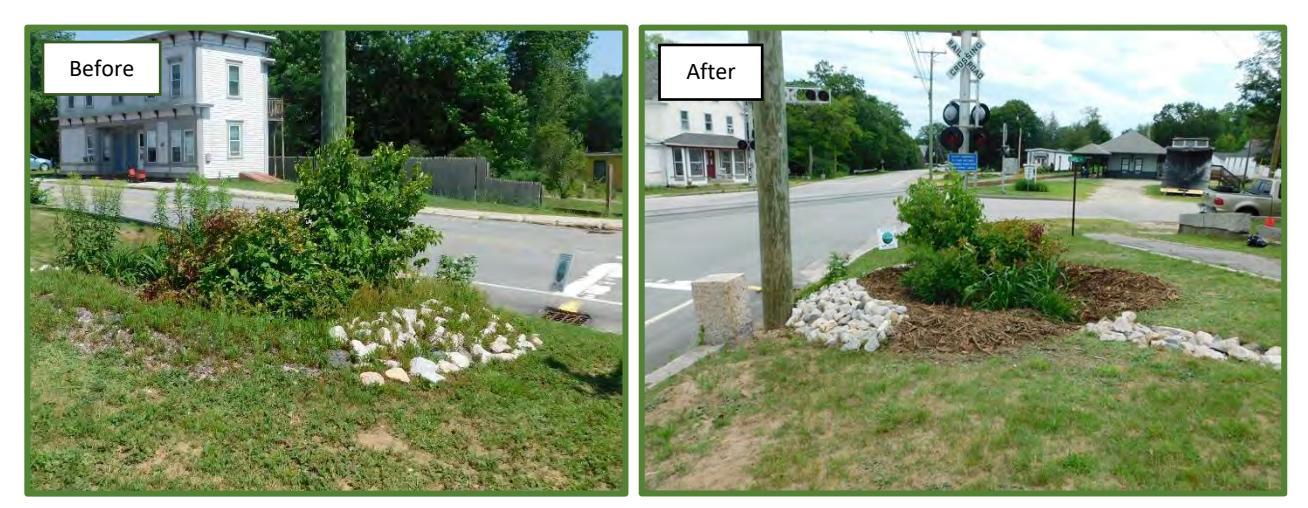
Canal Road

Many of the municipal sites we have worked on need continued maintenance in order for them to work properly and effectively. This summer, an infiltration trench along Robinson Road on the Great East Lake Canal was cleaned of sediment and debris. Before being installed in 2008, water would flow across a flat, gravel open area, picking up sediment, crossing paved Canal Road, and would subsequently flow into the Great East Lake/Horn Pond canal. Continued maintenance is essential to keeping this a highly effective BMP.

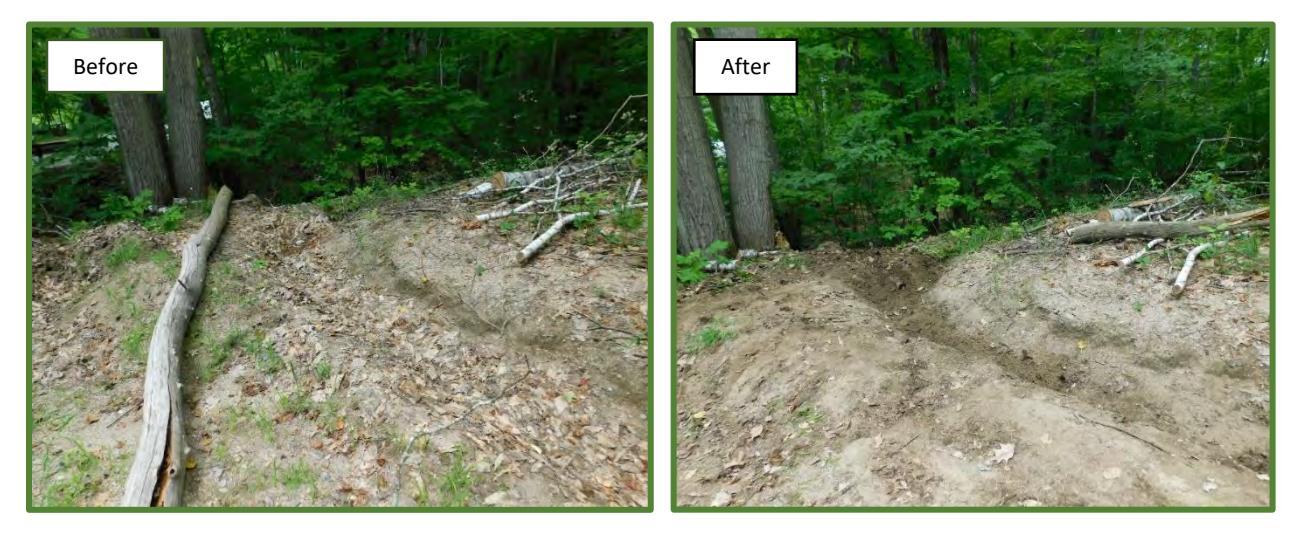
Gottlieb Detention Basin & Firehose Diverters

In 2007, a detention basin was installed where Veazey Point Road meets Charlene's driveway. Firehose diverters were also added to the very steep driveway to direct water into a wooded area.

Almost every year the YCC removes sediment from the detention basin because it clogs with road material. This year the crew also replaced 2 firehoses that were over 10 years old and falling apart. The old hoses had large rips and tears and therefore were not catching sand like they should.

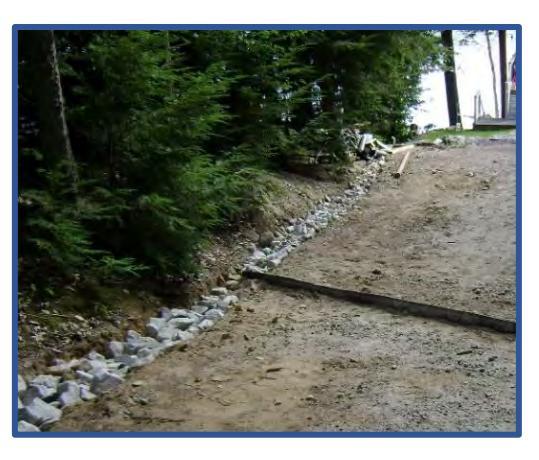
AWWA installed a project at St. Anthony's Church in 2007. The church sits directly in front of the Branch River and since then the project has been maintained annually. This year, accumulated sediment was removed from the infiltration trench located along the parking lot.
